Waldo Fire Recovery

Overview

The Waldo Canyon Fire Master Plan for Watershed Restoration & Sediment Reduction

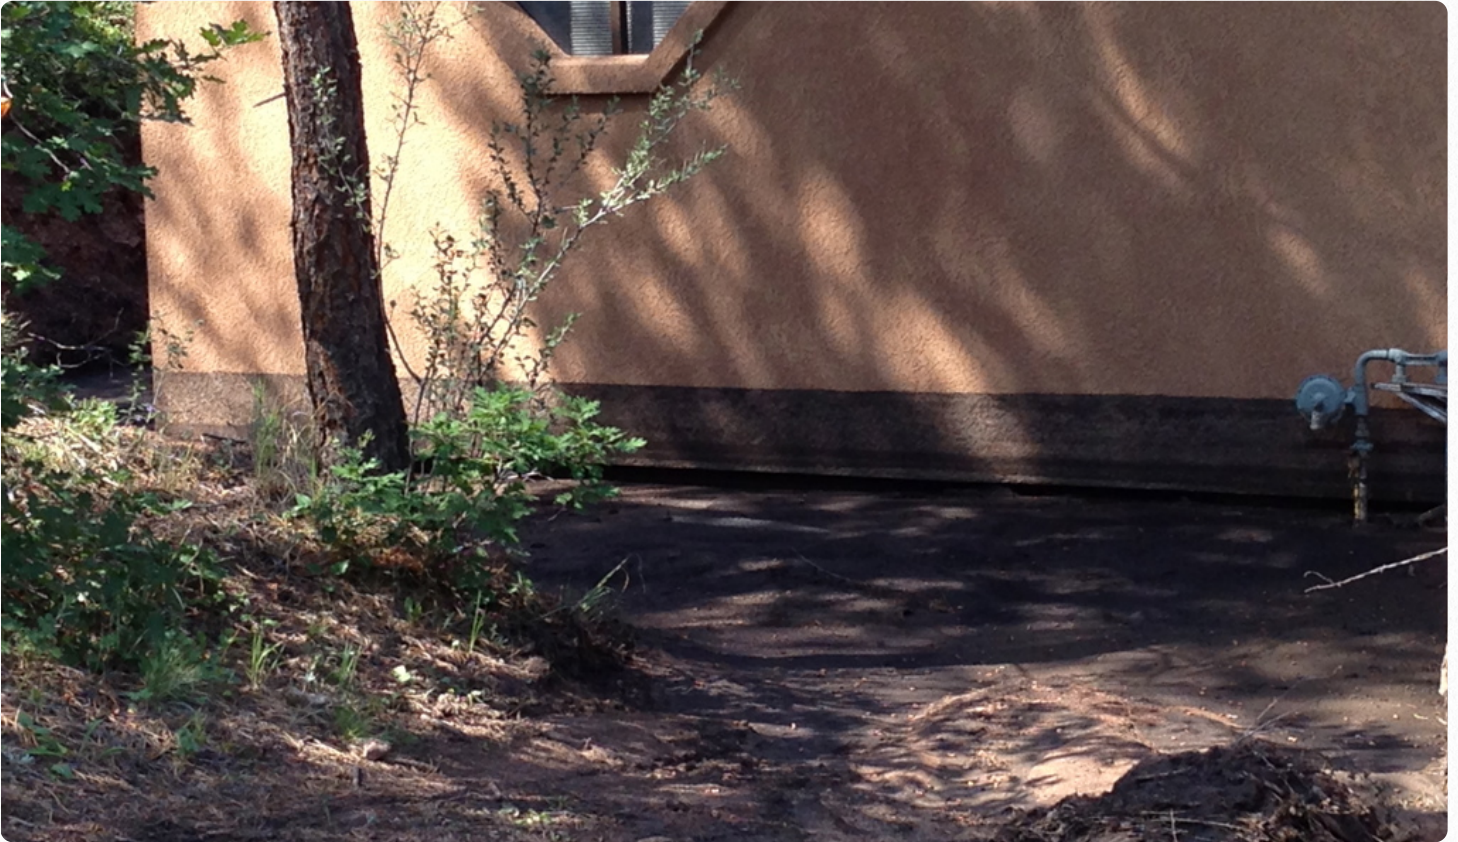
Mud flow line from a post-fire flood on a home in Cascade.

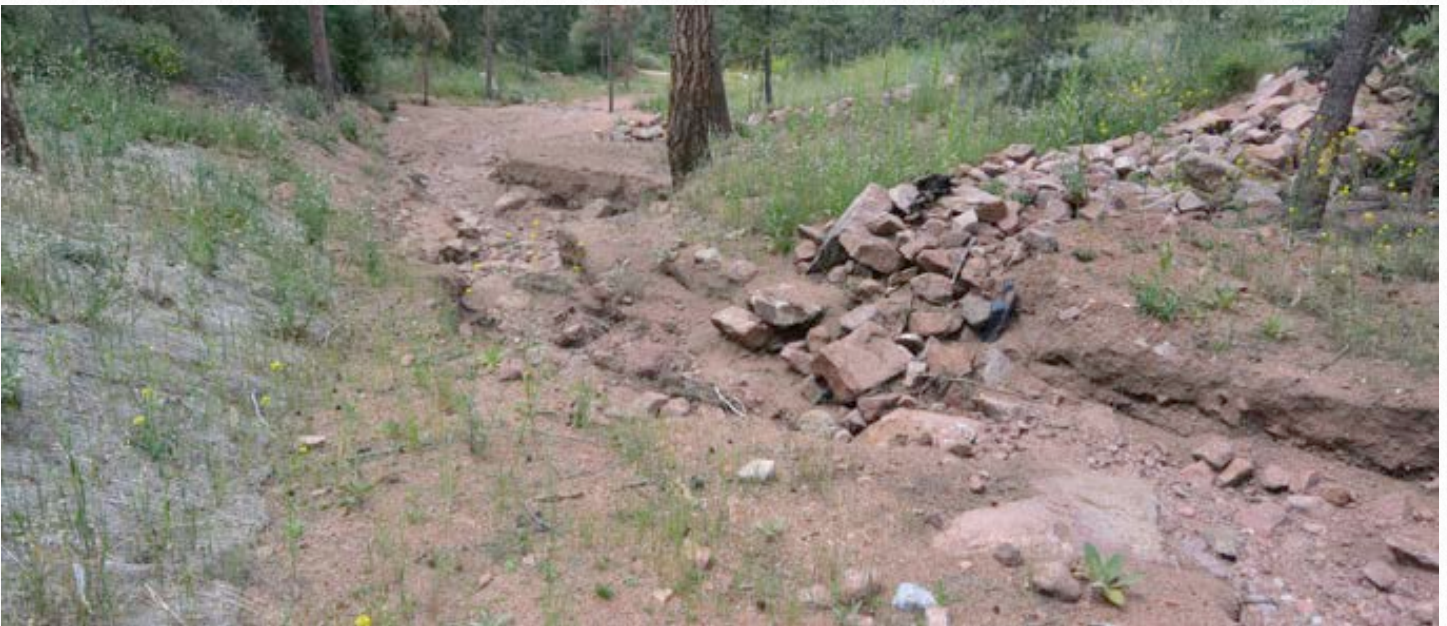
The hard-engineered structures were somewhat effective, with the exception of the bendway weirs, where we observed that 70 % of these treatments were at least partially failed. Bendway weirs likely are not a good choice in this particular channel, given the small substrates found and the mobility of the decomposed granite materials comprising the channel bottom. In every case, we observed channel down cutting at the channel end of these weirs, resulting in the bed eroding to a lower level and increasing the slope of the banks in the immediate vicinity of the weir.

Bendway Weir causing channel down cutting in Lower Cascade Creek.

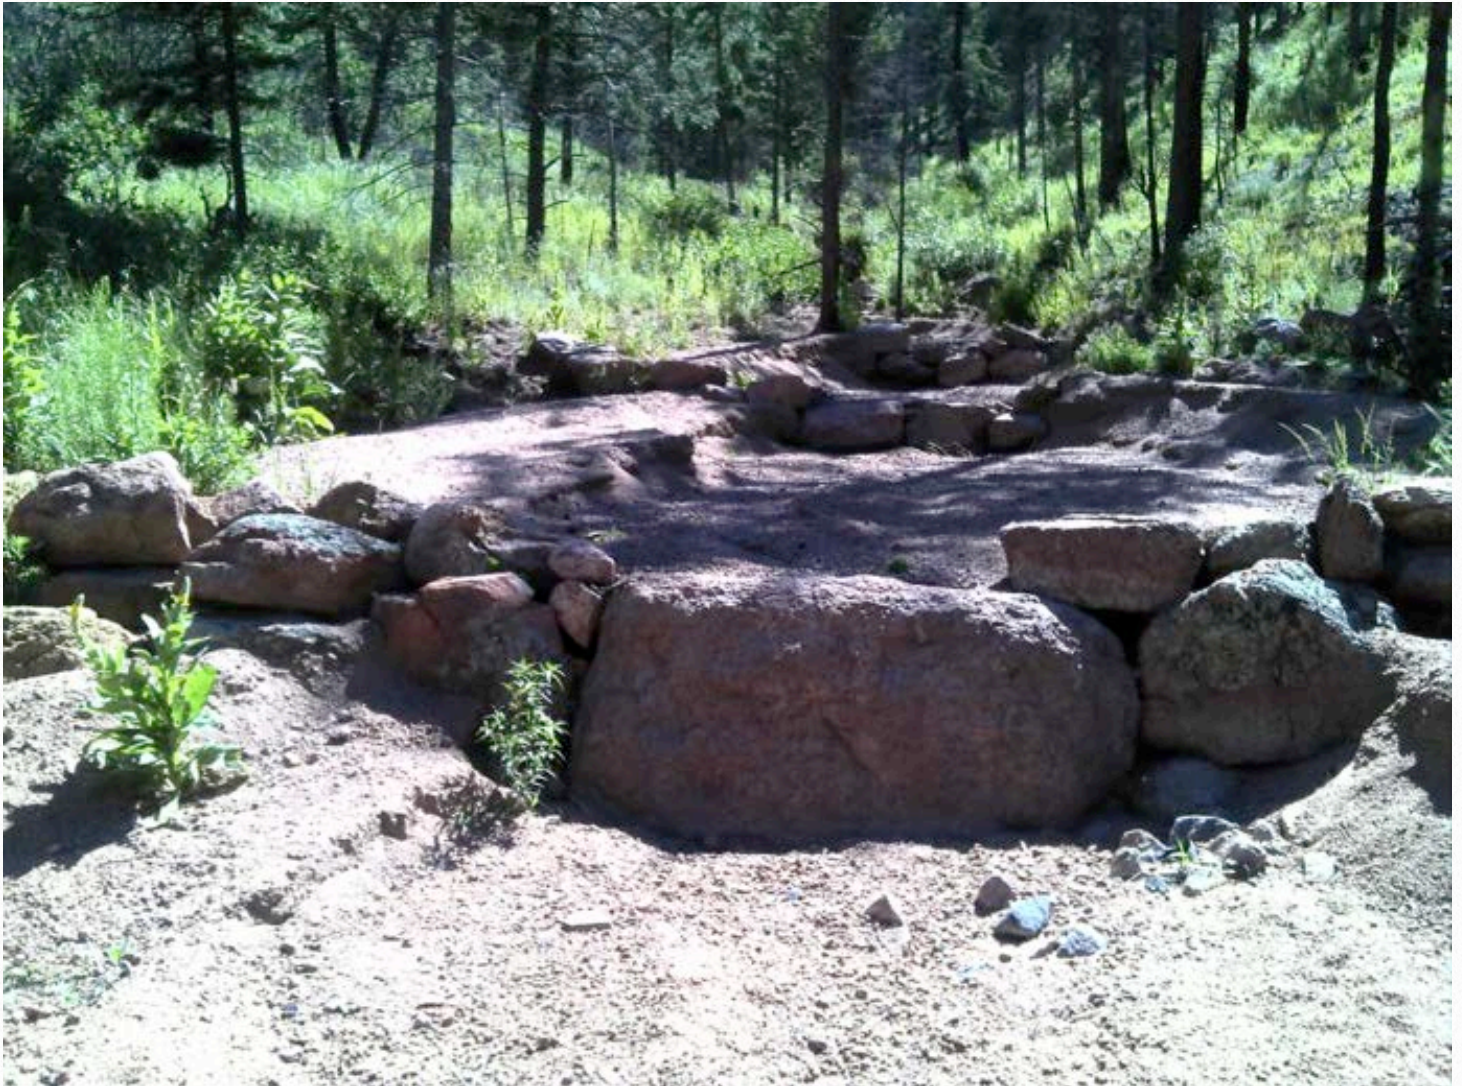
Boulder Drop Structures in Upper Cascade Creek

Both natural channel and engineered treatments have been effective in the upper Cascade Creek reach. Boulder drop structures and log sills were the most common treatments, which would be expected in this higher gradient transport reach. Failure rates of these structures were less than observed in other sub-basin. Sediment basins in the reach were still providing storage for flood debris and sediment, even though one crib wall was functioning at risk, and one basin sill had completely failed. We did observe that some of the hard treatments had not performed as well as expected, most notably a rip rapped bank that had partially failed due to collapse of the toe slope. Additionally, one of the two rip rapped channels observed in the lower segment of the reach appeared to be functioning at risk, and may not withstand a future significant flood event. Overall, 77% of the treatments

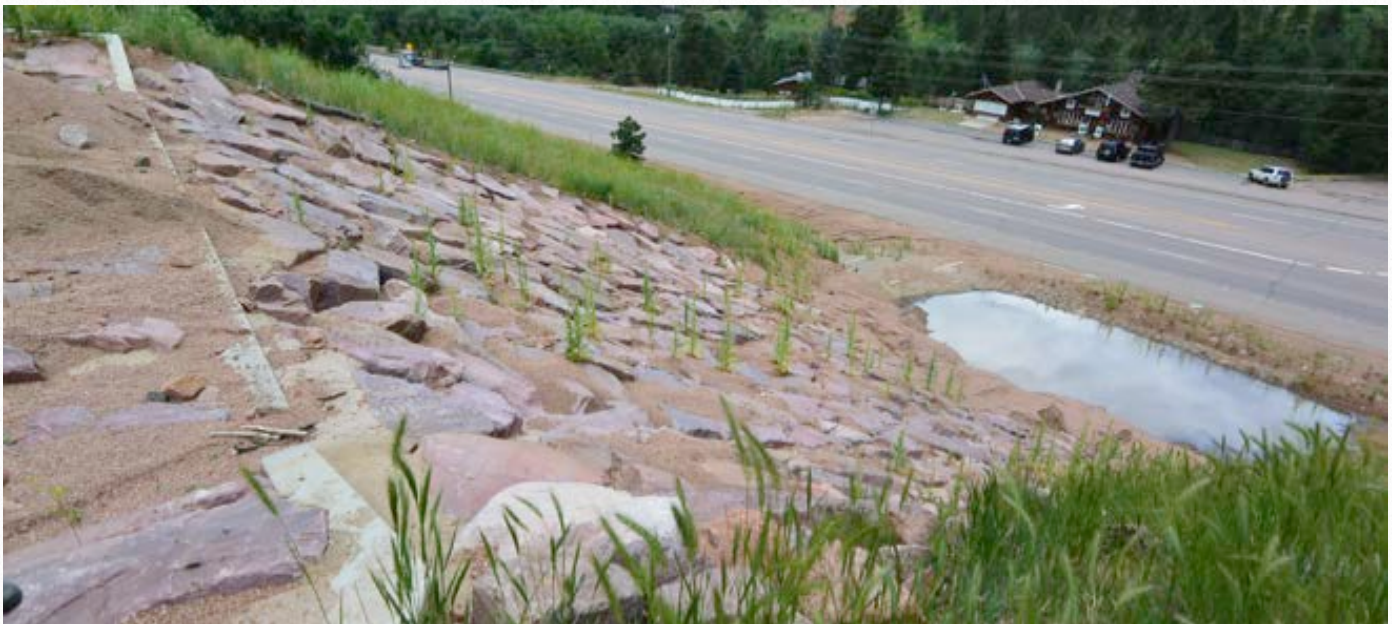
The hard engineered structures are, for the most part, very effective, with the exception of a failed rip rap bank, which had failed due to undermining of the toe of the bank. A concrete box culvert had also partially failed, but was still functioning. Overall 86% of the work was still functioning as designed, although the sediment basins and the ditches along the highway downstream of Spring Gulch require regular maintenance after every storm. Increased run-off velocities are an issue, and tend to cause down cutting of channels immediately below the hardened channels. The ditch along the west bound lane of US24 immediately downstream of Spring Gulch is particularly susceptible to high flow erosion. Given the intensive maintenance requirements we rated the overall work as functioning at risk.

Massive Grouted Boulder Drop Structure & Basin at Spring Gulch.

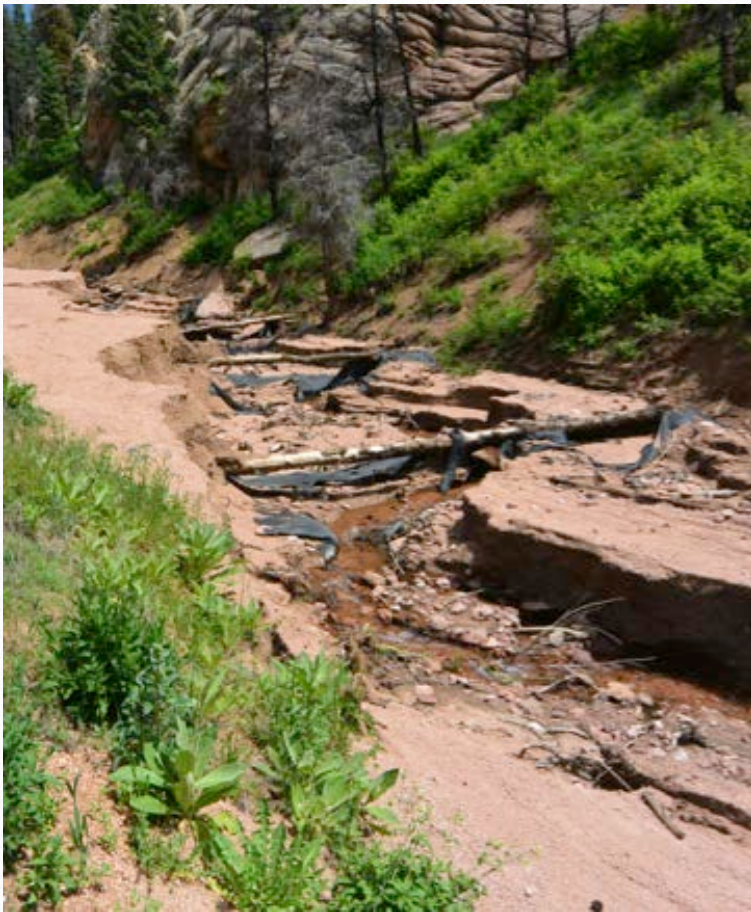
One of the key lessons throughout this evaluation, and that we took away fairly early, was that single-log sills do not work well in a brand new fire scar, though they were very effective 10 years after Hayman. Buried log sill walls, on the other hand, did perform well. Although they failed, during repeated cycles of flooding they would aggrade again, and once vegetation reestablished they were functioning (circa 2016).

Failed sills in Middle Wellington

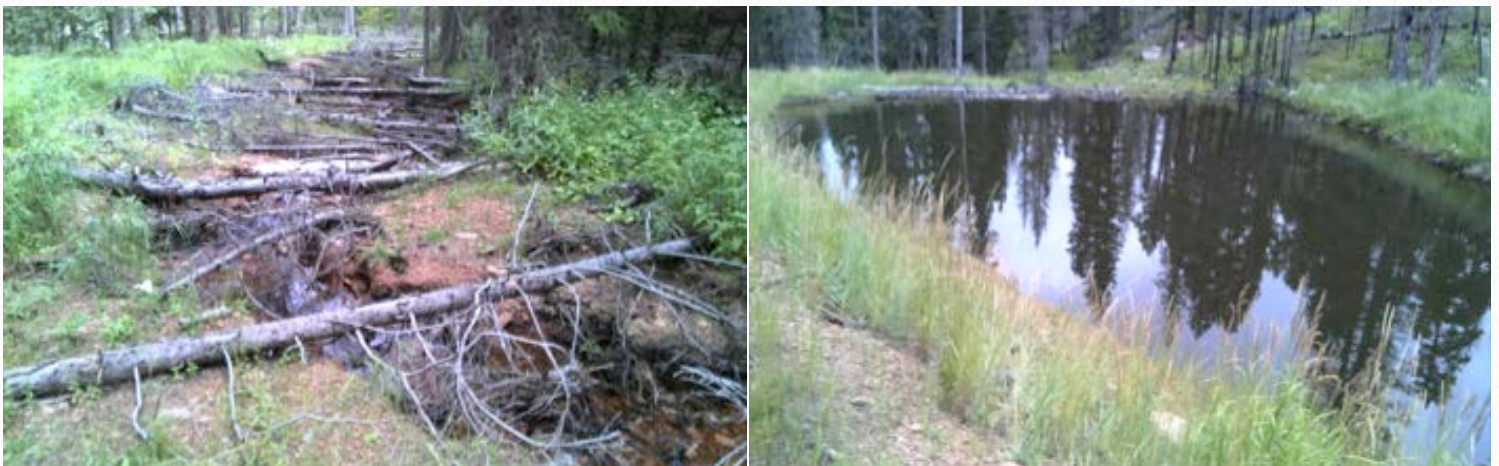
The two sediment basins in the project reach are still functioning to capture sediment and debris, despite the fact that the log crib walls and basin log sills on each feature have failed. The lower basin still has some storage capacity, but will likely fill up in the near future. A segment of the channel between the two basins was hardened by laying dozens of small diameter cut logs across the channel perpendicular to the flow (log corduroy). While this treatment may have helped add roughness to the surface, it failed in the first rain.

Log corduroy (left) and sediment basin (right)

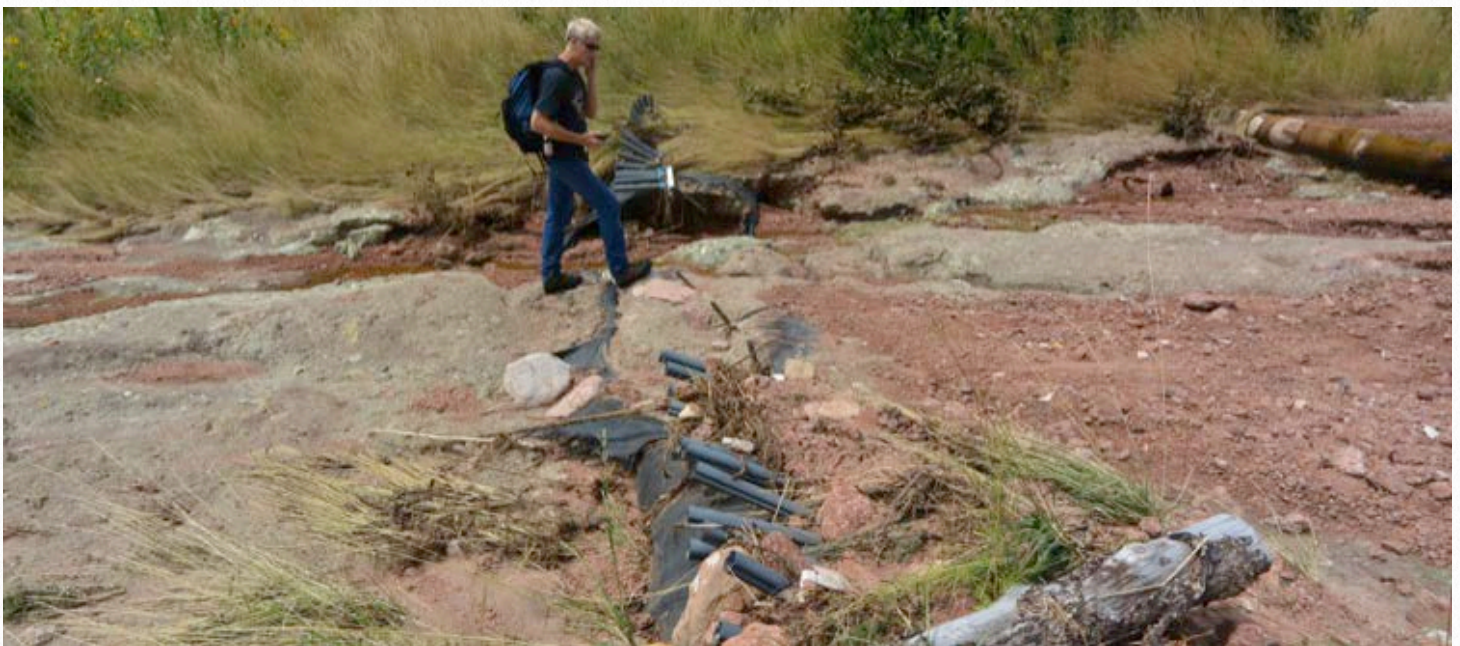
Damaged Whisker Sills: These were a new product recommended by a hydrologist, but they failed quickly.

The upper part of the reach sustained significant damage during the flood event. 40% of the log sills and 90% of the whisker sills sustained damage and were no longer fully functioning. Several of the whisker sills, which are constructed of PVC plastic pipe, had shattered, likely due to the large boulders and cobbles that were mobilized in the channel during the flood. The sediment basin, although damaged, was still functioning, and was being excavated by the City of Colorado Springs during the course of our survey. The trap bag walls surrounding the school were still fully intact, but flood was high enough to allow water to enter the building around these features.

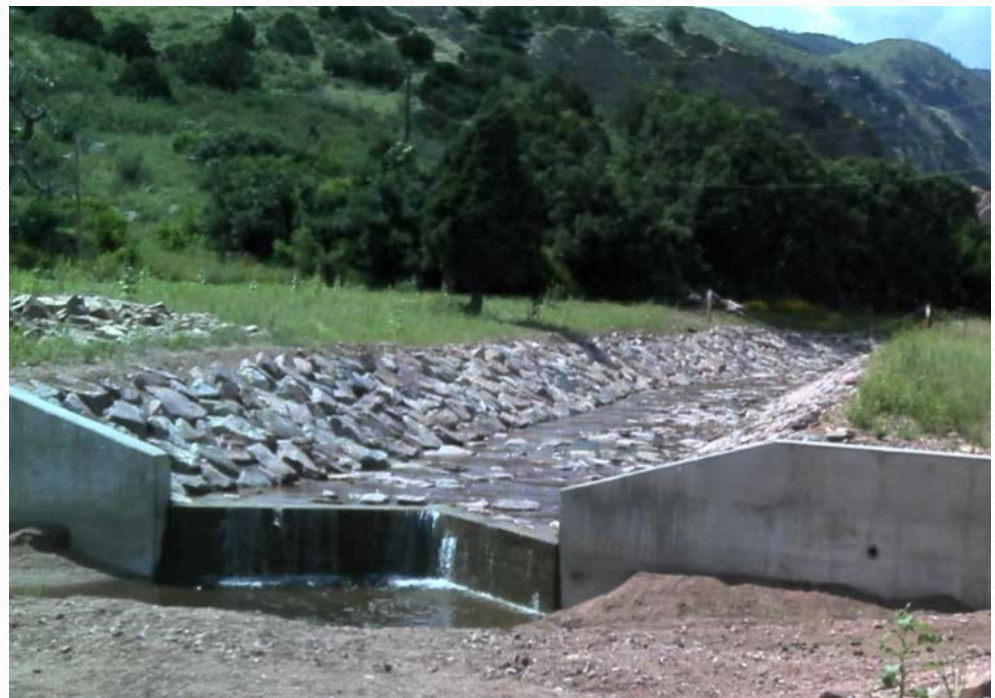
The hard engineered treatments through the Navigators compound appear to be very effective, although there was some evidence of sediment deposition and channel aggrading in some of the channel segments, which may indicate that the channel will lose capacity over time. The massive debris net at the upstream boundary has effectively captured larger debris coming into the reach from the watershed above.

Riprap channel through Navigators

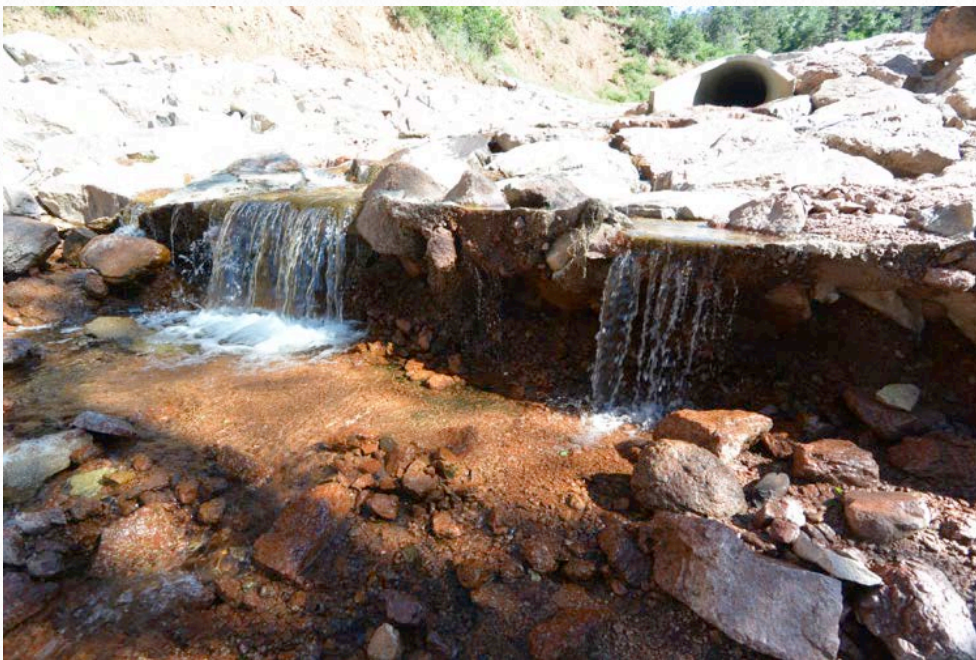
Grouted Rip Rap Channel functioning at risk as the toe begins to erode.

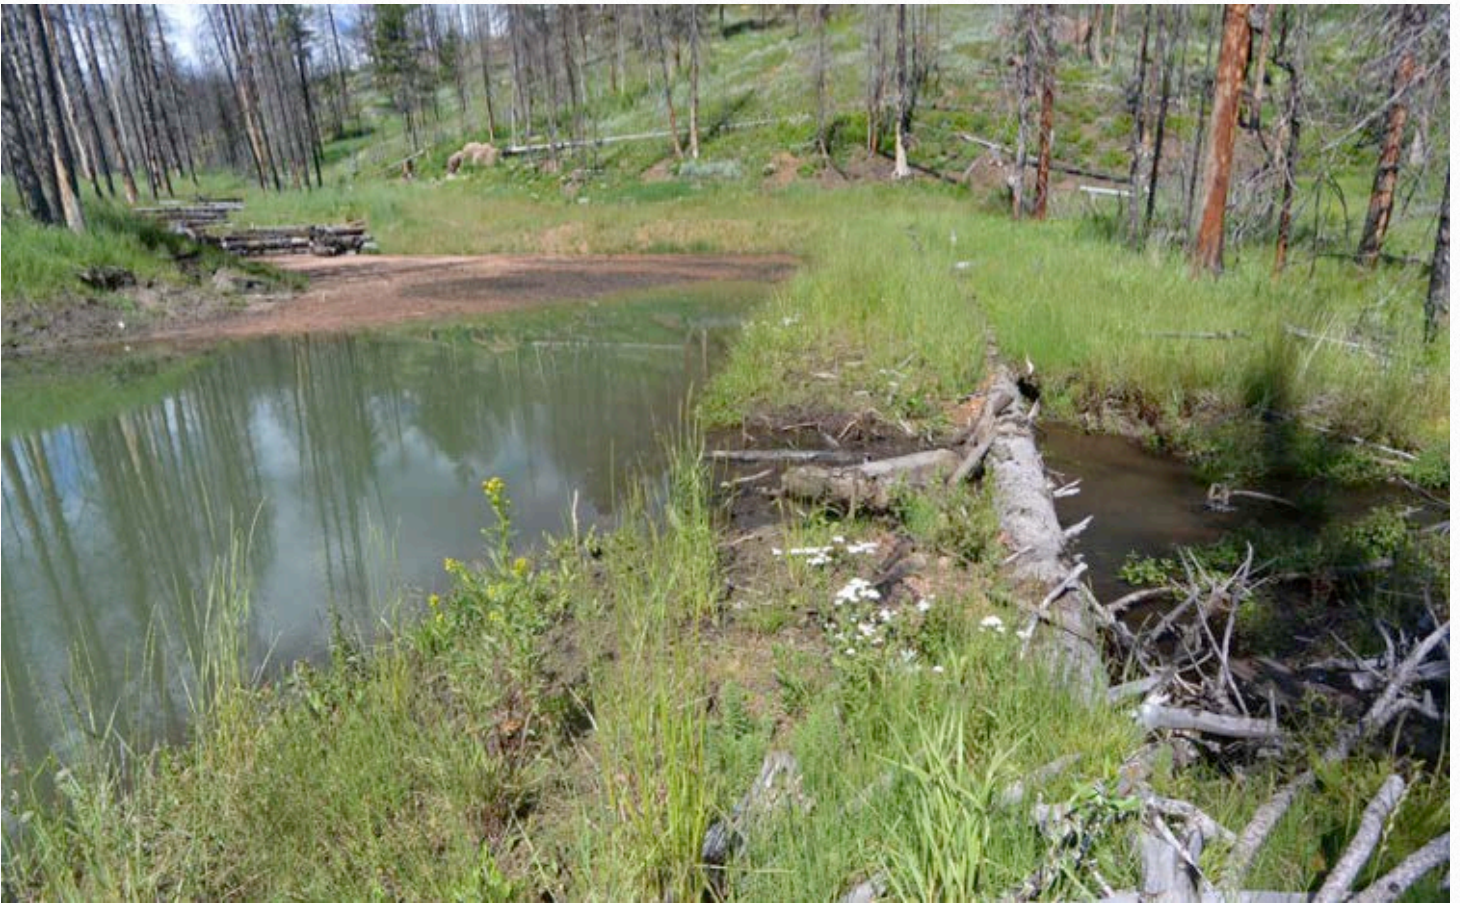
Functioning basin sills in Northfield

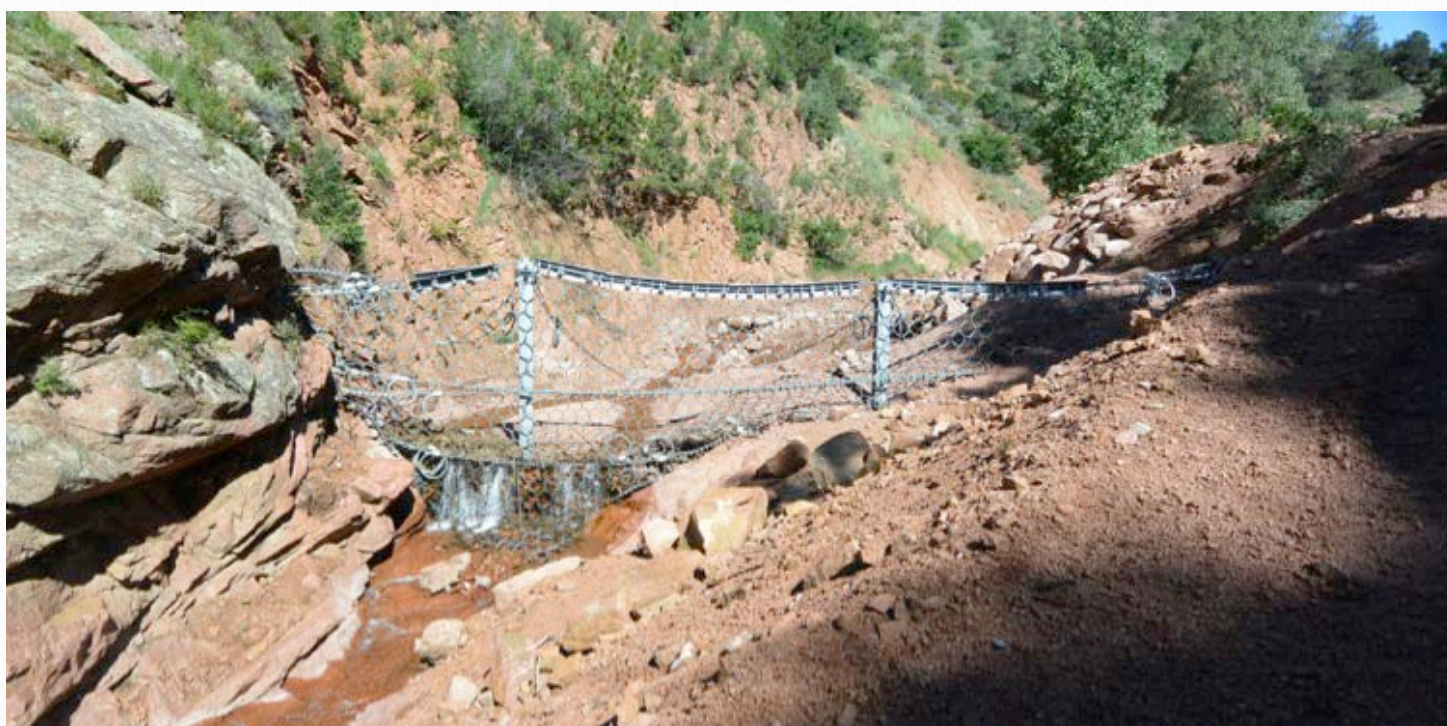
Five steel debris nets have been employed in Camp Creek, lower Williams Canyon and Waldo Canyon to capture larger cobble and boulders, as well as large wood and other organic matter. These structures range in size from the massive net above Glen Eyrie to much smaller detention structures in Waldo Canyon and Williams Canyon. These engineered structures have been very effective in capturing material before it can damage flood control infrastructure downstream, but are quite expensive to install and require frequent maintenance.

CDOT Debris Net in Waldo Canyon

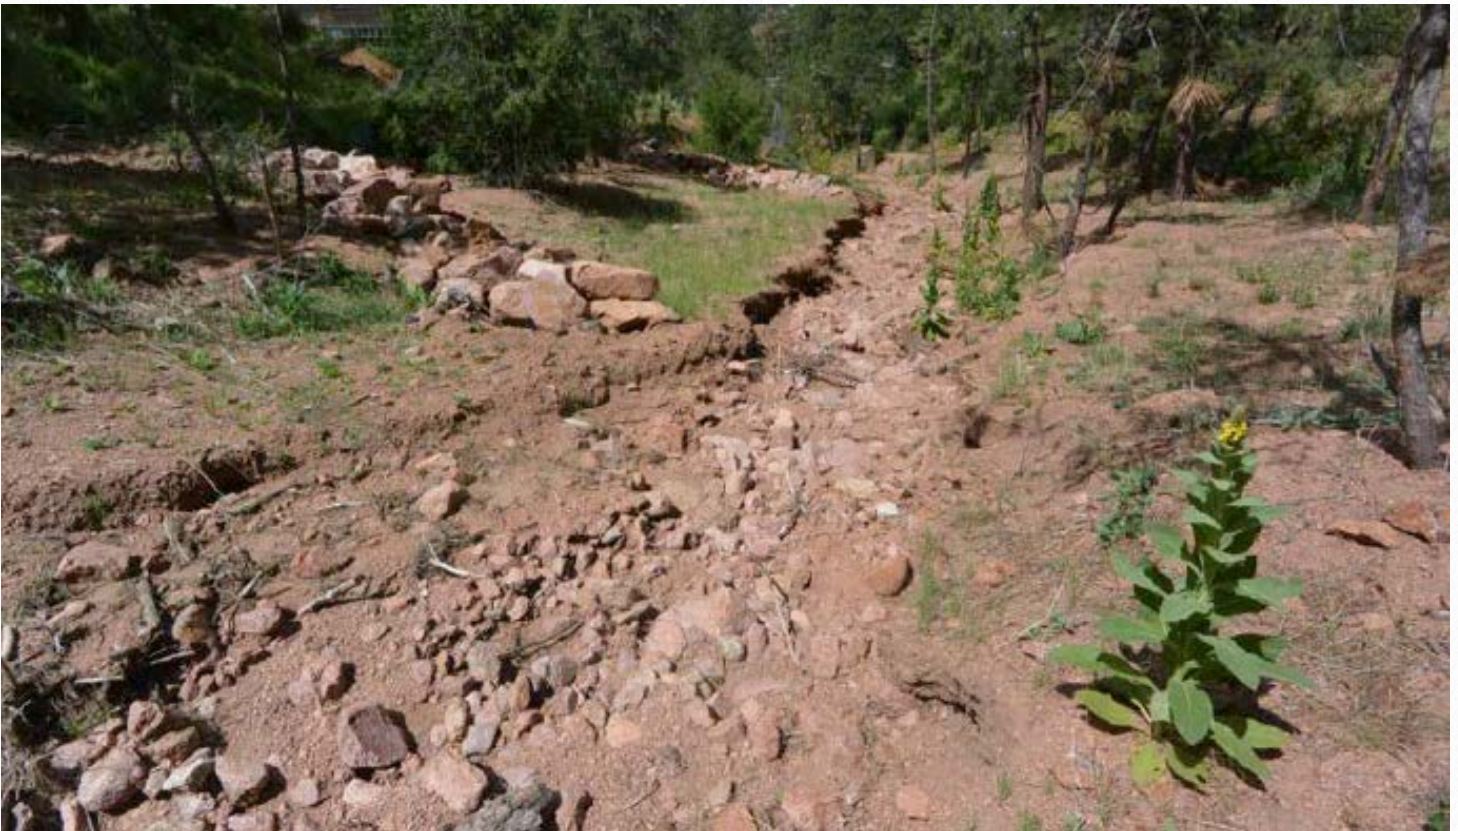
Bendway weirs are a common channel and bank stabilization technique employed throughout the US for flood control. Bendway weirs are typically installed perpendicular to the direction of flow, and extend across only a portion of the active channel. Bendway weirs were utilized in only one project reach in the Waldo Canyon burn, and were found to be ineffective in the highly erosive decomposed granite channels found in the burn area. We observed that the weirs actually accelerated erosion and down cutting of the channel bed surface, due to convergence of flow at the channel end of the structure, and 70% of these treatments had partially failed, or failed completely, and could threaten more functional treatments both upstream and downstream.

Failed, bendway weir
