SECTION 319 NONPOINT SOURCE POLLUTION CONTROL PROGRAM
WATERSHED PROJECT FINAL REPORT

High Park Bum

Reclamation by

Jennifer Kovceses, Coalition for the Poudre River Watershed
Fiscal Sponsor
Rocky Mountain Flycasters

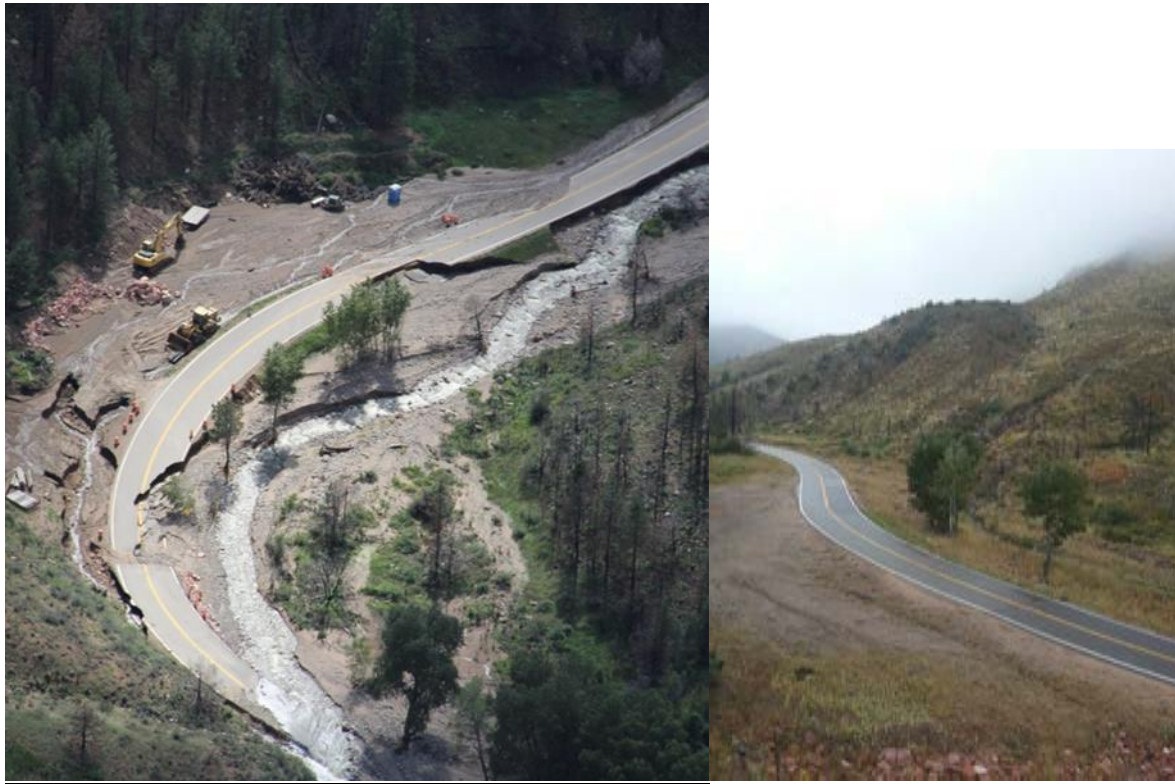
Figure 7. (Left) Skin Gulch showing damage resulting from rain event after the High Park Fire. Image shows the damage to Stove Prairie Rd and Co-14 and excessive sediment being delivered to the Poudre. Photo courtesy City of Ft Collins. (Right) Stove Prairie Road

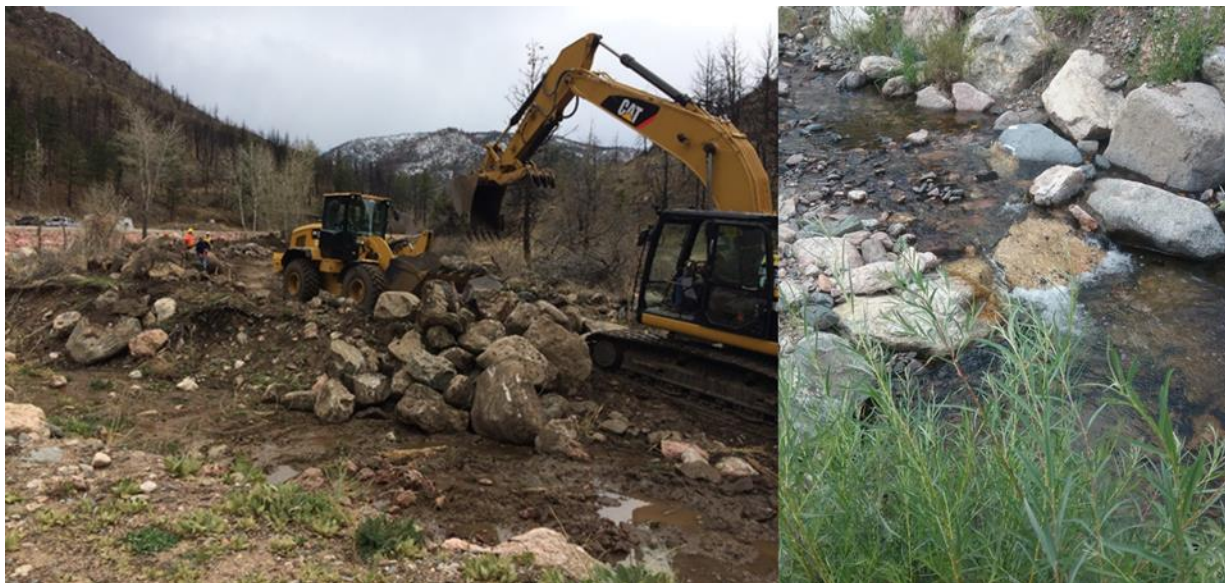
Figure 8. Heavy equipment working to create stable channel formation at Skin Gulch, 2015 (Left). An example of a rock/log grade control structure installed with heavy equipment at Skin Gulch (Right).

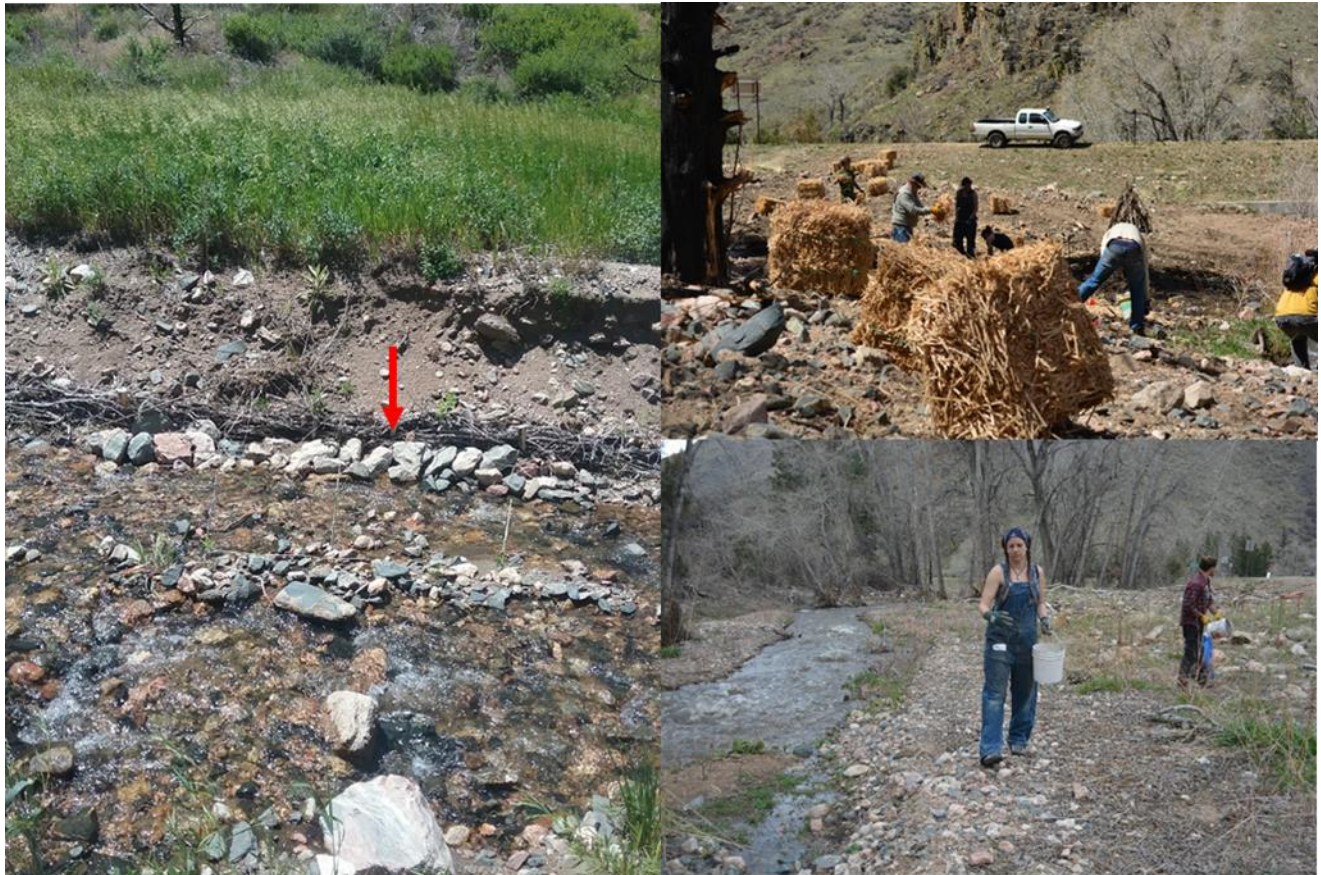
Figure 9. Red arrow indicating a willow fascine installed along the bank in Skin Gulch (left). Volunteers laying mulch over newly planted & seeded floodplain area in Skin Gulch (upper right). Volunteers seeding the floodplain at Skin Gulch (Lower left).

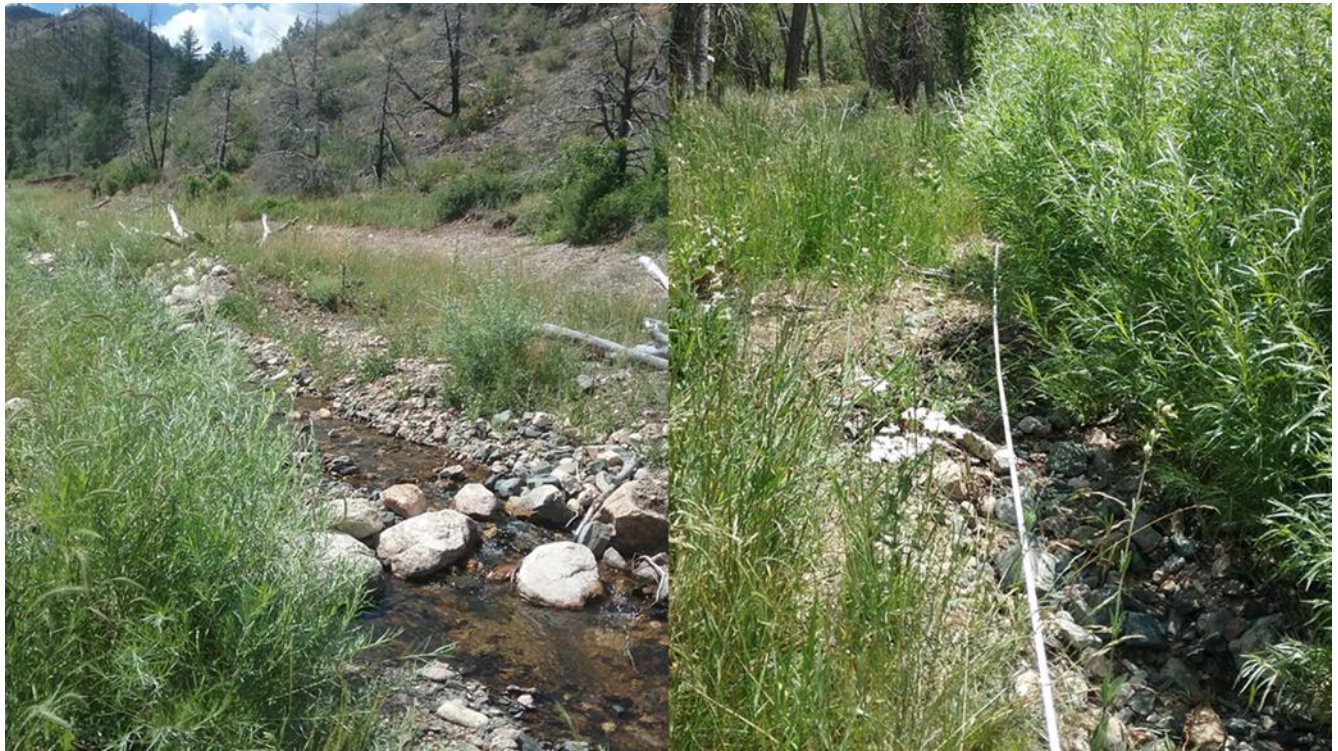
Figure 10: Post treatment monitoring images from Skin Gulch showing strong growth of willows and other plantings at Skin Gulch. On the left, the floodplain roughness logs are visible.

The BMPs installed at Skin Gulch have all performed well. The system has been tested by multiple storms and the channel has remained in place, the road has not been damaged, willows and other native plants have grown well and there is now a thriving riparian vegetation community established. Although we did not do quantitative sampling of benthic macroinvertebrates at the site, anecdotal sampling of benthic invertebrates indicates a diverse benthic community is taking advantage of the newly established channel. The one area where our vegetation work did not thrive was in the upper reaches of the project site. This area already had very nutrient poor soils, which was compounded by post fire deposition of large cobble and rock. Even though we added soil amendments to this section, we did not have successful recruitment of native grasses or other riparian vegetation in the upper section of the project.

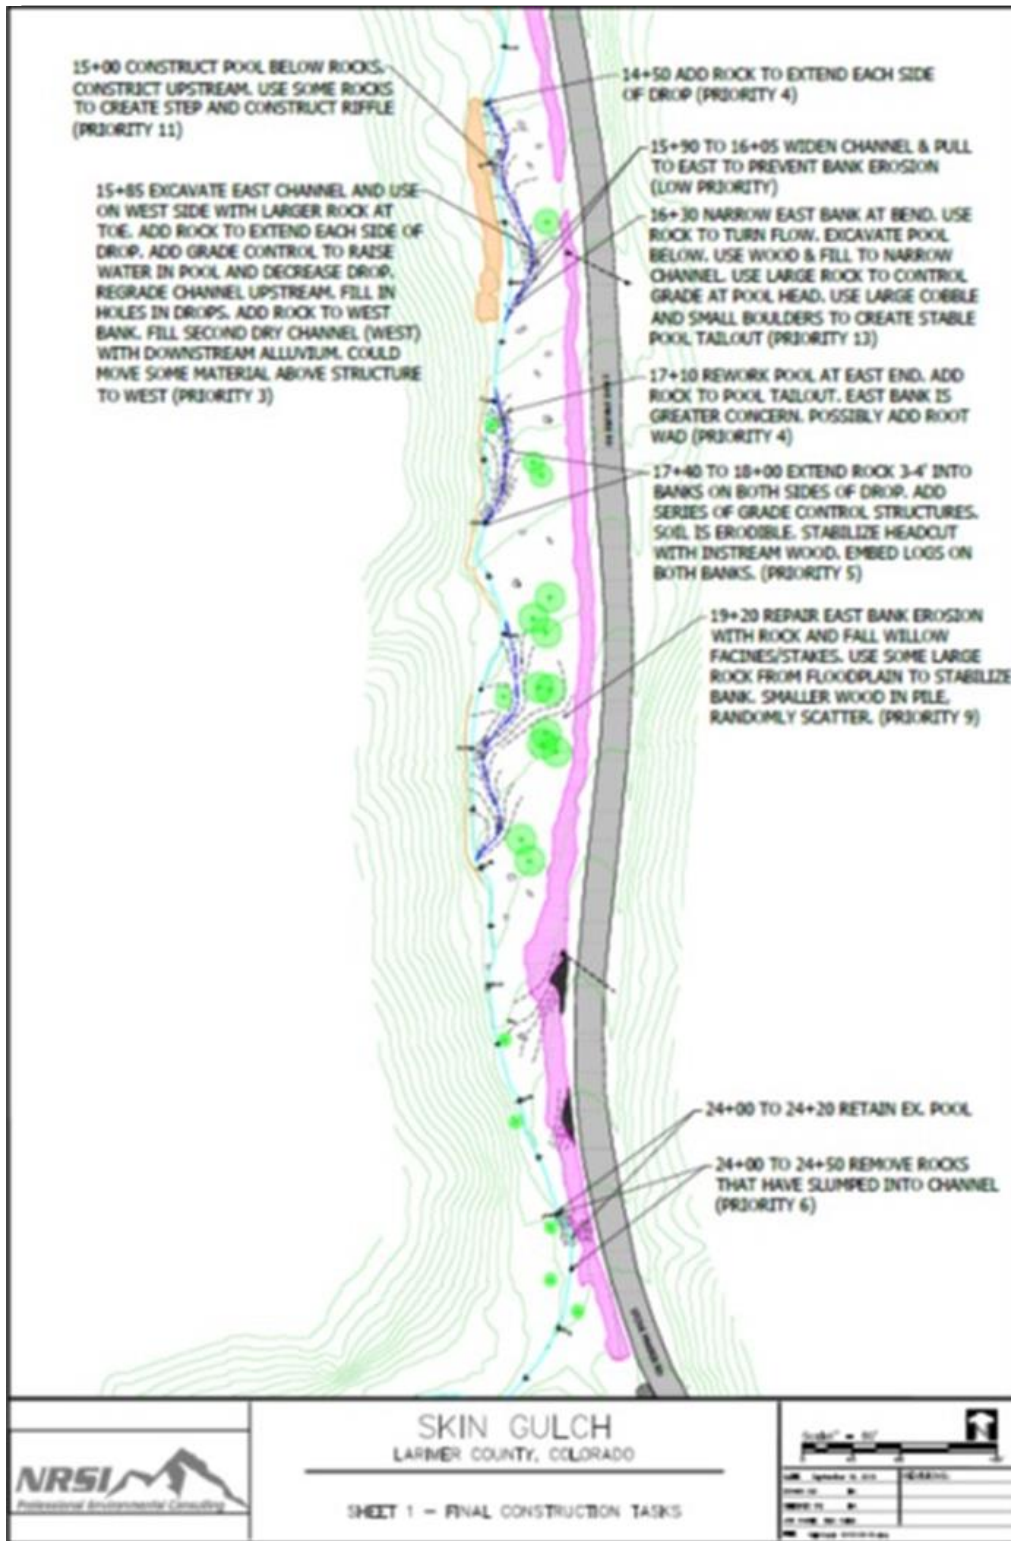
Figure 15 shows the final design and locations of BMPs used in the Skin Gulch project. This project site involved the largest channel reconstruction work of all three of our projects. This was because of how unstable and damaged the post fire channel had become after multiple rain events that damaged Stove Prairie Road and caused debris flows and excessive sediment. The project site was divided into two design reaches, Reach A, which flowed parallel to Stove Prairie Rd, and Reach B, the upstream portion of the site. Heavy equipment was used to create a channel with a more natural sinuosity, create terraces/floodplain benches to connect the channels to its floodplain (Figure 8). Heavy equipment was also used to dig large trees with root wads into the floodplain to help create floodplain roughness features, which should help slow down high velocity flows and allow sediment to settle out in the floodplain. We also seeded the floodplain with native grass seeds and planted willows and other native vegetation throughout the floodplain. In addition, we re-used all sediment on site. All excavated sediment was used to cover pink riprap on the road embankment and then seeded that with native grass seeds, making this portion of the Wild & Scenic corridor remain more natural looking. For a complete description of the final design, see [Appendix 1](#).

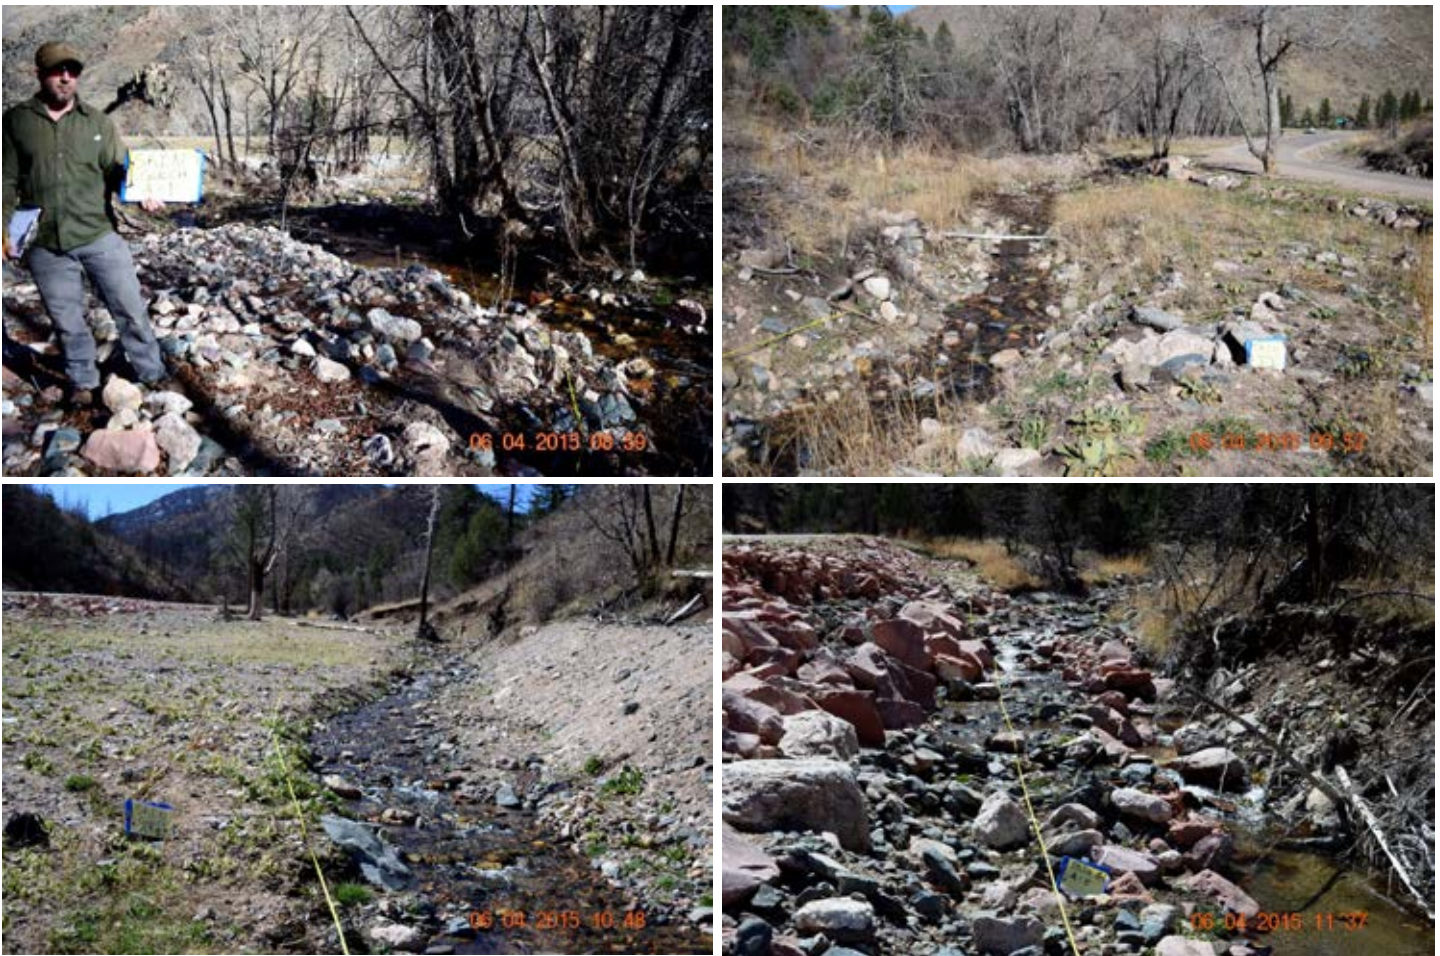
Figure 3. Field photos of Skin Gulch Reach A. Clockwise from top left: Looking downstream at subreach A-1 at deposited sediment piles. Looking downstream on subreach A-2 at relatively stable reach with low banks and low floodplain. Looking upstream on subreach A-4 at loose sand, gravel, and cobble material on both banks. Looking upstream on subreach A-6 at large riprap along right bank and eroded hillslope toe on left bank.

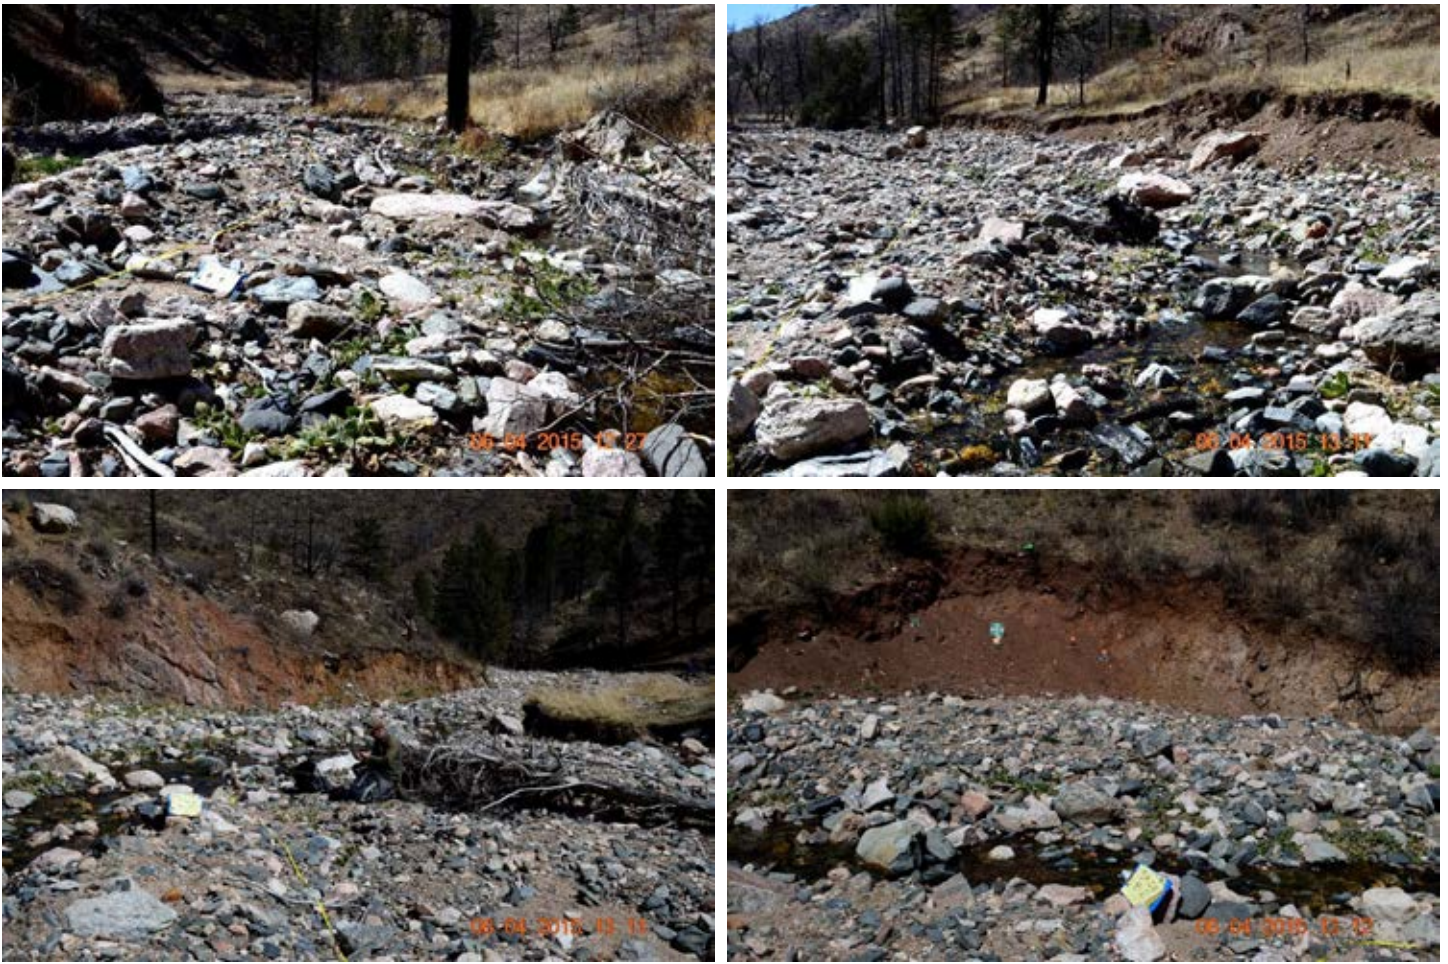
Figure 4. Field photos of Skin Gulch Reach B. Clockwise from top left: Looking upstream on subreach B-1 over sand to boulder material deposited in channel and floodplain. Here, low flow seeps underneath this large wedge of deposited material. Looking upstream on subreach B-2 at channel through newly-deposited sand to boulder material and eroded hillslope on left bank. Looking downstream on subreach B-2. Eroded hillslope with loosed sand to silt-sized material on left bank of subreach B-2.
