# Re-wetting the Sponge: Meadow restoration in the Upper Gunnison River Basin

*A Collaborative Project of the  
Gunnison Climate Working Group*

Sustaining Watersheds Conference

October 10, 2018

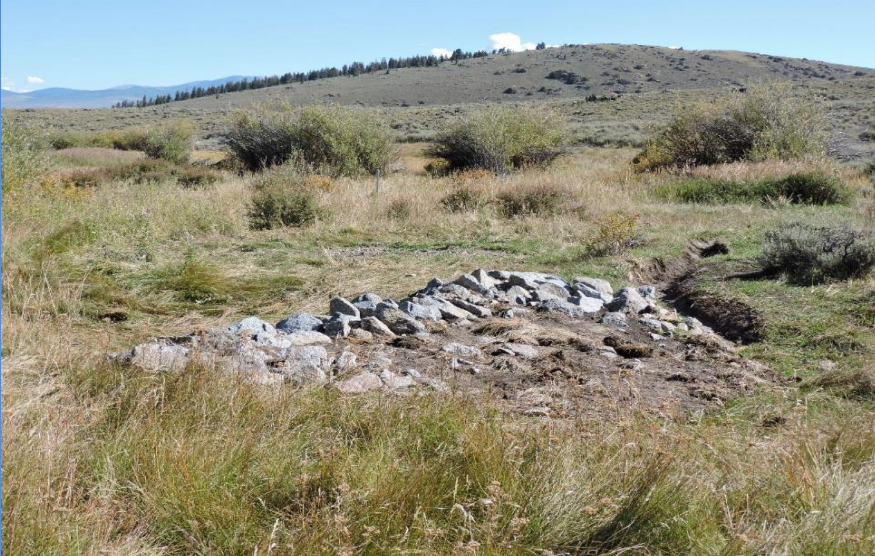
**Post Construction 2016**

# Filter Dam-Chance Gulch

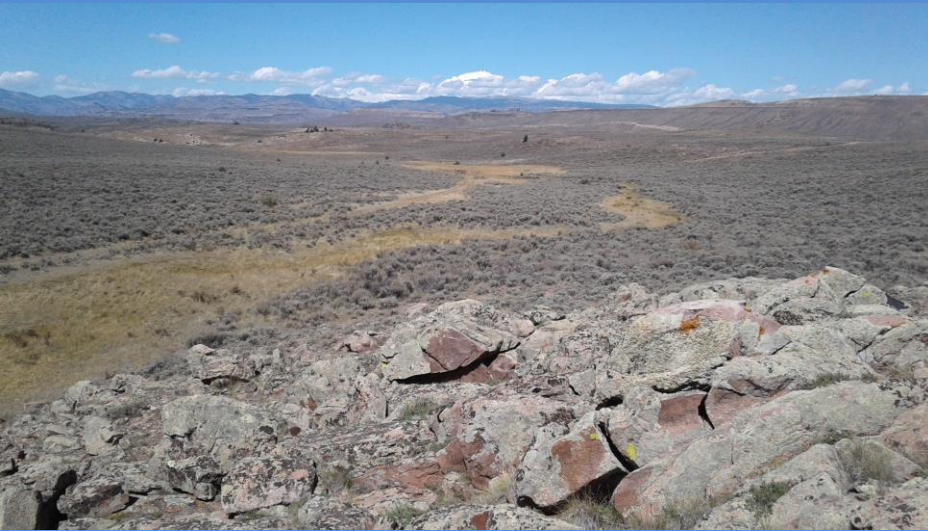
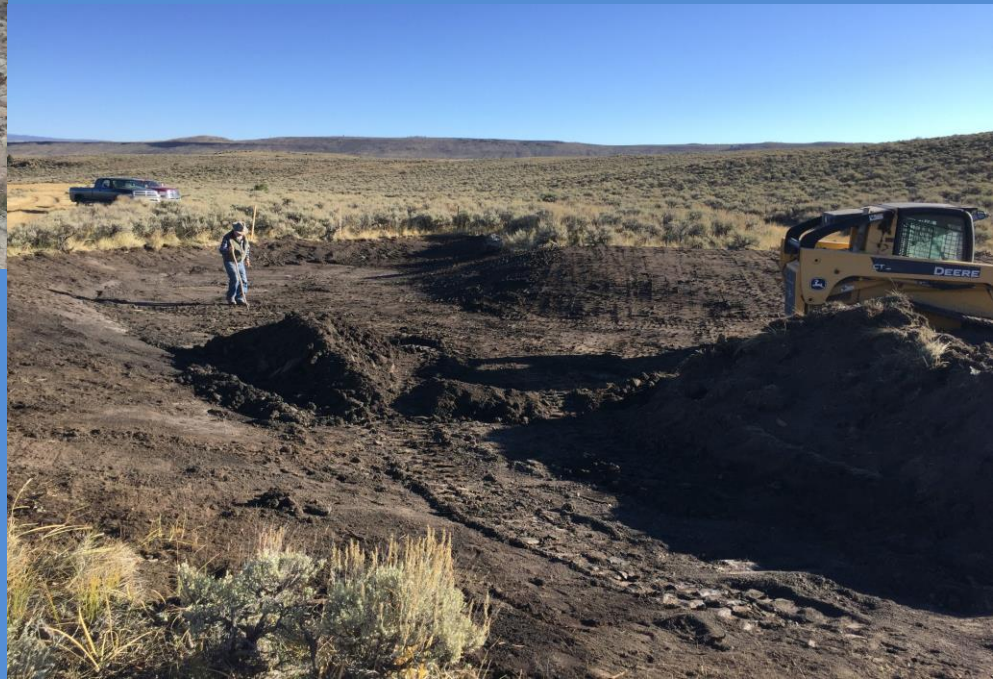
## Plug and Spread

# Sapinero Mesa-September 2018

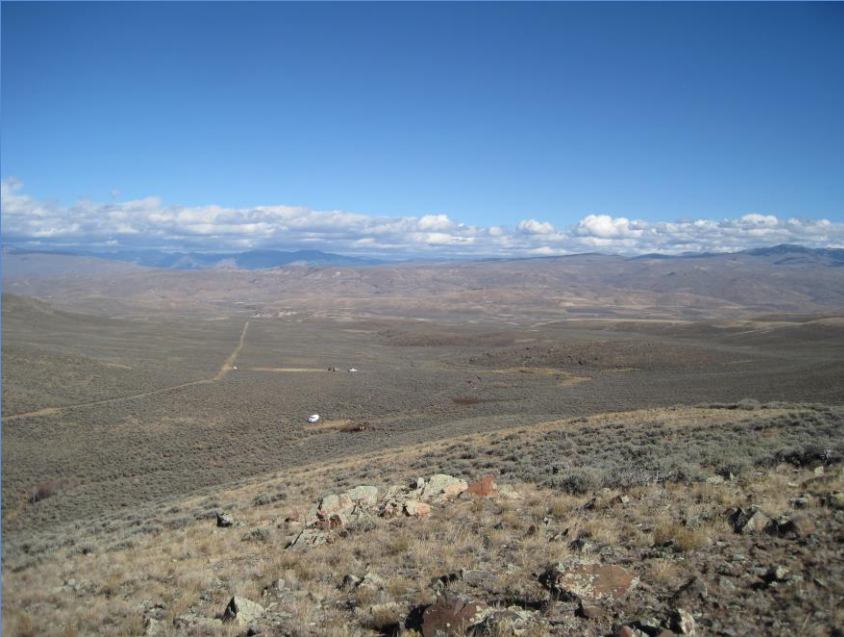
**Construction (10/16)**

# Chance Gulch-Plug and Spread

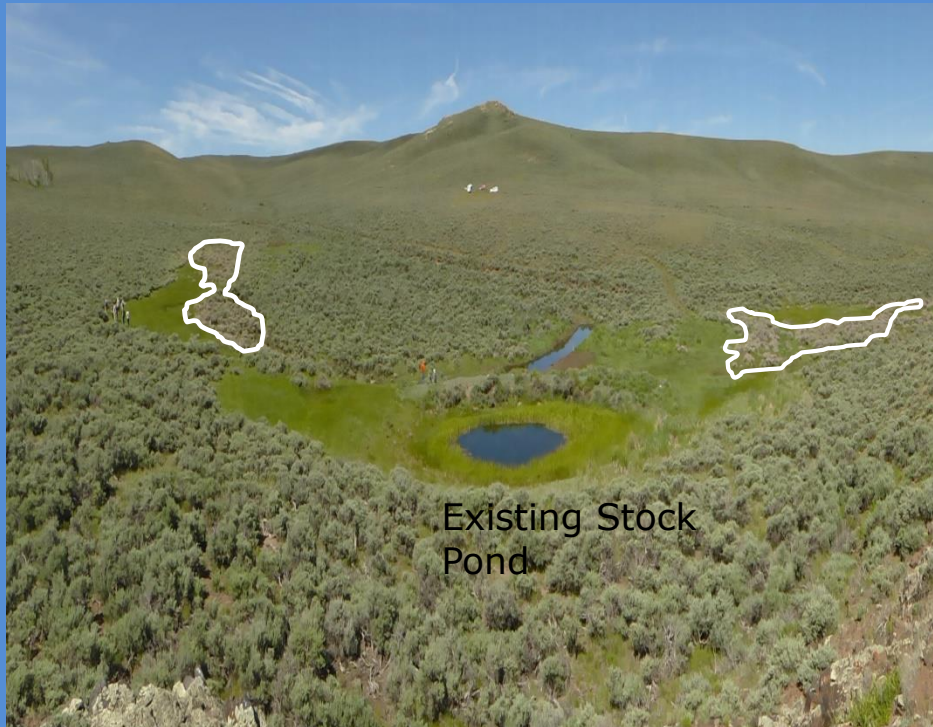
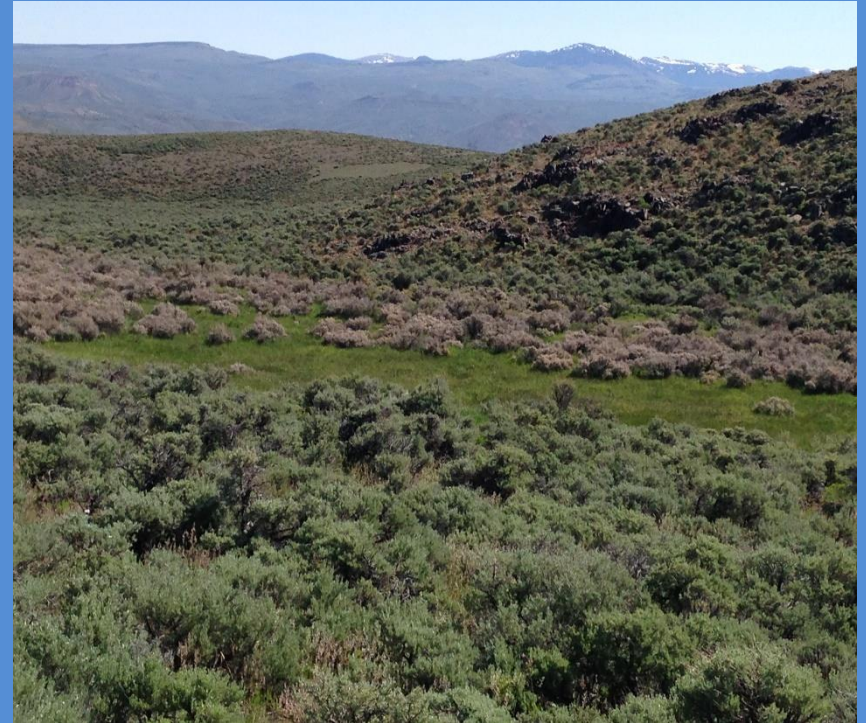
# Re-Connect Paradigm Plug and Spread

The sagebrush had invaded the former wetland due to down cutting. The plug and spreads were built in the fall of 2016 and by June, 2017, the wetness had increased enough to kill sagebrush.

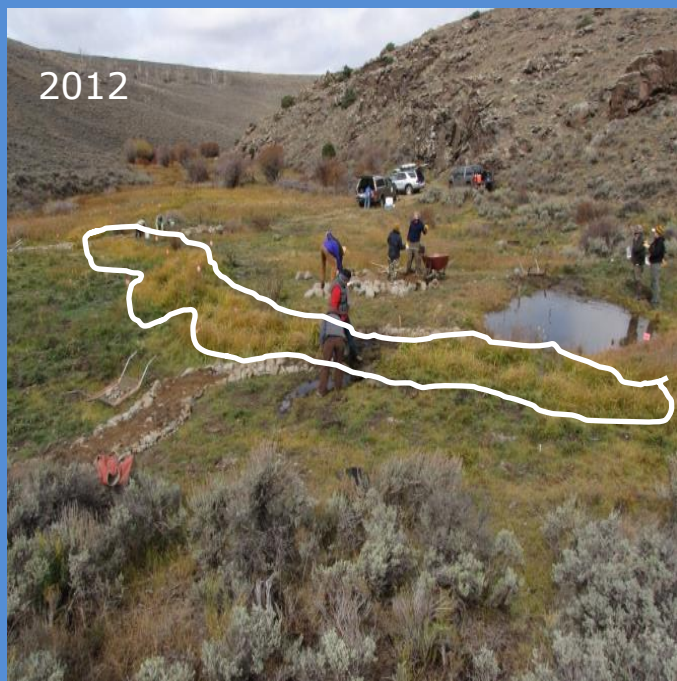
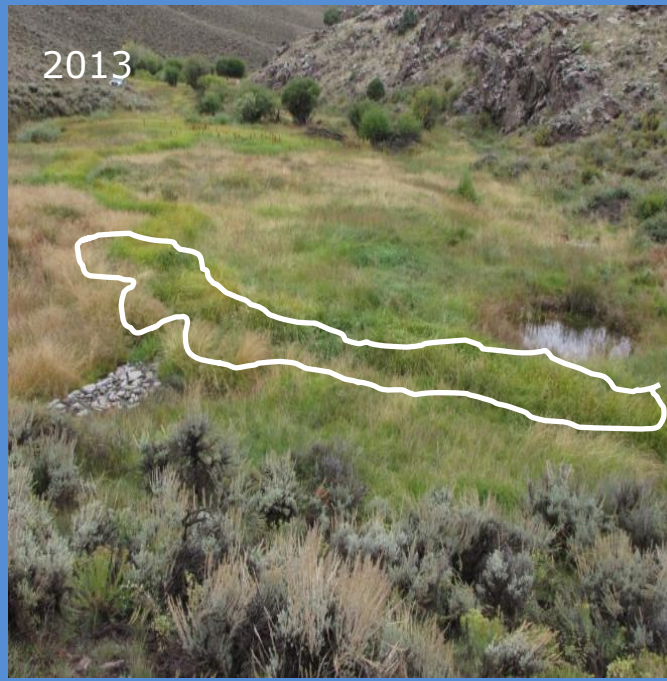
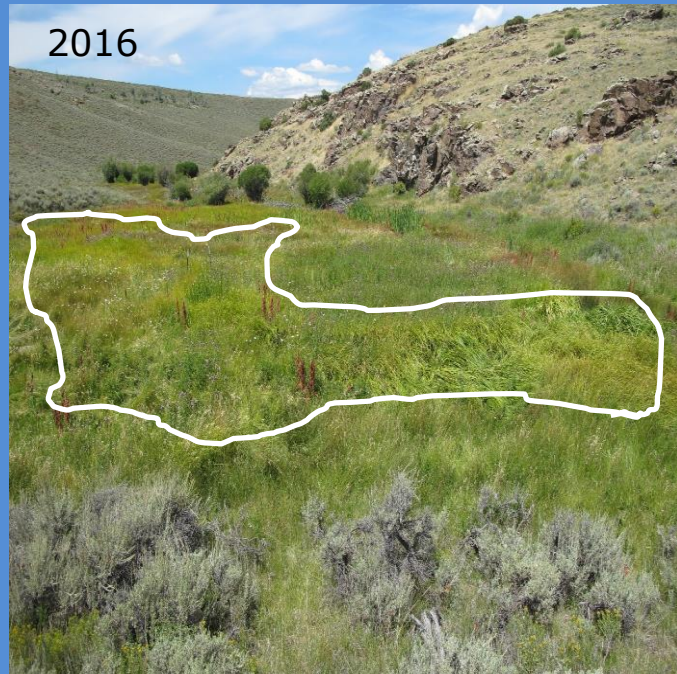
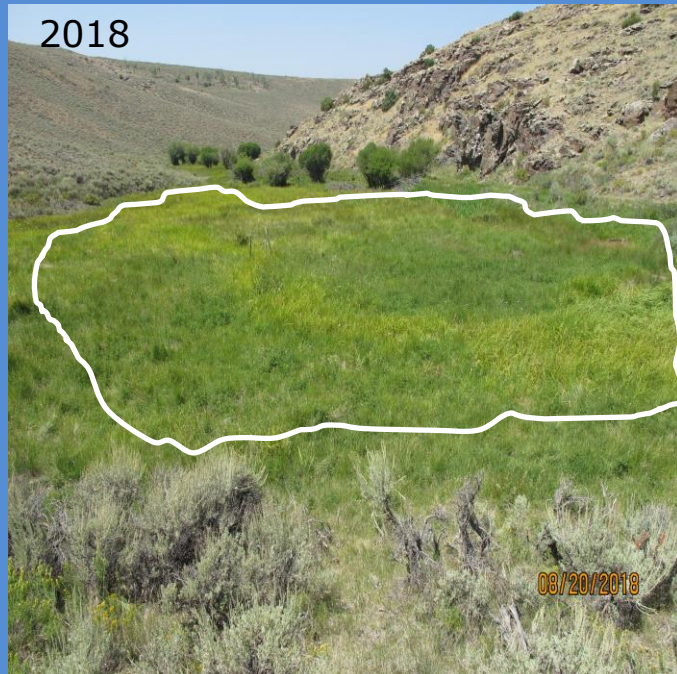
The white polygon represents the wetland area. In general the wetland area occupied approx. 25% of the floodplain in 2012 and around 95% in 2018.
