2016 Big Thompson River Water Quality Summary Report

1 November 2017

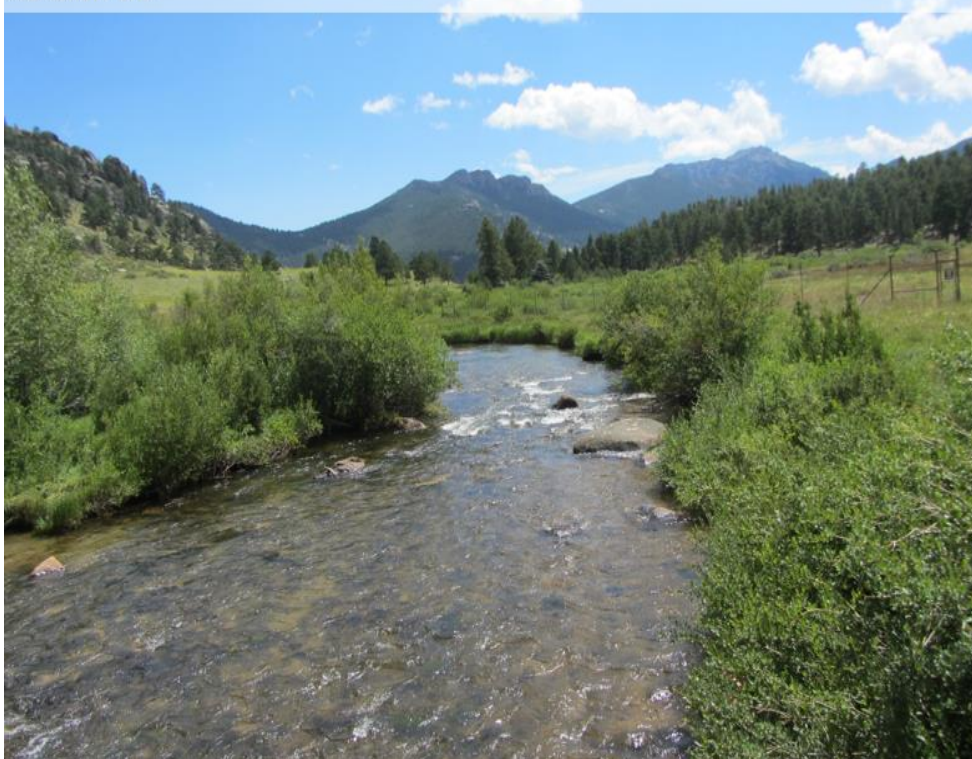
Sampling station M10 near the headwaters of the Big Thompson River in Rocky Mountain National Park.

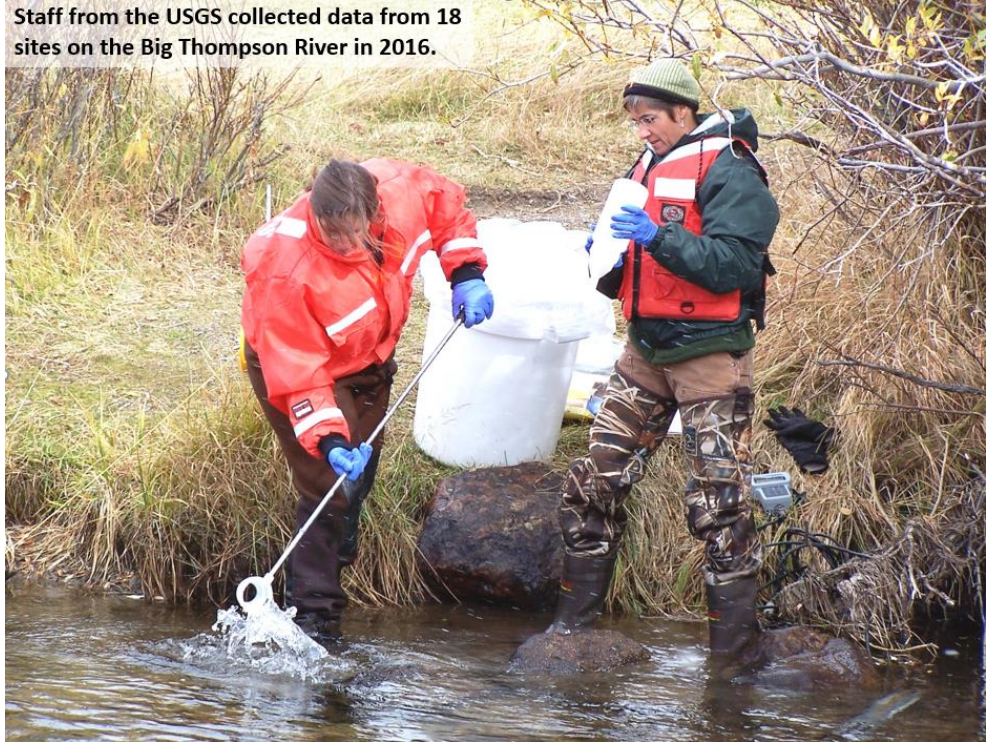
Figure 1. Locations of sites on the Big Thompson River, canals, and associated tributaries in 2016.

A total of 18 sites were sampled on the mainstem and tributaries of the Big Thompson River in 2016 (M10, M20, M30, M40, M50, M60, M70, M90, M130, M140, M150, T10, T20, NFBT05, VT05, VM05, C10, and C20) (Figure 1). All sites were sampled by the USGS as part of the COOP Program. The two tunnel sites, C10 and C20, are part of the Colorado-Big Thompson Project conveyance system, where

C10 monitors the quality of water originating from the Upper Colorado River watershed as it enters the East Slope from the Adams Tunnel.

Tributary samples were collected from the North Fork of the Big Thompson (NFBT05 and T10), Buckhorn Creek (T20), and the Little Thompson River (VT05).
