BIG THOMPSON STATE OF THE WATERSHED

2015 Report

**BIG THOMPSON
WATERSHED
FORUM**

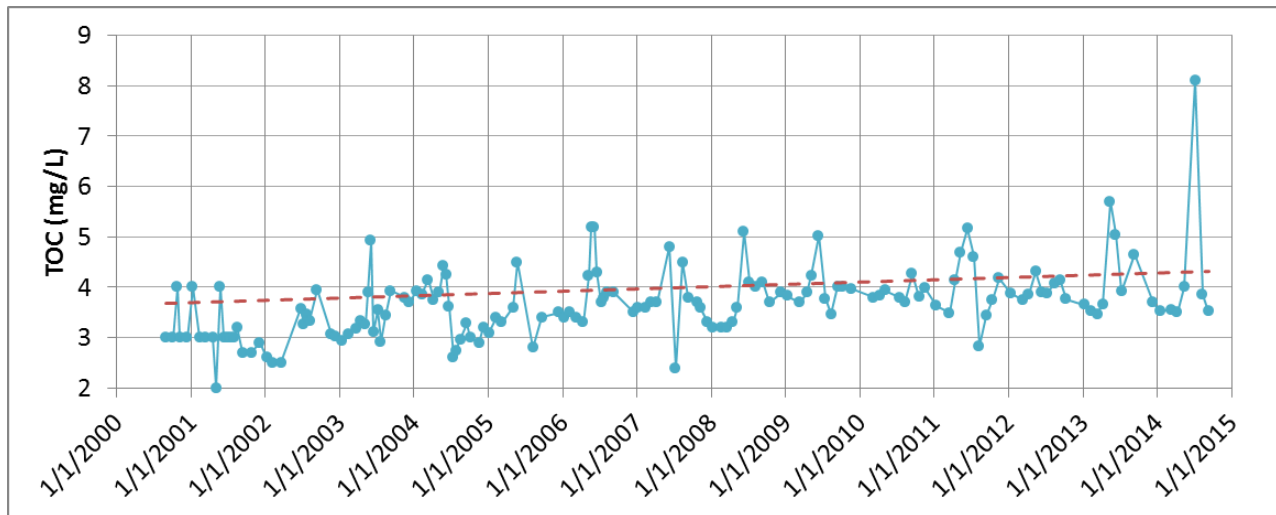
Figure ES-6. TOC Concentrations (mg/L) at C10 (Trend slope shown as red dotted line.)

Increasing TOC in canals and the upper watershed: Statistically-significant trends of increasing TOC concentrations were found in the C-BT canal system (C10, as shown in Figure ES-6, C20, C30, C40 and C50) as well as in much of the Big Thompson upper watershed mainstem (M20 to M130). This finding is in agreement with findings from previous State of the Watershed reports (Hydros, 2011), but it includes more stations. The magnitude of this increasing trend ranges from 0.02 to 0.09 mg/L of TOC per year. This finding of increasing TOC is important because it can directly affect drinking water treatment costs, operations, and regulatory compliance. These increasing trends include the reach from which the City of Loveland diverts water for drinking water treatment, as well as inflows to major C-BT reservoirs including Horsetooth. Further trend testing suggests that the increasing trend may have recently begun to plateau. The cause of this increasing trend in TOC concentrations in water from the west and east slopes is hypothesized to be the large-scale tree death from the ongoing mountain pine beetle epidemic. This finding agrees with recently published research from Colorado (Mikkelsen et al., 2013).

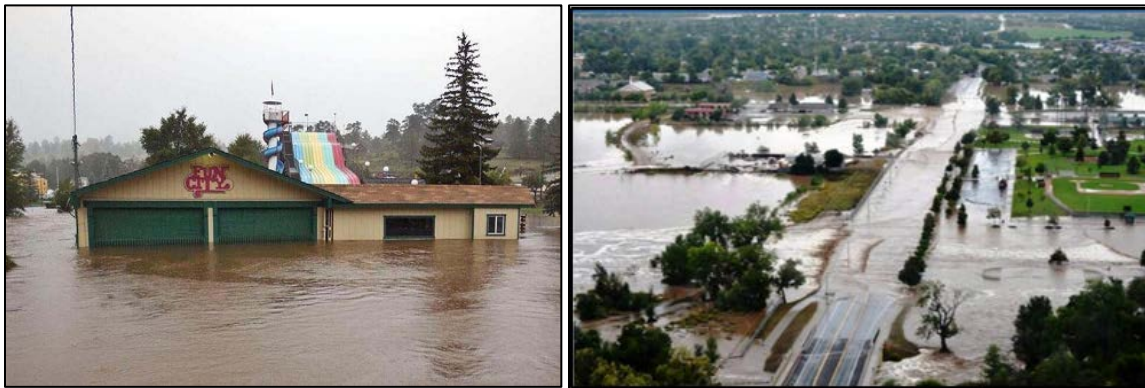
Figure ES-10. September, 2013 Flooding on the Big Thompson River

(Left: Fun City in Estes Park [Photo from Twitter by @TWCBreaking]; Right: 1st Street and Taft Avenue in Loveland, CO [Photo Courtesy of the City of Loveland])

In September 2013, a week of record-breaking rainfall resulted in extensive flooding along the Front Range. Rainfall amounts over a seven-day period exceeded 15 inches near Estes Park. The Colorado Water Conservation Board [CWCB] estimated the flood to have been a 100- to more than 500-year flood in the Big Thompson and Little Thompson Rivers (CH2MHill, 2014, Jacobs, 2014, and Jacobs, 2015). Damage from flash flooding and debris flows was extensive (Figure ES-10).

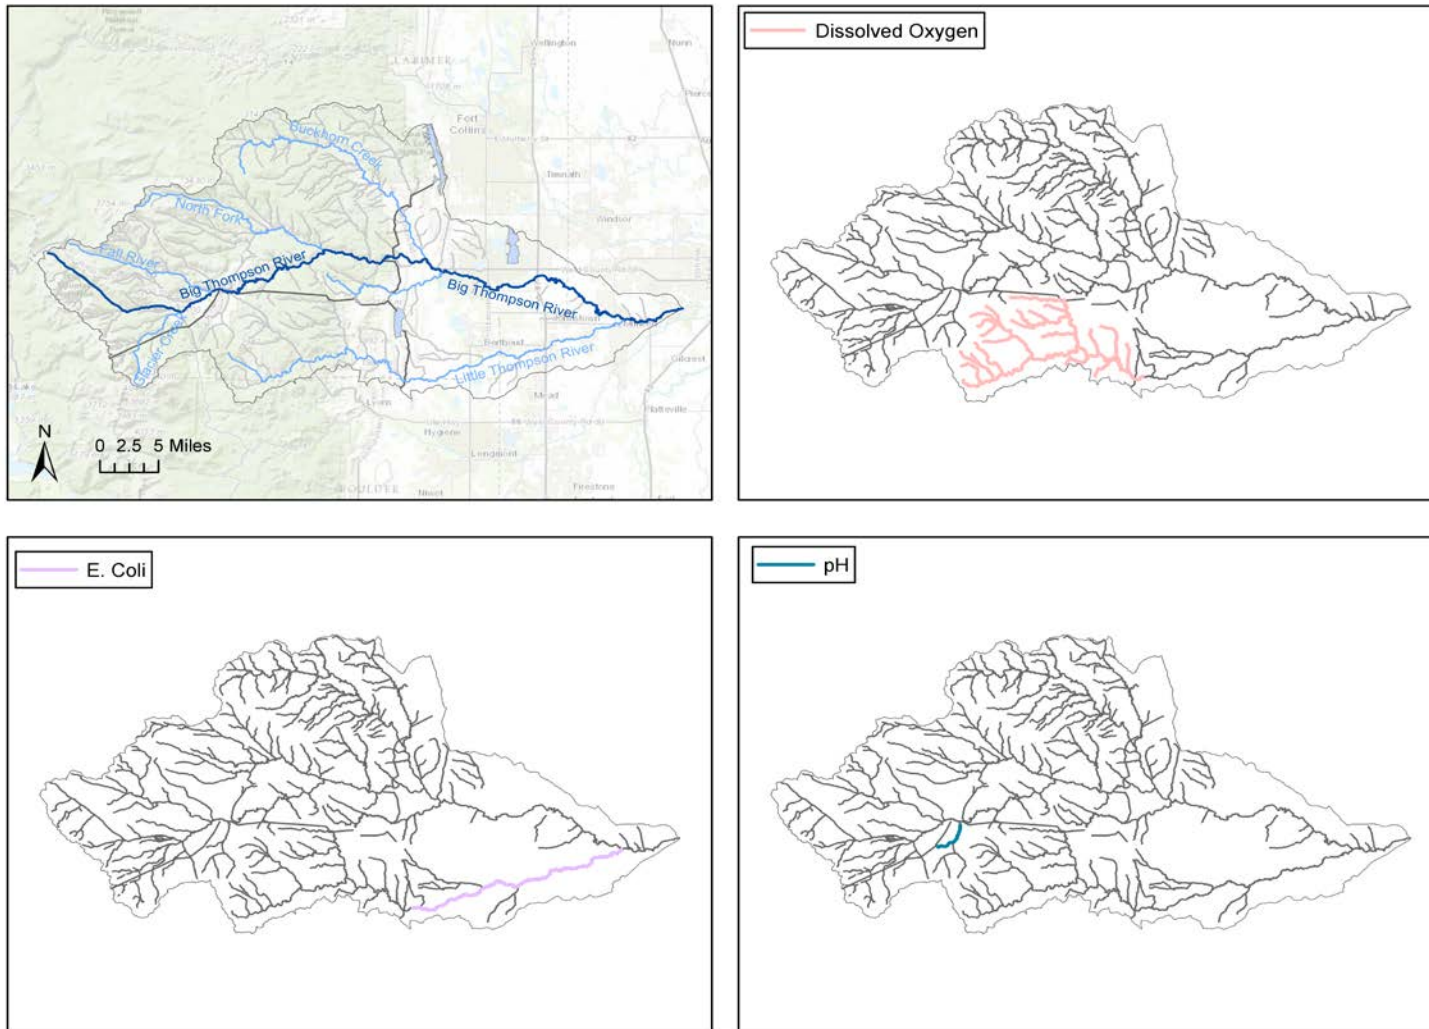
Figure 8a. 303(d)-Listed Stream Segments in the Big Thompson Watershed; Dissolved Oxygen, *E. Coli*, pH

copper, cadmium, selenium, zinc, dissolved oxygen, Escherichia Coli (*E. Coli*), sulfate, pH, and temperature (Water Quality Control Division [WQCD], 2012a). Of these, the high priority listings are for segment 1 (copper), segment 2 (pH, copper, cadmium, and zinc), segment 7 (copper), segment 8 (sulfate, temperature, and dissolved oxygen), and segment 9 (*E. Coli* only). The only change in the 2012 listing from the previous listing in 2010 (WQCD, 2010) was the addition of sulfate for segment 8. A summary of the 303(d) listings is presented in Table 1. Figure 8a through 7c present these listings spatially.

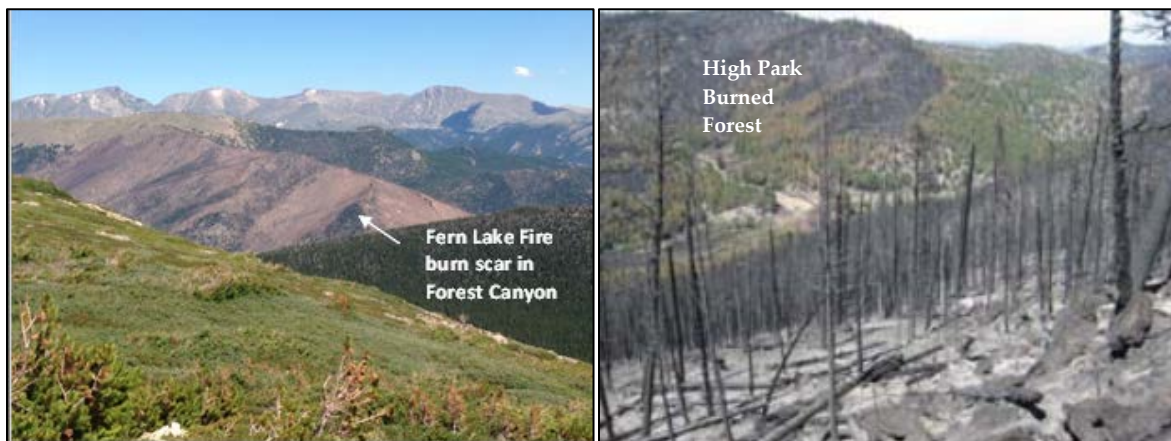
Figure 10. Post-Fire Images: (Left) Fern Lake Fire Burn Scar in Forest Canyon (Photo: August, 2014 by J. Billica); (Right) High Park Burned Forest (CDOT et al., 2012)

- **High Park Fire:** This fire was started on June 9, 2012 by a lightning strike in an area suffering from hot, dry conditions with an extreme fire danger. The fire burned over 87,000 acres, destroying 259 homes before being fully contained on June 30, 2012 (Figure 10). The majority of the burn area was located in the Cache la Poudre River watershed; however, the fire also affected upper Buckhorn Creek of the Big Thompson watershed.

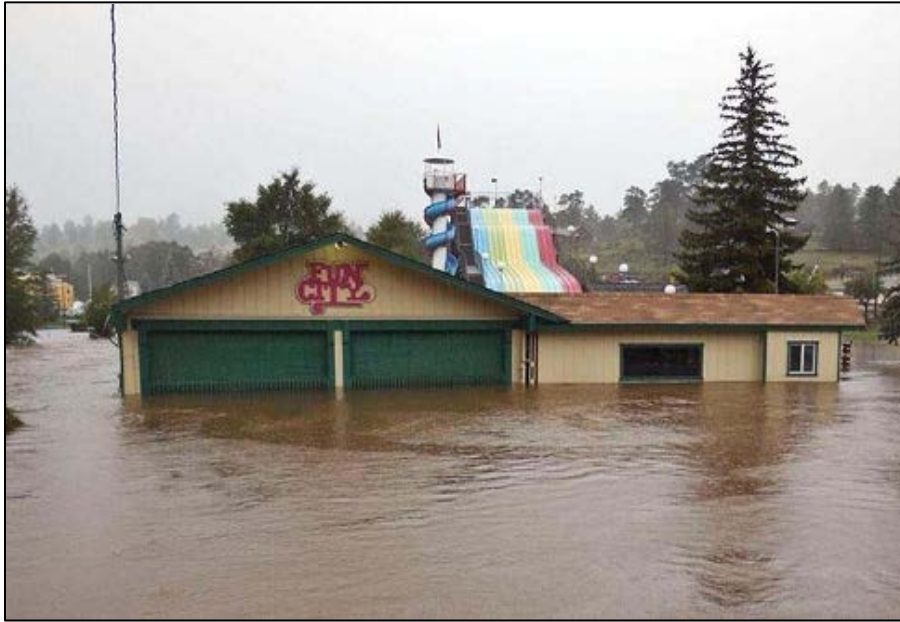
Figure 12. September 2013 Flooding, Fun City in Estes Park (Photo from Twitter by @TWCBreaking)

Damage from flash flooding and debris flows was extensive. The flooding impacted 20 counties, resulting in 10 fatalities. Damages were reported to more than 16,000 homes, 750 businesses, and hundreds of miles of highway (CWCB, 2014). Examples of flood damage in the Big Thompson watershed are presented from upstream to downstream in Figure 12 through Figure 17.

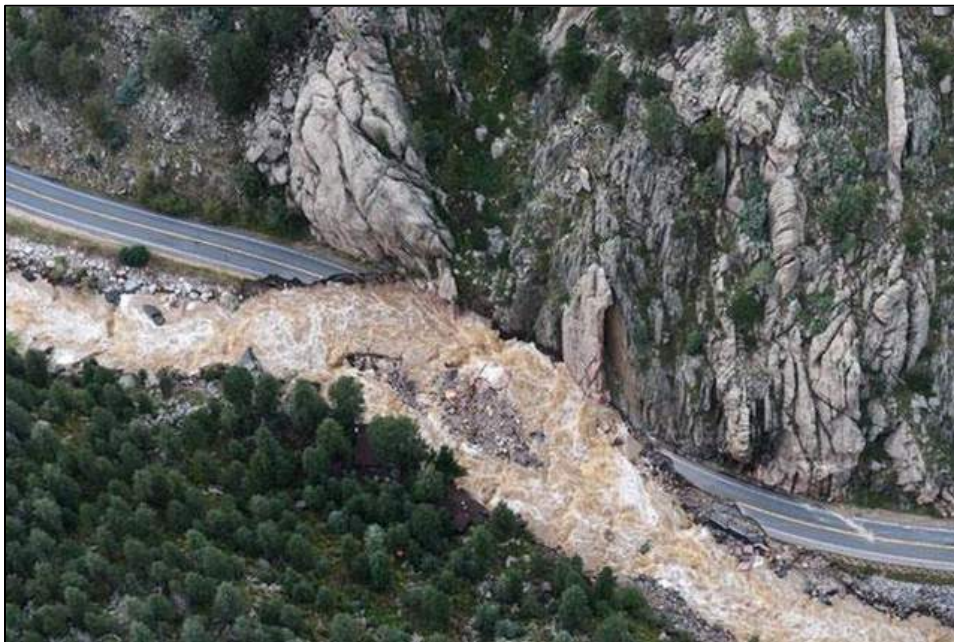
Figure 13. September 2013 Flooding, Highway 34 Big Thompson Canyon, Highway Damage (Photo by Andy Cross, The Denver Post)

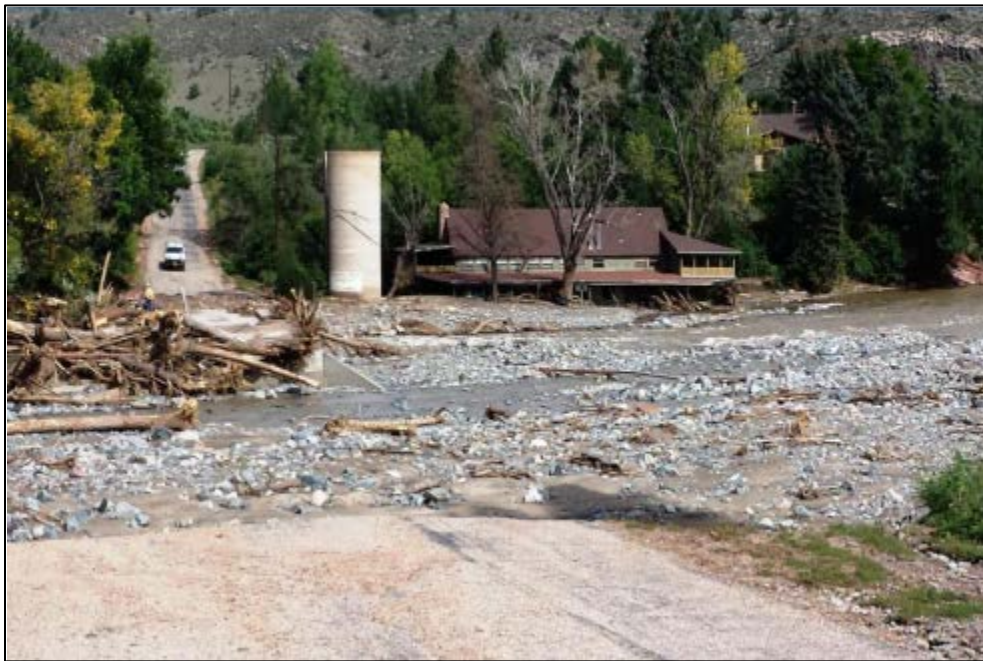
Figure 14. September 2013 Flooding, Sylvan Dale Guest Ranch, Located West of Loveland and Just Outside the big Thompson Canyon Narrows (Photo courtesy of Shelley, 2014)

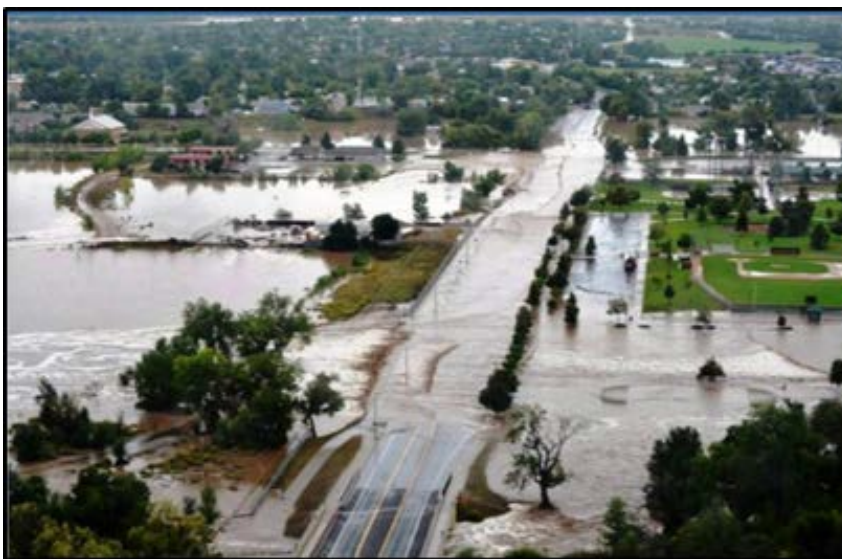
Figure 15. September, 2013 Flooding on the Big Thompson River at 1st Street and Taft Avenue in Loveland, CO (Photo Courtesy of the City of Loveland)

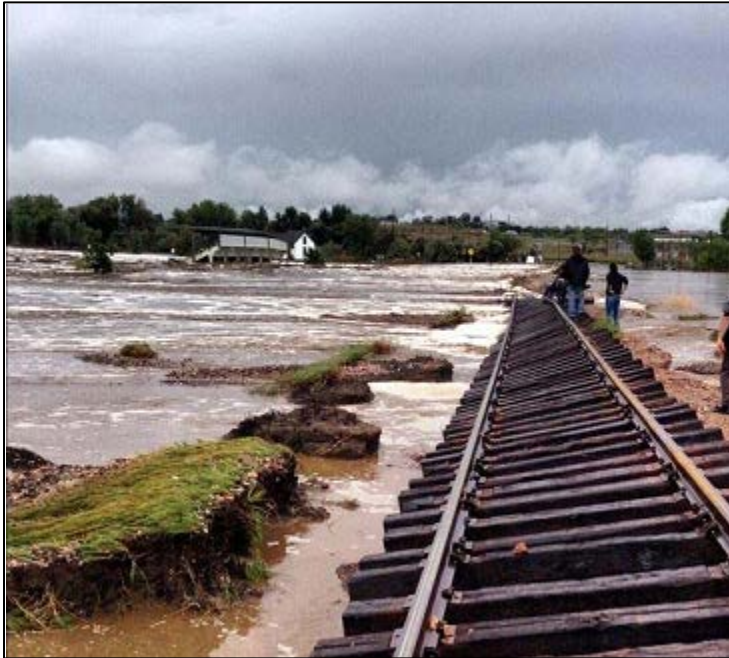
Figure 16. September 2013 Flooding, Loveland Fairgrounds (Photo from Twitter by @CJose)

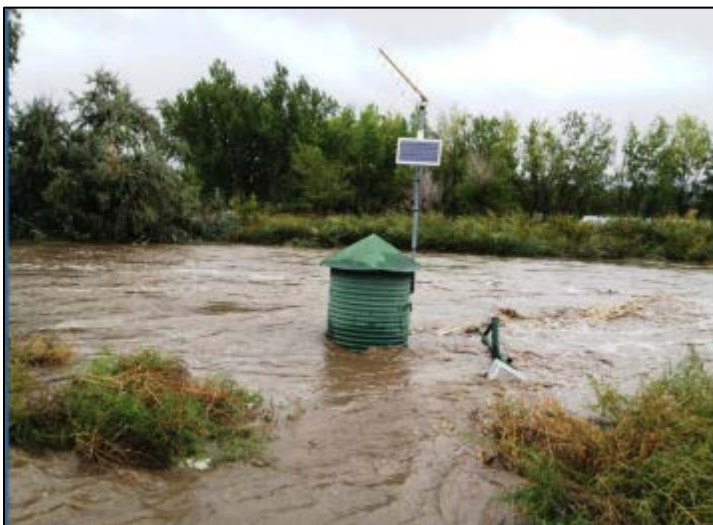
Figure 17. USGS Stream Gage on the Big Thompson River near Loveland on September 12, 2013 (Photo courtesy of Shelley, 2014)

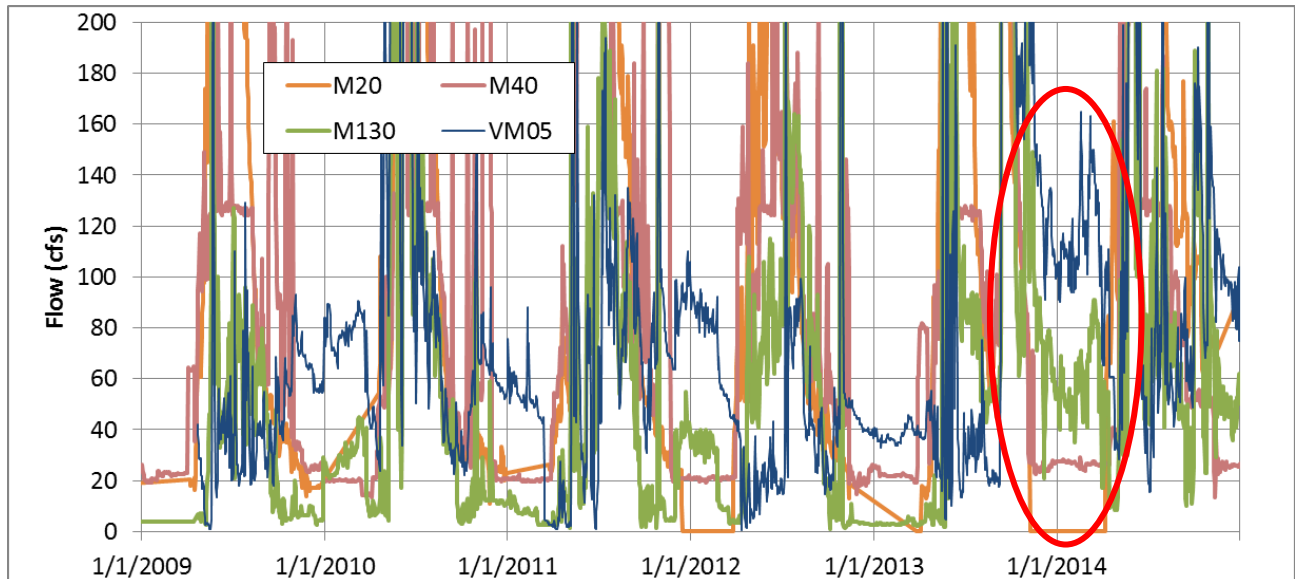
Figure 25. Hydrographs M20, M40, M130, VM05; 2009-2014; Focus on Lower Flow Rates, Post-Flood Winter Flows Circled

(e.g. M20, M40). In contrast, baseflow rates were much higher in the lower part of the watershed (e.g., M130, VM05); as shown in Figure 25. It appears, from the end-of-2014 data, that baseflow continued to be higher in the second year following the flood; however, the long-term duration of this effect will have to be evaluated with additional data in the future.

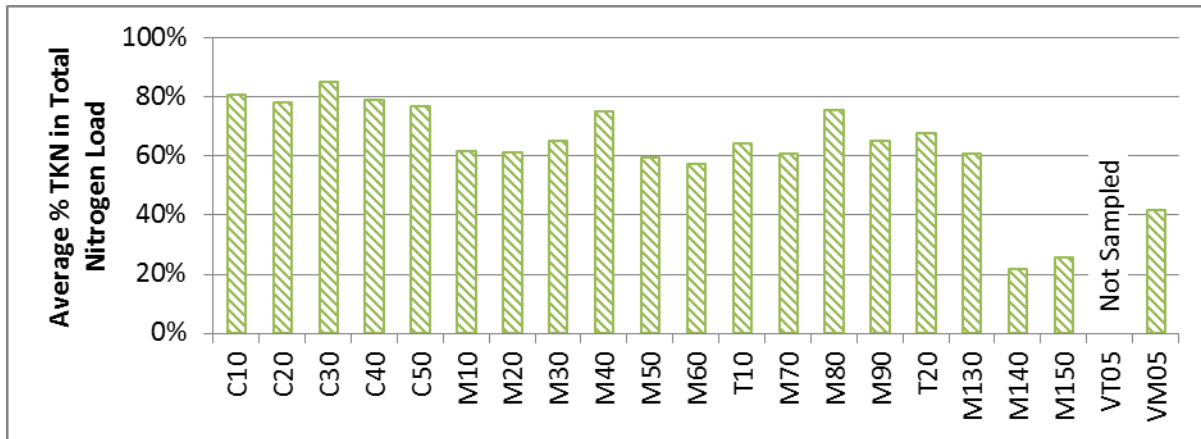
Figure 30. Average TKN Fraction in Total Nitrogen Load, 2000-2014

Loading results were reviewed to help assess the relative composition of total nitrogen and total phosphorus across the watershed. As shown in Figure 29 through Figure 31, TKN (organic nitrogen plus ammonia) comprises the majority of the total nitrogen load from the headwaters to M130 and in the canals. Because ammonia is a small fraction of the TKN, this indicates that the total nitrogen is dominated by organic nitrogen in these areas. From M140 to the confluence with the South Platte and in the Little Thompson (VT05), the pattern changes. In these reaches, nitrate comprises the greater fraction of the total nitrogen load, reflecting WWTP loading and possibly the influences of livestock.

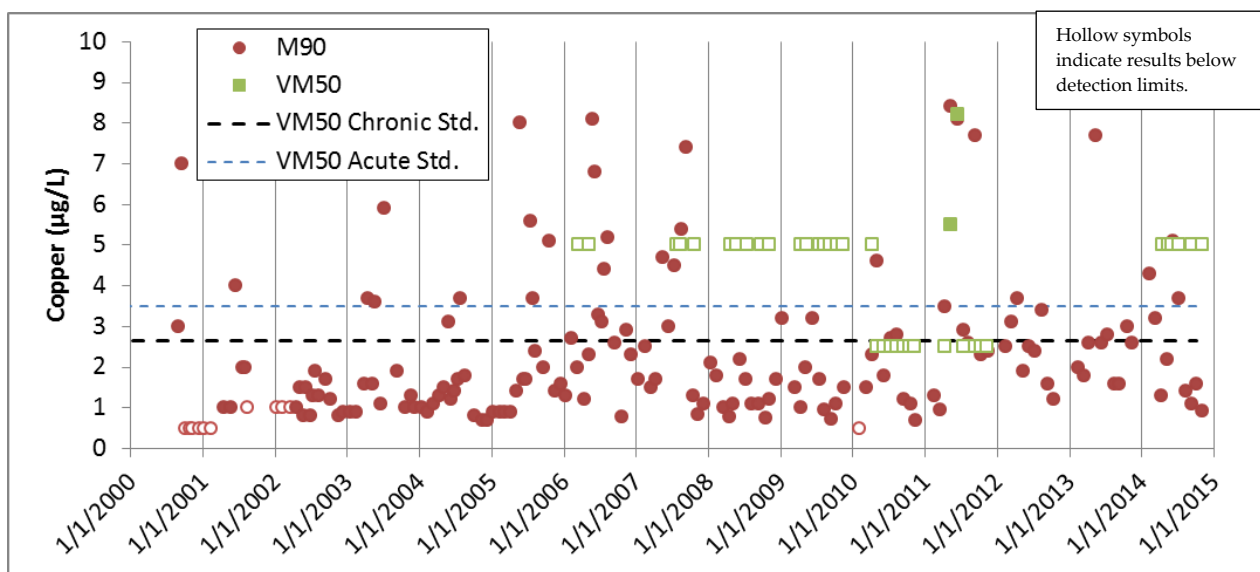
Figure 61. Copper Concentrations at M90 (COOP) and VM50 (Volunteer) Shown with Applicable Estimated Acute and Chronic Standards, 2000-2014
