Big Thompson River

Cooperative Monitoring Summary: Spring 2019

Andrew H. Fayram
Monitoring Program Manager
Big Thompson Watershed Forum

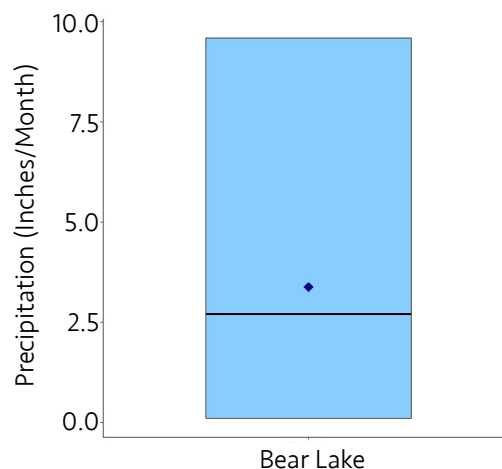
Figure 2. Range of historical median monthly precipitation at the Natural Resources Conservation Service (NRCS), Bear Lake SNOTEL site (blue box) located in the headwaters of the Big Thompson River (<https://wcc.sc.egov.usda.gov/nwcc/site?sitenum=322>) (1990-2018) and the 2019 spring monthly precipitation median (blue diamond)

Precipitation at the Natural Resources Conservation Service (NRCS), Bear Lake SNOTEL site in spring of 2019 was very close to the long-term spring average (1980-2018) (Figure 2). This station is located at approximately 9,500 feet elevation in the headwaters of the Big Thompson River and is therefore reflective of conditions in the Big Thompson River.

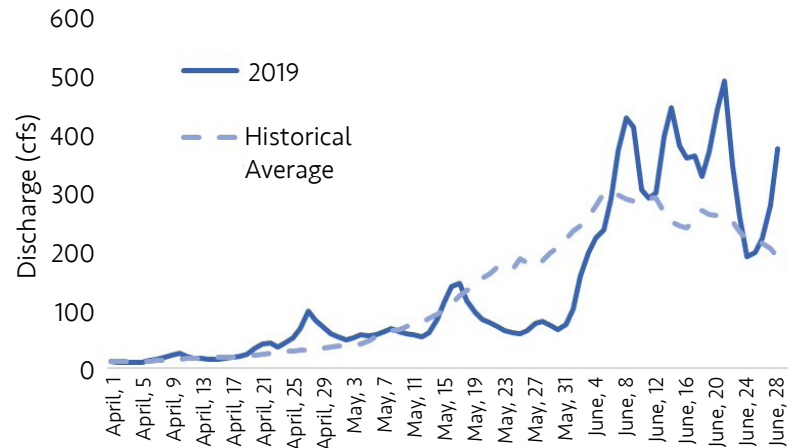
Figure 3. 2019 and historical daily spring flows at the USGS Moraine Park gage (<https://waterdata.usgs.gov/nwis/uv?402114105350101>)

Although the 2019 precipitation total was close to average, snowmelt occurred slightly later than average, resulting in a shift in the seasonal runoff pattern. Historically, peak flows at Moraine Park in Rocky Mountain National National Park have occurred in early June, while in 2019 peak flows occurred in mid- to late June (Figure 3).
