BIG THOMPSON STATE OF THE WATERSHED 2021 **Final** Report

**BIG THOMPSON
WATERSHED
FORUM**

Hydros
Consulting

December 10, 2021

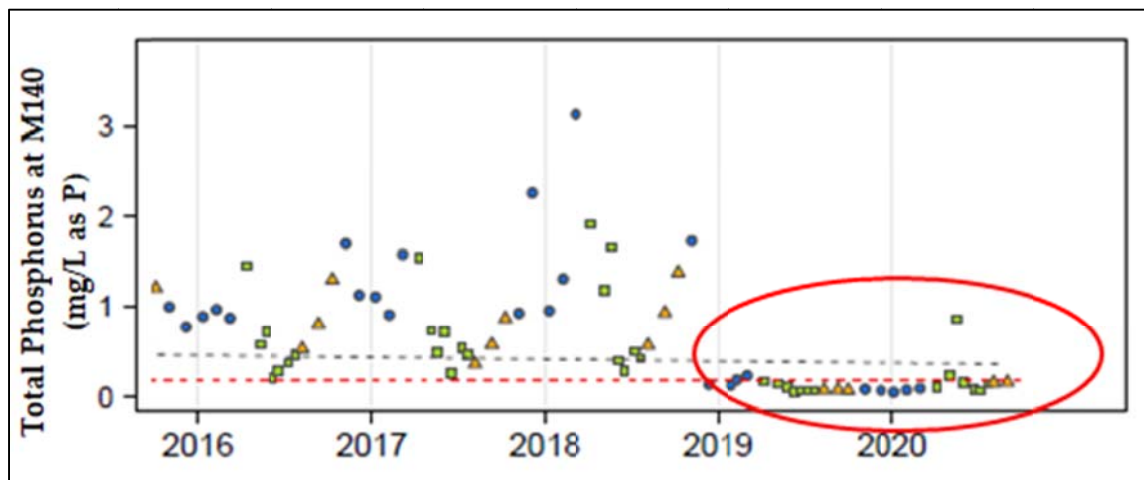
Figure ES-8. Total Phosphorus Concentration Data on the Big Thompson River Downstream of Loveland WWTP, 2016-2020 (Red Oval Indicates Period of Record Following Loveland WWTP Upgrade)

- A pattern of decreasing orthophosphate (as well as total phosphorus) upstream of Lake Estes is attributed to ongoing operational and structural improvements at the Estes Park Sanitation District WWTF.
- A dramatic step change reduction in phosphorus concentrations in the Big Thompson River downstream of the Loveland WWTP reflects upgrades to that facility that went online in 2019 (e.g., Figure ES-8). This improvement at the Loveland WWTP reduced phosphorus concentrations in that part of the lower watershed to values below the interim nutrient criteria value for the first time in the observed record.

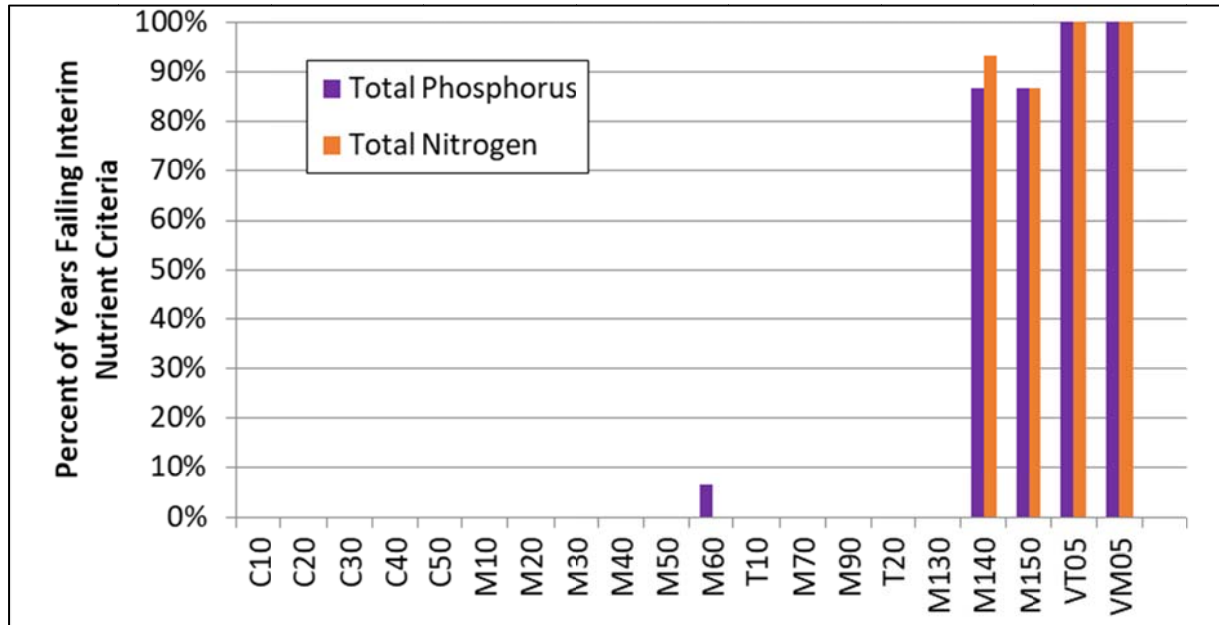
Figure ES-12. Summary of Data Comparison to Interim Nutrient Criteria (Annual Medians Compared to Interim Criteria for Rivers), 2006-2020 (Note that the Interim Criteria are Only Currently Applicable for Total Phosphorus at M10, M20, M30, and M40.)

Interim Nutrient Criteria review suggests possible future challenges: The interim numeric criteria are only currently applicable in Segment 1 and part of Segment 2 for total phosphorus; however, both total nitrogen and total phosphorus criteria may be considered for adoption as water-quality standards across the watershed prior to or after May 31, 2022, depending on determination by the WQCC. Observed data indicate that the interim criteria would be routinely exceeded in the lower watershed, including the Little Thompson River (Figure ES-12).

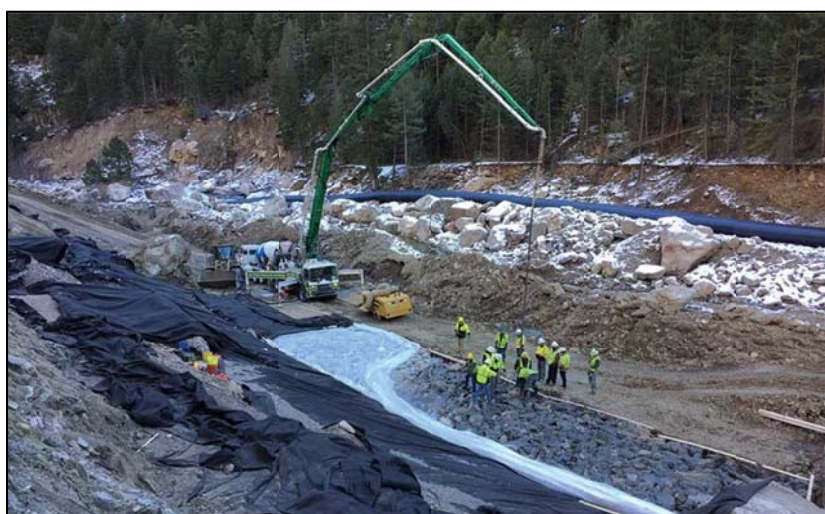
Figure ES-14. Example Image of Repairs to U.S. 34

Top Right: Repairs to Highway 34 - Image shows crews conducting innovative soil-cement mixing as part of extensive post-flood repairs to Highway 34 from 2015-2018.

Post-Flood Road Reconstruction Activities: Extensive reconstruction of roads and infrastructure was needed following the September 2013 flood. A multi-year project, led by the Colorado Department of Transportation (CDOT) Flood Recovery Office, was initiated in 2016, including rebuilding of bridges and repair of nearly 23 miles of U.S. 34, mostly between the City of Loveland and Estes Park (e.g., Figure ES-14). The project was largely completed in early 2019, with some minor repairs continuing into 2020.

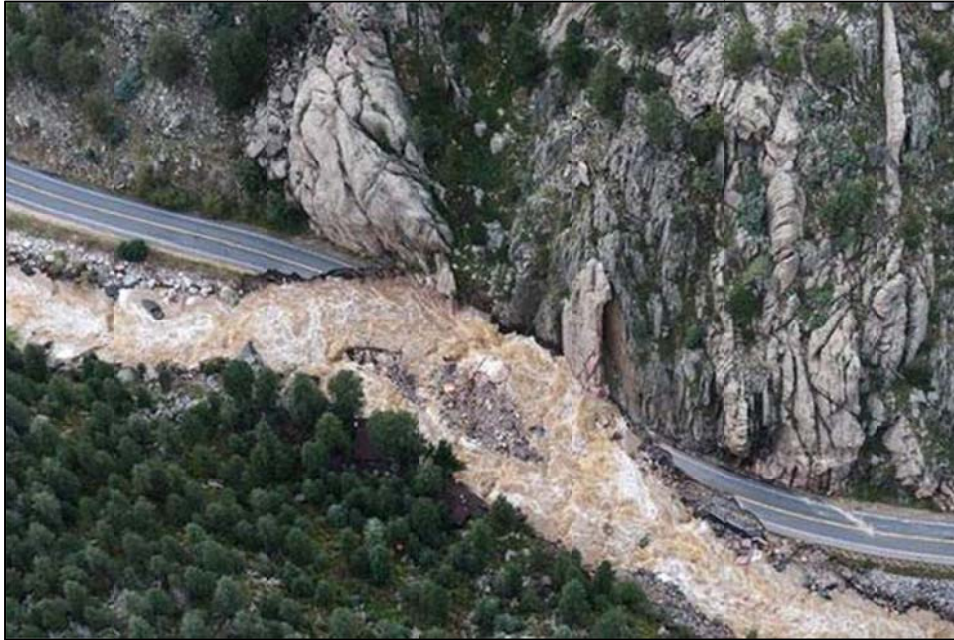
Figure 14. September 2013 Flooding, Highway 34 Big Thompson Canyon, Highway Damage (Photo by Andy Cross, The Denver Post)

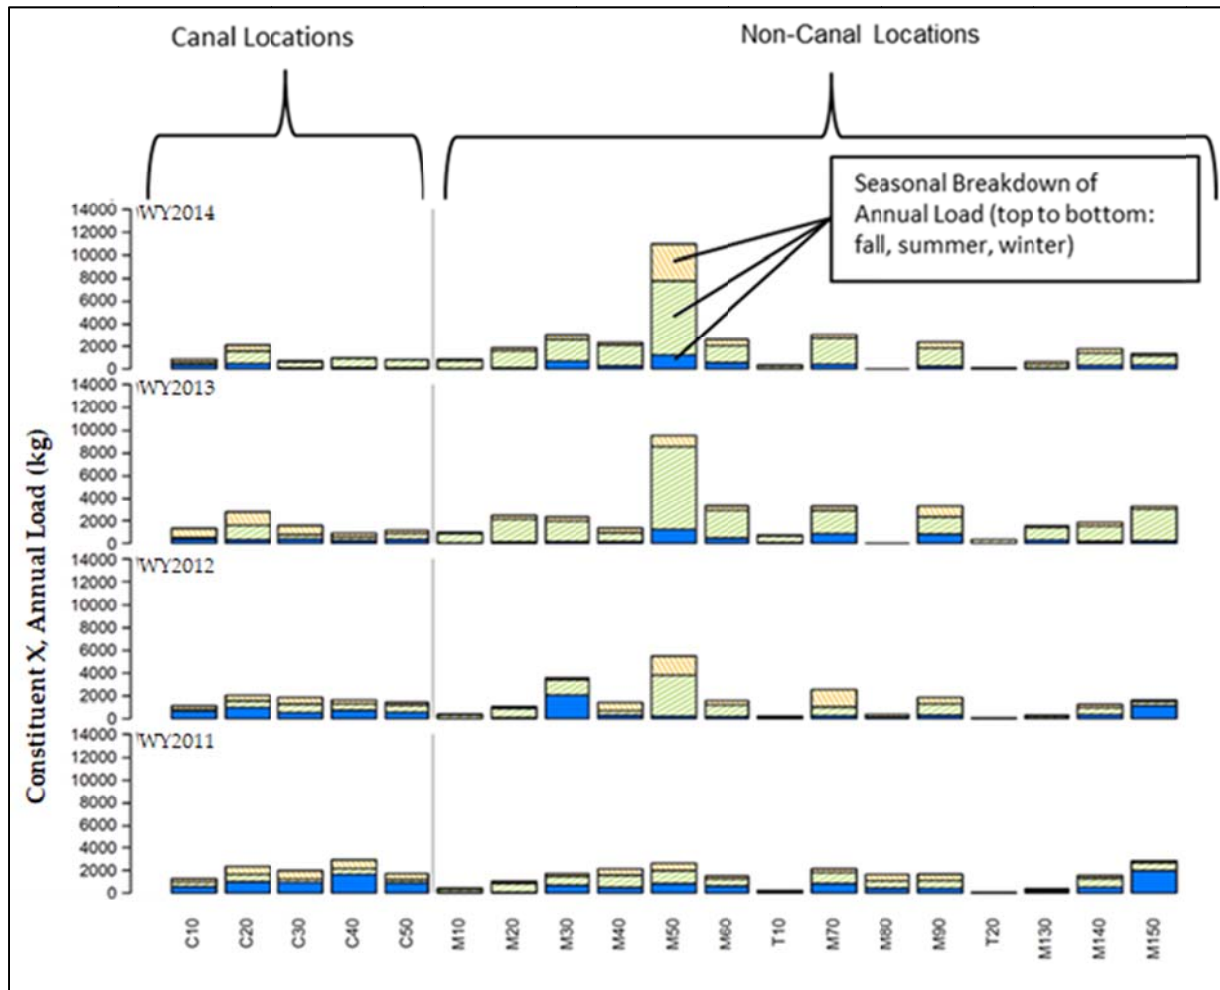
Figure 20. Hypothetical Example Loading Bar Graph

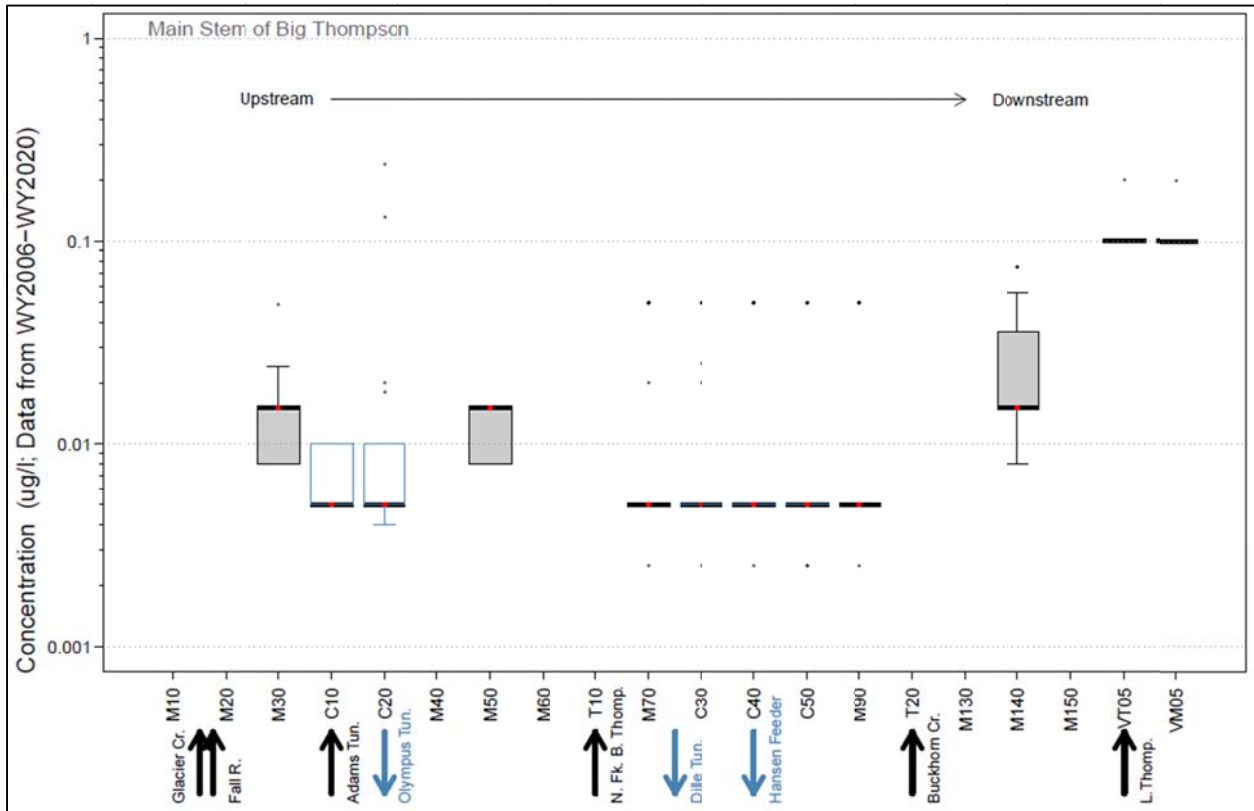
Figure 41. Box Plot of Dissolved Cadmium Concentrations ($\mu\text{g/L}$) in the Big Thompson River, WY2006-WY2020
