SECTION 319 NONPOINT SOURCE POLLUTION CONTROL PROGRAM

WATERSHED PROJECT
FINAL REPORT

Bullion King Mine Waste Remediation Project

WQC 60522

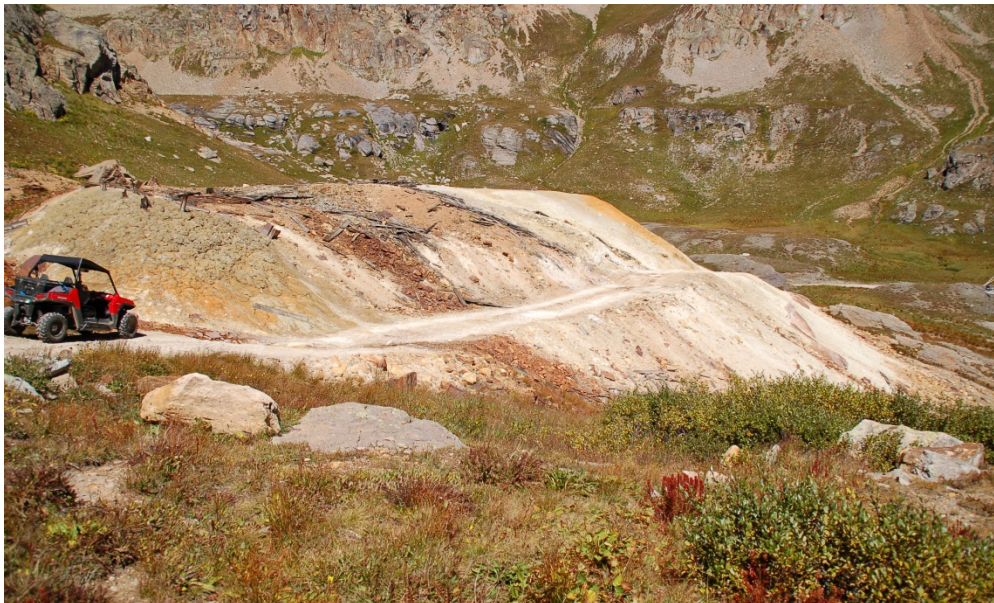
Figure 1a - Bullion King before Remediation

The Bullion King Mine is located high (12,300 ft. elevation) in the Mineral Creek watershed in the Porphyry Gulch sub-basin. Of the 160+ mine waste sites sampled in the Animas River watershed, it is one of larger piles and ranked by ARSG as one of the highest in terms of total potential metal loading to the surface water bodies. Access is limited to about four months during the year by snow and by a rough, extremely narrow four-wheel drive road.

Creating an on-site repository to isolate the mine waste from precipitation and surface runoff was determined to be the least expensive method of remediation. Under the initial plan, the mine waste would be graded to slopes no more than 3H:1V, and then covered with approximately 30,000 square feet of geotextile liner. Six inches of topsoil and a native vegetative cover would be placed over the liner. (For more details on the liner and coverings, see the DRMS Closeout Report in Appendix A.) Mine drainage from the portal would be routed around the repository.

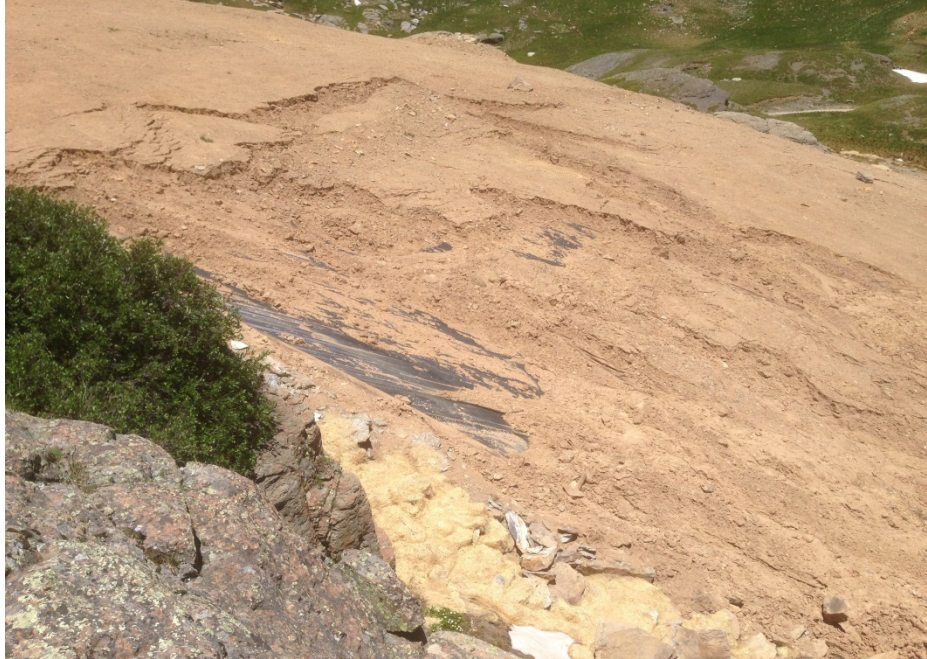
Figure 3 – Soil Slippage – July 2016

The amount of mine waste proved to be much extensive than anticipated. In an attempt to keep within the slope parameters, the repository had to be expanded to almost twice the initial size. Even with the expansion, the southeast corner exceeded the desired slope because of topography and other physical constraints at the site. After equipment had been demobilized, soil began to slip off and expose the liner. It was too late in the fall to re-mobilize and fix the issue.

In 2016, a new bidding process was initiated to fix the site. A different contractor was chosen for the work. Funding included a portion of the ARSG 319 grant, DRMS severance tax and additional DRMS 319 monies.

Of the nearly 60,000 square feet of liner, 10,000 square feet was removed from the steeper sloped portion. The cover material in this area was removed and stockpiled. Ninety tons of Portland cement was mixed in the top six inches of mine waste to neutralize pH and bind the material. Rock and the stockpiled topsoil were used to cover the material. Finally wood mulch, native seed and Biosol fertilizer were applied to the entire site. Overall, the Bullion King mine waste remediation cost \$599,038.80 or 92% of project.

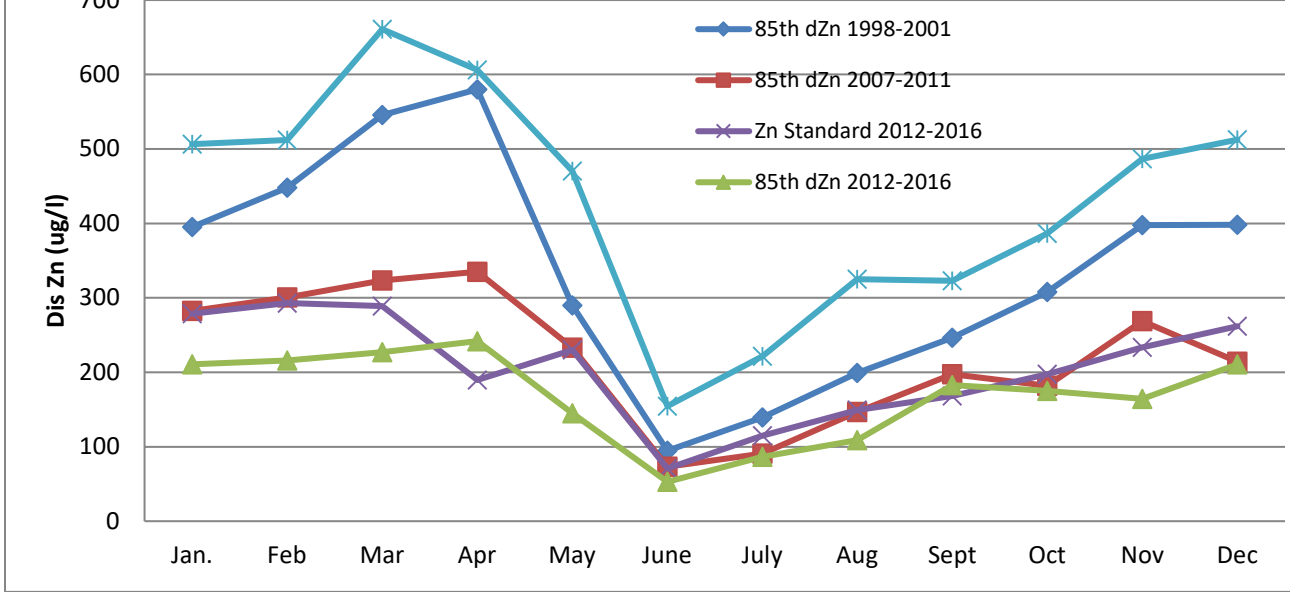
Figure 4 - Dissolved Zinc Concentrations at M34

The graph below shows the 85th percentile of dissolved zinc data collected each month over a certain time period. During winter months, only one sample was collected per month. So over five years, the 85th percentile may be calculated on only five samples. During the rest of the year, there were often multiple samples collected by various entities each month which should be more representative of actual water quality.

The water quality standard for zinc is also depicted. The standard is TVS, calculated for each month using the average hardness for that month over the specified years. May is an exception. The standard is 230 ug/l for that month as specified by WQCC at a hearing in 2001.

The percentage drop in dissolved zinc concentrations from 1991-mid 1996 to 2012-2016 varies from month to month but is generally between a 60-70%. The one exception is September where concentrations fell only 43%. In addition, dissolved zinc meets TVS nine months of the year and is very close to meeting TVS during the other three months.
