WATERSHED PROJECT FINAL REPORT

Sugarloaf Mountain Mine Waste Erosion Mitigation

Colorado Mountain College

July 2019

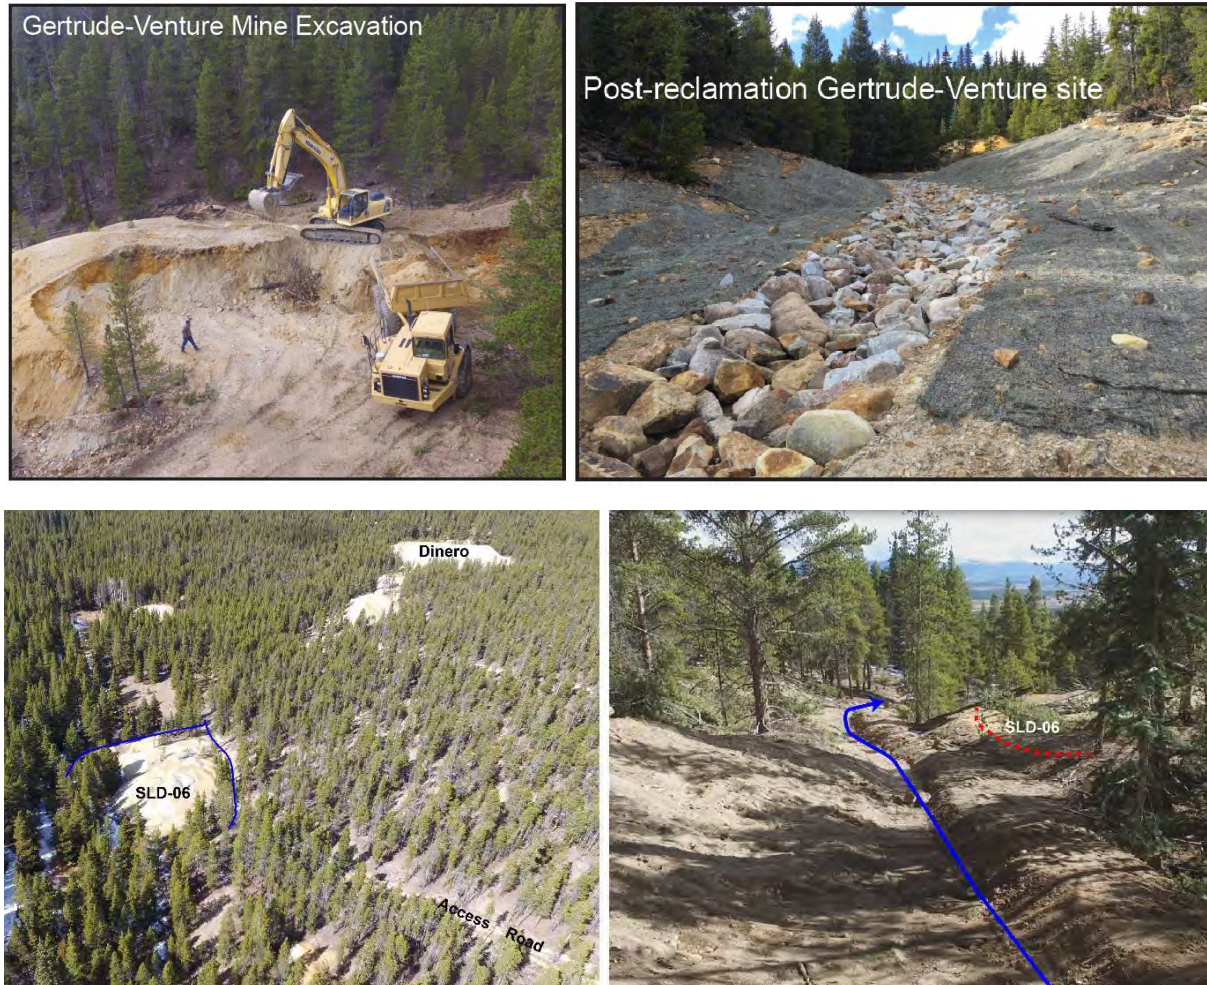
Figure 5. Images of active site remediation by DRMS and post-remediation outcomes at the Gertrude-Venture Mine and completed storm intercept system at SLD-06 in Sugarloaf Gulch.

Figure 1 is a map of implemented BMPs and locations of water quality monitoring sites. Figure 5 shows before and after images of remediation at the Venture Mine. Additional pictures of the BMP construction, before, and after images are contained in Appendix 1.

While this BMP does not prevent erosion caused by water that falls or melts directly on the pile, it will likely prevent continued erosion caused by flowing surface water that is now being diverted around both sides of the pile. In the future, Turf Reinforcement Matting (TRM) treatments on the pile itself could additionally stabilize the waste material.

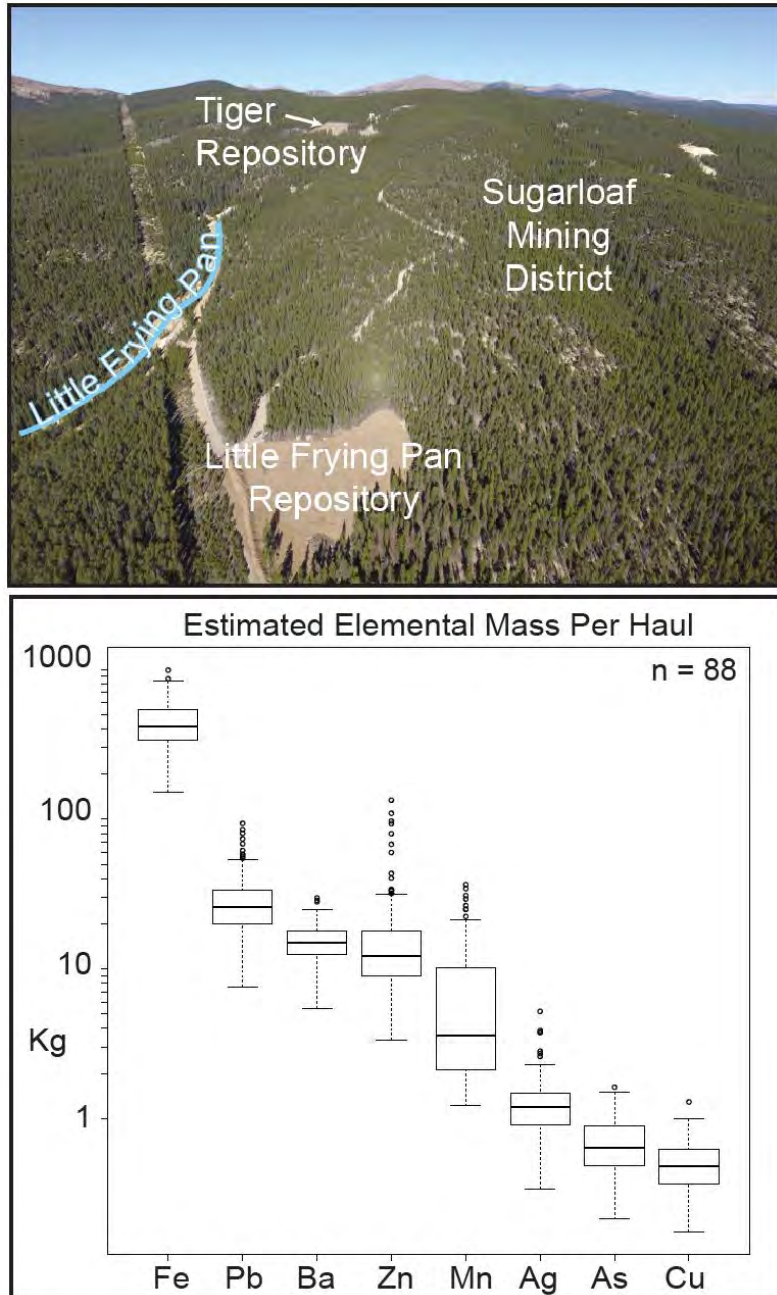
Figure 7. A) Aerial overview of the 319 project site in the Sugarloaf Mining District. B) Estimate of metal mass per excavation load derived from UAV photogrammetry analysis and XRF results.

During excavation of waste rock piles, composite samples were obtained from individual haul dumps for analysis of whole rock composition by X-ray Fluorescence (Figure 7 and Appendix 3). Using the metal concentration values from these samples, combined with volumetric estimates of individual haul dumps, we estimated the mass of metal sequestered in the repository. Our analysis indicates that a minimum of ~37,000 kg metals were removed as metal loading sources from Little Frying Pan Gulch and sequestered into the waste rock repository. Details of this analysis are in Appendix 2 (see Rasmussen and Mohrmann, 2017).

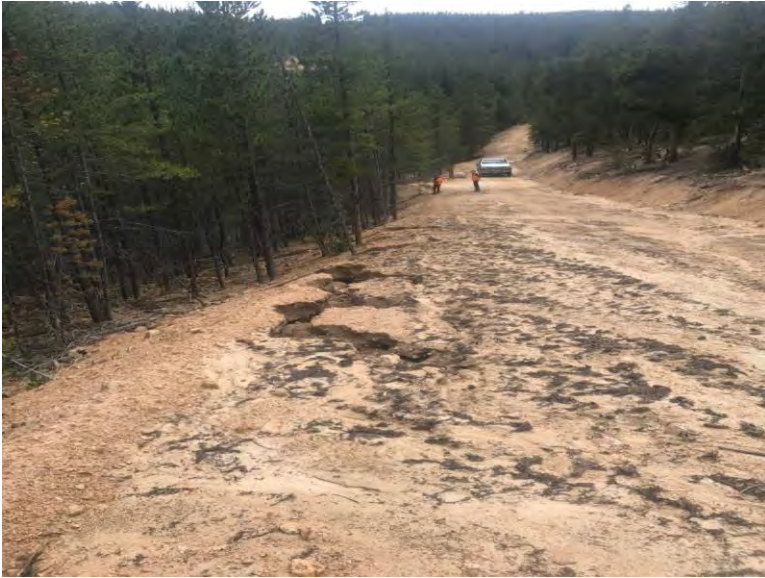
Road Damage above Little Frying Pan on Powerline Road

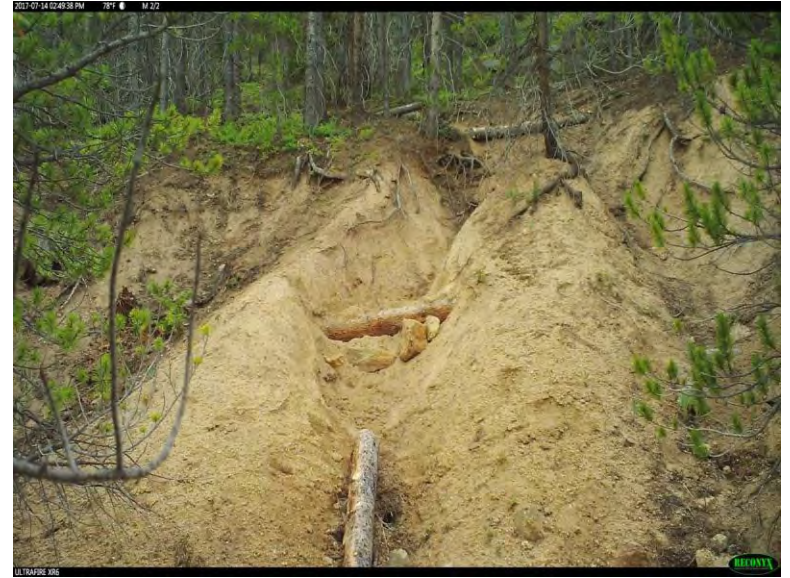
LEB Installation West of Little Frying Pan

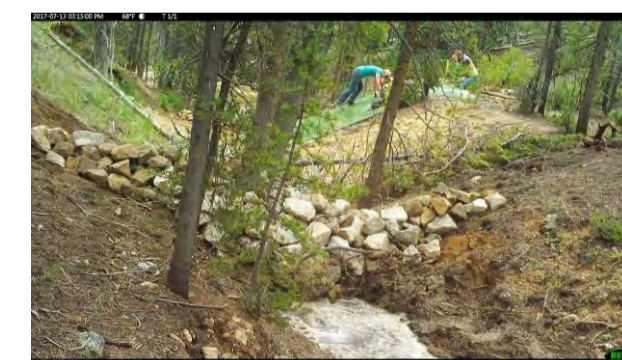
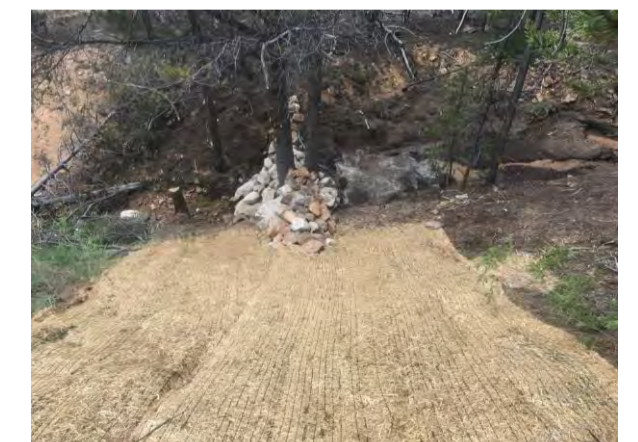
4. Erosion control matting

Two types of erosion control matting were used on this project. Disturbed soil was seeded and coconut husk matting (right) was installed above the recently constructed sediment basin in an attempt to establish vegetation and increase bank stability. Coconut husk matting is biodegradable, and can help hold seed and moisture in place as plants reestablish and stabilize the soil. We also installed Excelsior brand heavy duty turf reinforcement matting (left) to help prevent erosion of a small tailings pile, and along a steep road-side slope above Little Frying Pan Gulch. Excelsior TRM matting is made from woven polypropylene fibers, and is designed for use on challenging slopes and environments.

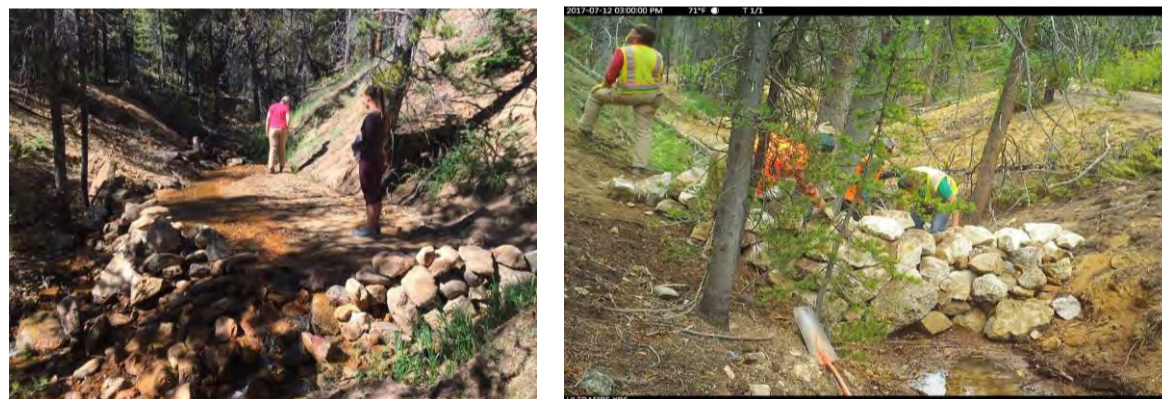
1. Sediment basins

Three sediment basins were installed along Little Frying Pan Gulch. The sediment basin in the photo on the left was built in the fall of 2016, and filled with sediment in under one year. The basin on the right was constructed by NRM Field Institute field technicians in the summer of 2017. These basins were designed to allow water to flow through the rock face, while slowing velocity and sequestering sediment on-site.

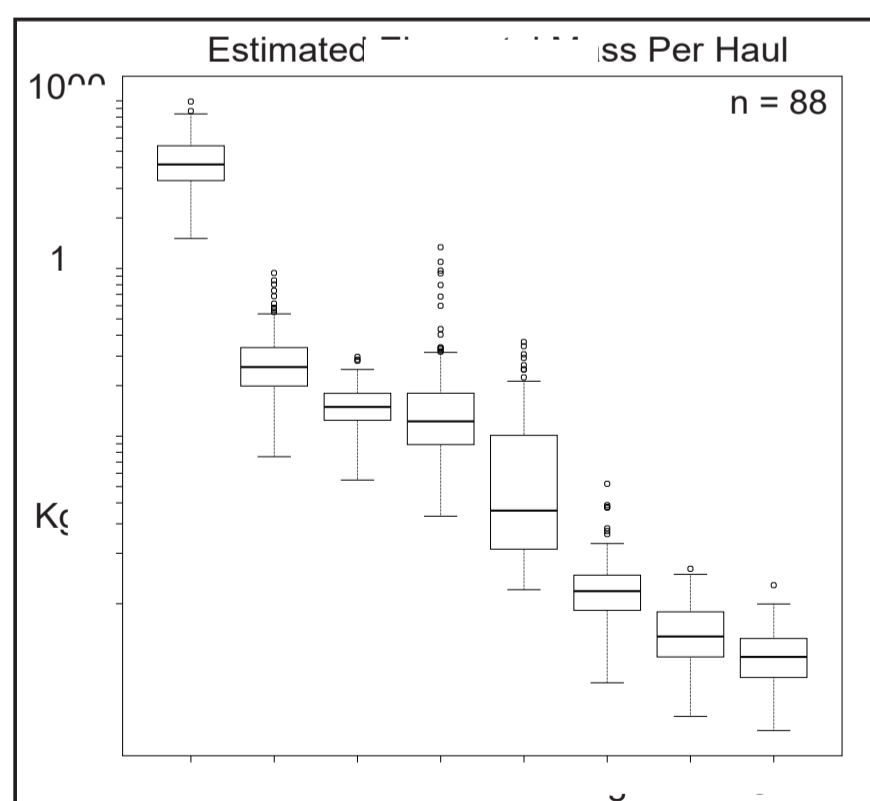
Estimated in situ waste volume	~4100 m ³
Total excavated waste material	~12300 m ³
Estimated minimum metal mass removed	> 10 ⁴ kg
Estimated total metal mass removed	~10 ⁵ kg

CONCLUSIONS: ~12,300 cubic meters of mine waste were removed from Little Frying Pan Gulch into the waste repository during this project, four times the surveyed estimate. Our analysis indicates that a minimum of ~37,000 kg Fe, Pb, Ba, Zn, Mn, Ag, As, and Cu were sequestered into repository. The total mass of these metals in the repository is likely on the order of 10⁵ kg. Unmanned aerial systems (UAS) are an effective tool for gathering detailed land surface information necessary for mine remediation projects and a complimentary workflow to more traditional methods.

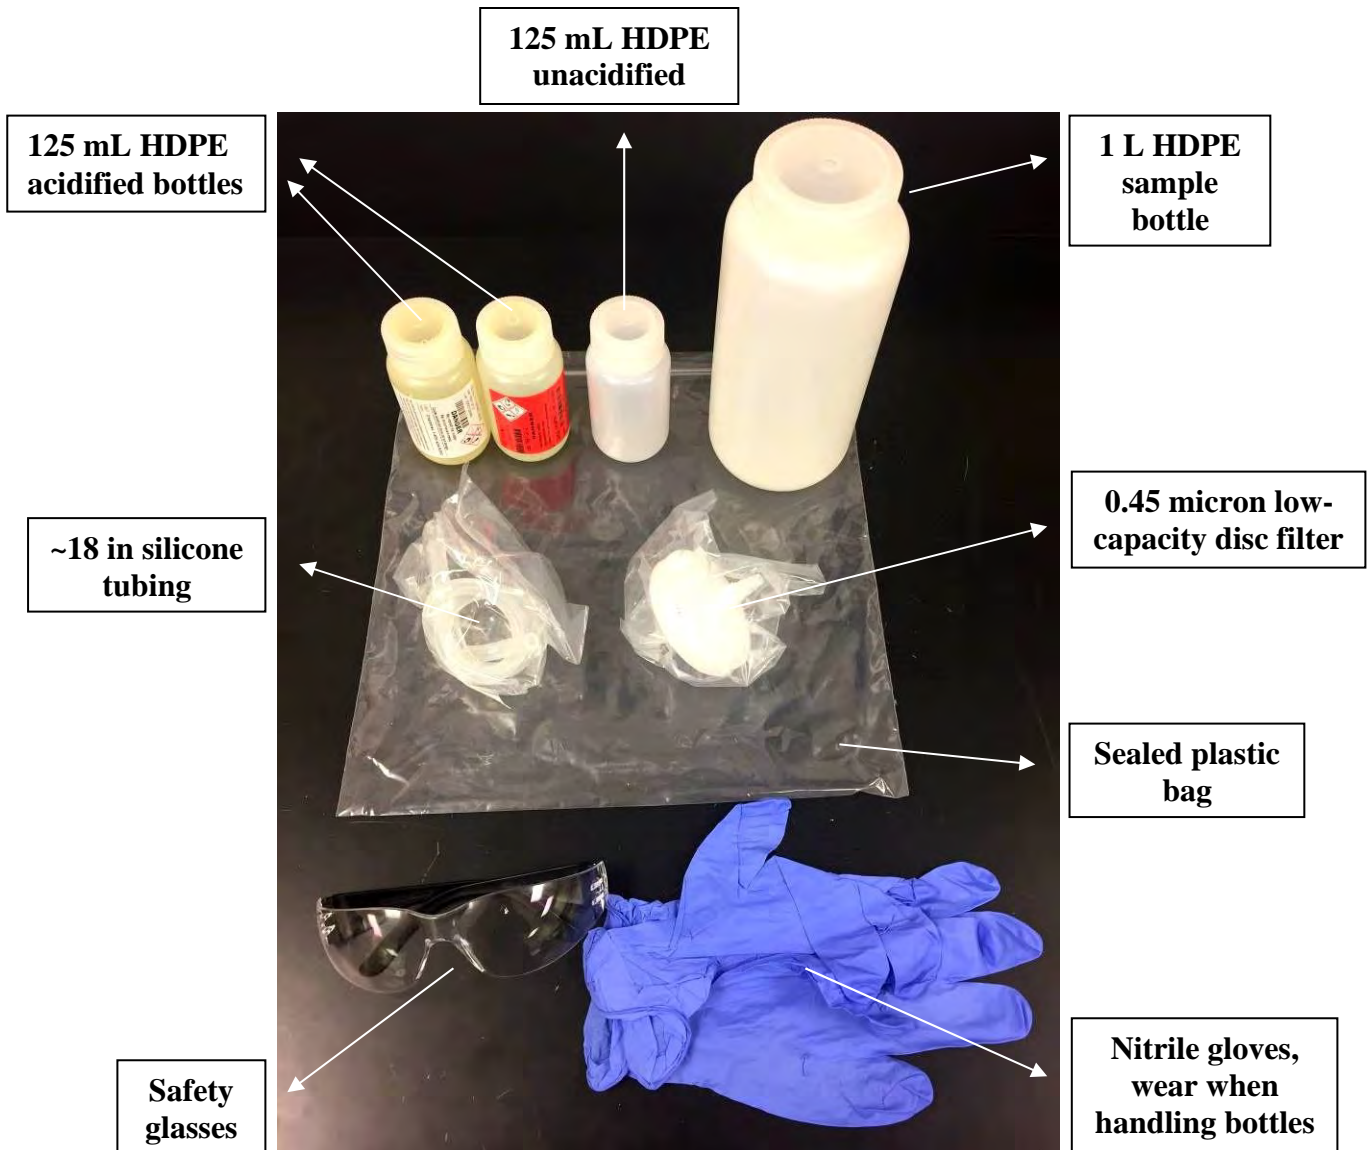
Figure 1: Lake Fork sample kit items and personal protection equipment (PPE).

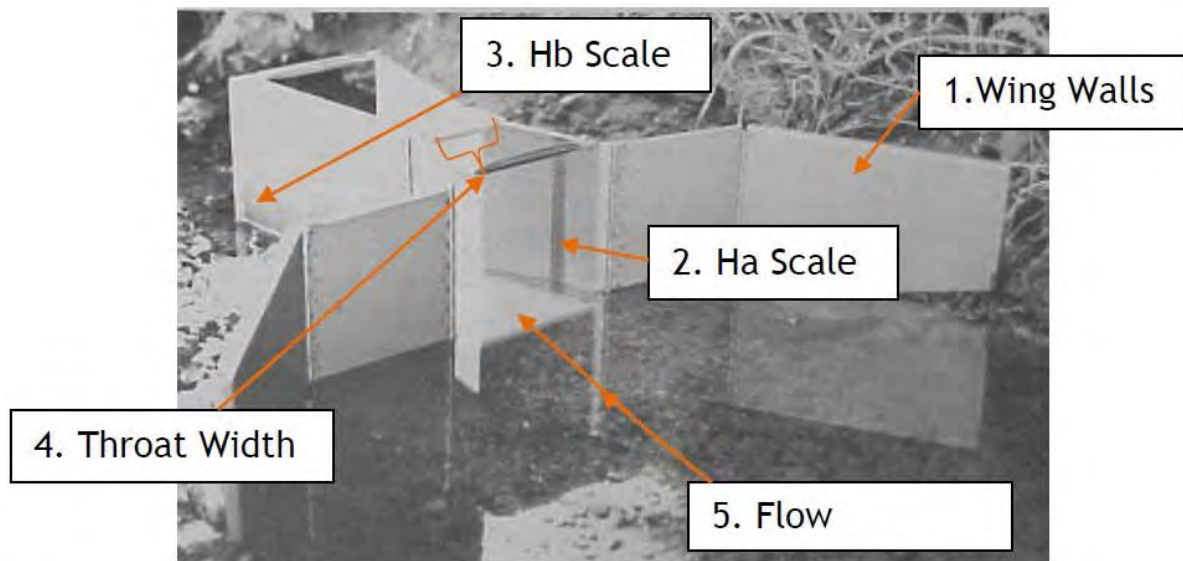
Figure 2: 8 in Cutthroat Flume with annotations (CDPHE, 2016)

A Baski Cutthroat Flume (Figure 2) should be used for stream flows that are too low for the use of the Flow Tracker and too high for the use of volumetric measurements (Table 5). Please follow the detailed instructions from CDPHE's Standard Operating Procedures for Flow Measurements using a Cutthroat Flume (CDPHE, 2016).
