SECTION 319 NONPOINT SOURCE POLLUTION CONTROL PROGRAM

WATERSHED PROJECT FINAL REPORT

Lower North Empire Creek Restoration Project

Diane Kielty & J. David Holm

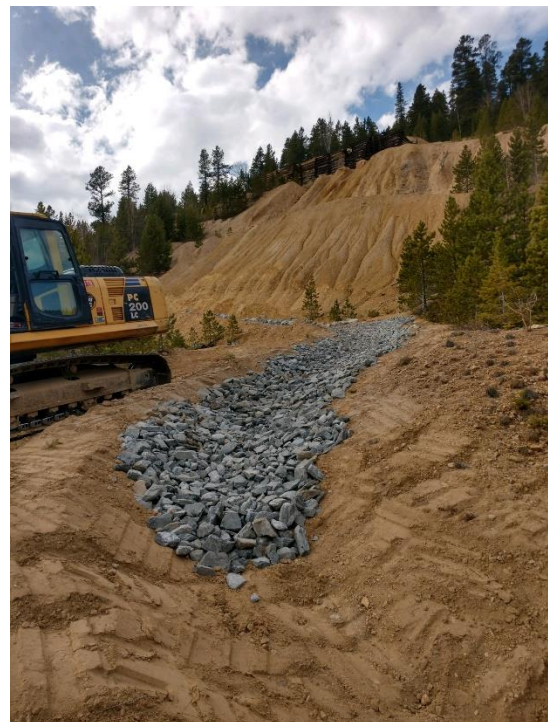
Figure 2 - Interceptor Channel from Benson Mine Cribbing

1. Two constructed diversion channels and interceptor channel from the Benson Mine cribbing (Figure 2).
2. Two constructed sediment storage embankments along mining Road 253 in the upland drainage area of North Empire Creek.
3. A turning berm to divert mining impacted drainage flows to the north and to the south within runoff control interceptors following the roadway.
 - a. The channel redistributes flows to the stream, utilizing Road 253 crossing locations near the Lower Placer Pit on the southern slope of the road, and near an abandoned pump house on the northern slope of the road. These road crossings transport the runoff water into loose boulder rundown structures toward North Empire Creek.
4. Removal and placement into approved repository of mine waste and contaminated sediment in streambed at the Bay State Mine location.

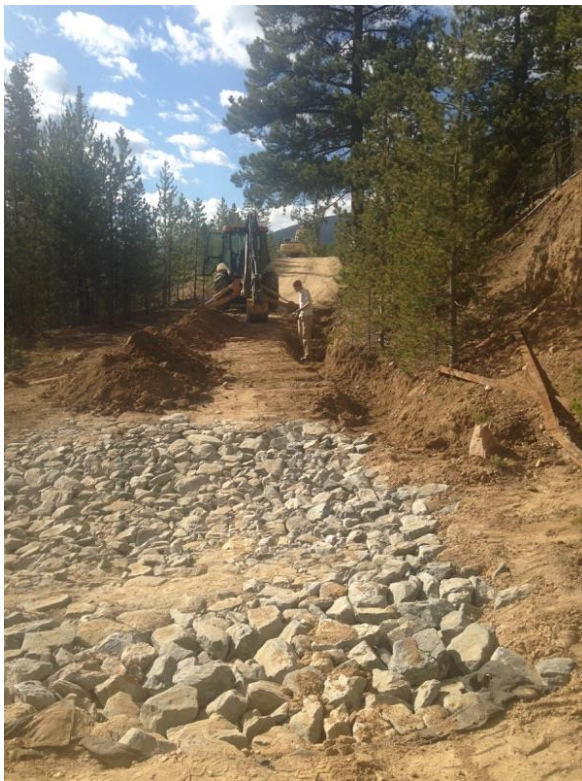
Figure 4 - North Road 253 Crossing Point Low Flow Crossing and Gradient Evaluation

During the first month of construction rock was hauled to a staging area by the closed Town of Empire landfill and a low flow crossing was completed at the north end of the Road 253 cross point (Figure 4).

The gradient evaluation of Road 253 showed the high point in the road at its highest elevation at a 2' gradient difference between the lowest points north and south of the Benson Mine cribbing location. To address this challenge the run-off ditch was widened where feasible to reduce the depth of the ditch to meet grade. A berm was placed along this portion of the run-off ditch to prevent vehicle traffic from driving into the ditch.

Also, based on this gradient difference, changes were made to the work plan to construct a run-off ditch of approximately 40' on the southern portion of Road 253 starting at the high point of the road located directly below the Benson Mine cribbing. An intercept channel was shaped on the south side of the Benson Mine area to connect with a southern Road 253 run-off ditch, and a low flow crossing was added at the lowest point of southern Road 253.

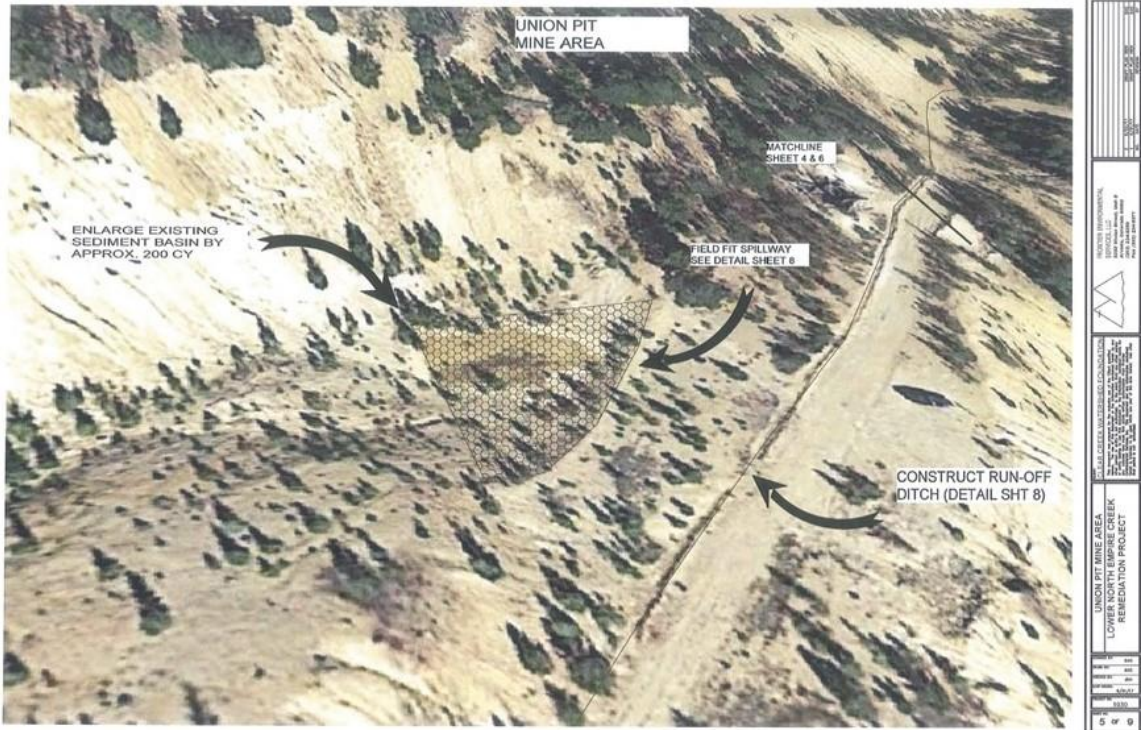
Figure 5 - Union Mine Area Sedimentation Detention Basin Engineering Features

Construction began on a berm and spillway at the Union Pit mining area (Figure 5) and the Benton Mine cribbing interceptor channel. A laser level was used to evaluate the slope of Road 253.

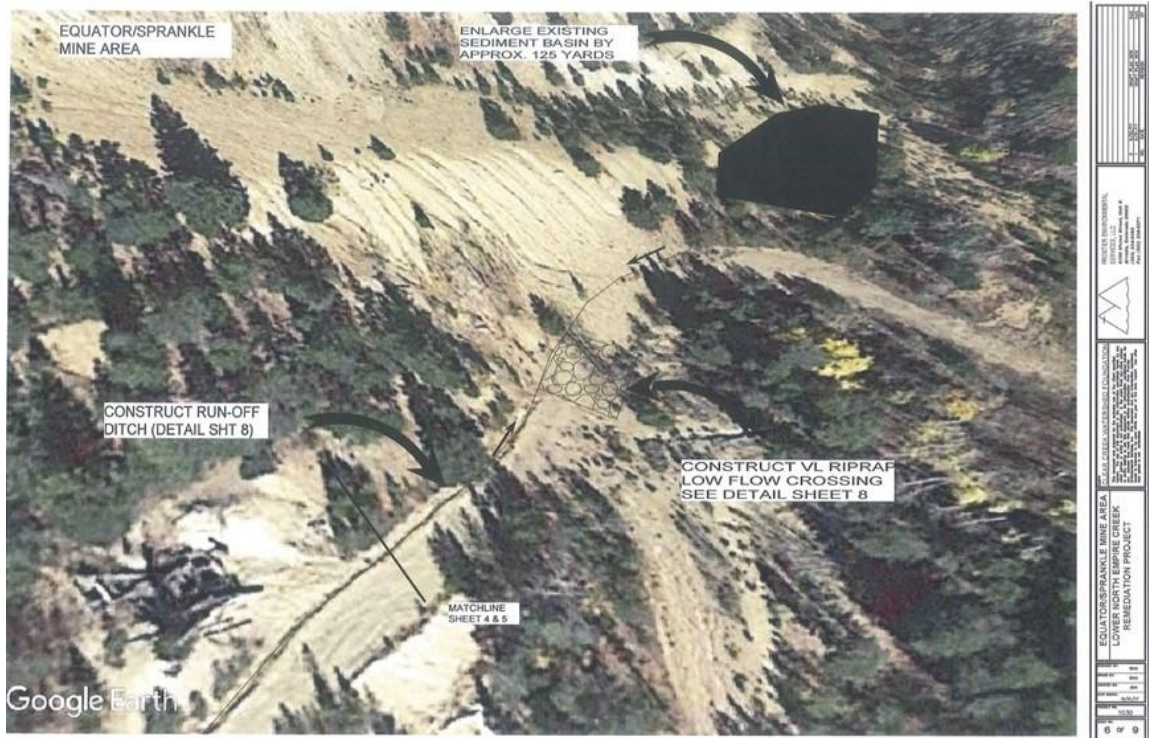
Figure 6 -Sprankle Mine Area Sedimentation Detention Basin Engineering Features

An additional 40+ cubic yards of rock for the Road 253 run-off ditch was needed due to the work plan change. Soil was spread to prepare the area for revegetation. By the second week in November the berm on Road 253 was complete. While the Benson Mine main intercept channel was being completed, straw waddles were placed at the Bay State area and Sprankle Pit mining area (Figure 6) to prepare build out of the sediment detention basins.

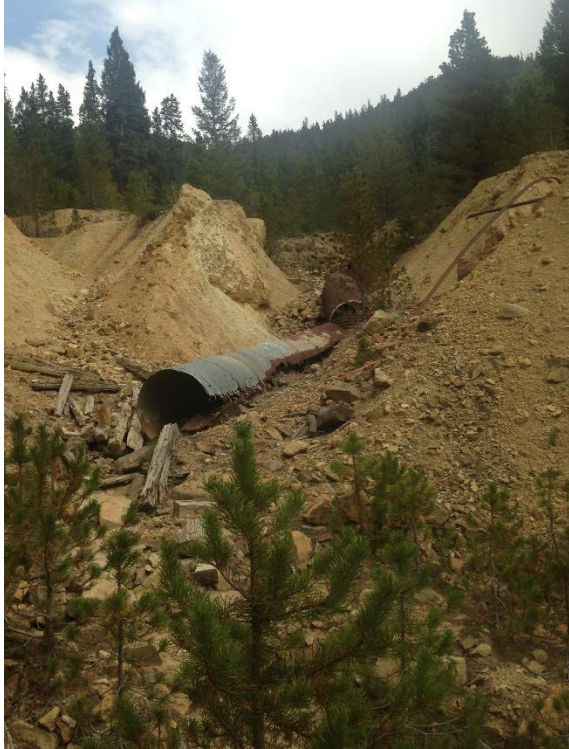
Figure 8 - West Mine Waste Pile Before

The crew then mobilized to the Bay State Mine area to begin grubbing the repository. The grubbed trees were stockpiled for reuse as site revegetation contour. A temporary stream bypass interceptor was placed, and repository excavation began. Crews started moving the west creek side mine waste piles into the repository. A discovery was made that the western most waste pile had a depth greater than estimated (Figures 7 and 8).

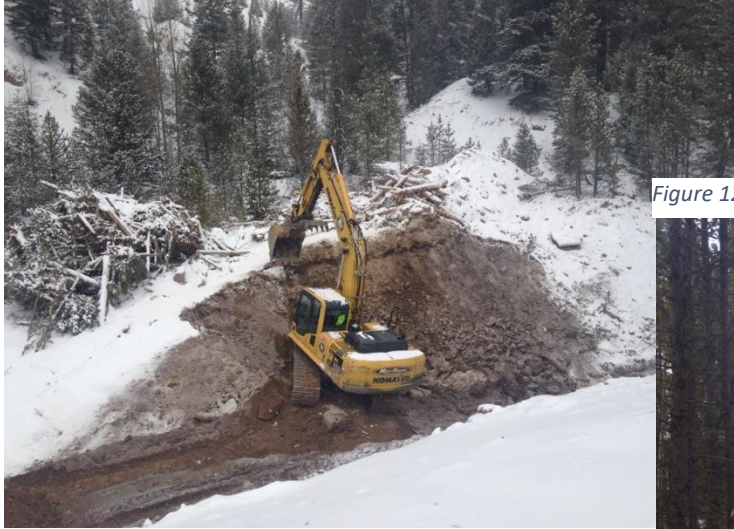
Figure 11 - Dropping Clean Soil Down to Reduce Hillside Gradient

In January 2018, FESI began removal of waste in the creek channel. The waste along the creek side was removed by undercutting the stream bank followed by dropping the clean soil down from above the undercut to serve as cap, thereby reducing the slope gradient of the hillside above the stream bank (Figure 11). Large rock was keyed into the hillside and extensive grub was used as cover to perform as a mulch in the steep slope sections, which are at the same grade as the natural slopes (Figure 12).

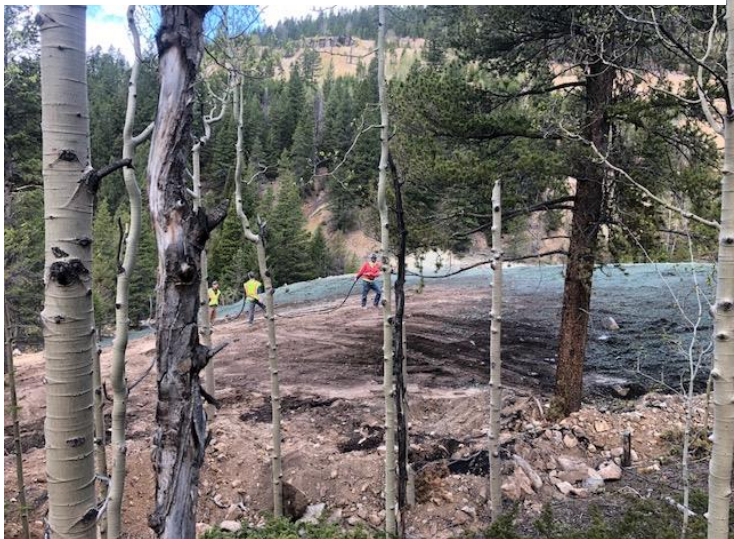
Figure 13 - May 2018 Hydromulch of Repository

In the Spring of 2018, a revegetation took place (Figure 13). Gypsum, Lot 125 and Eco-Flex, seed, fertilizer, hydromulch and water were applied.

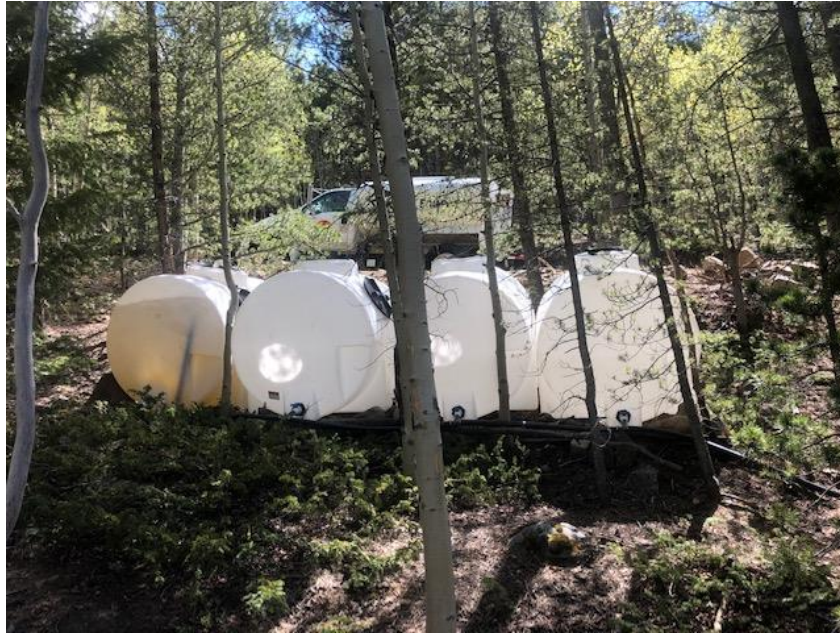
Figure 14 - Manifold System with Four 500-gallon Tanks

On June 5, 2019 spring revegetation took place. A manifold system with four 500-gallon tanks was constructed on site and filled with water. Drip tubing was strung to 300 planted plugs that include Aspen, Pine, Mountain Mahogany and Dogwood. A 2,000-gallon water truck topped off the tanks for a total of 40 watering events through the summer (Figure 14). The tank system was checked on a weekly basis.

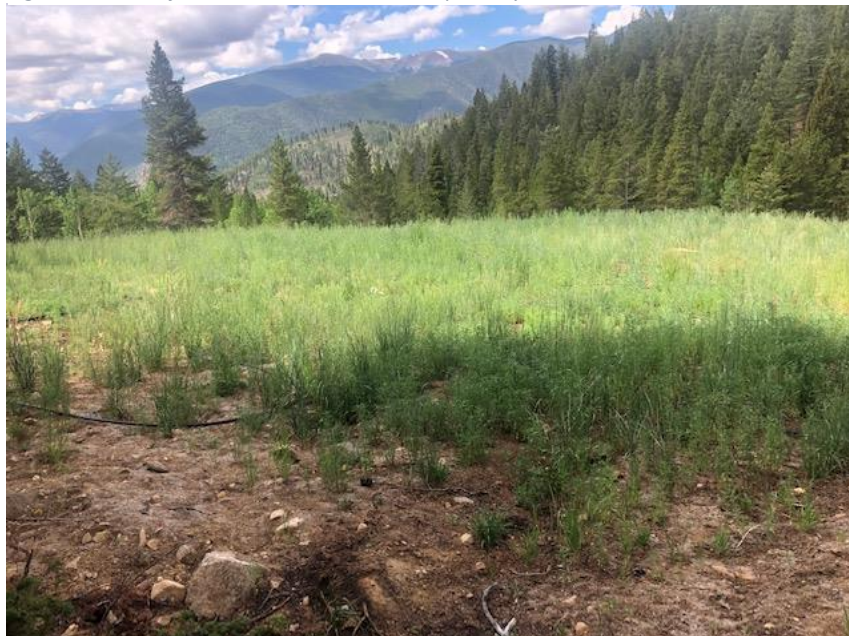
Figure 15 - Mix of Reclamation Grasses on Repository

By mid-August, site visits revealed a high percentage of weed growth associated with the compost from the cap, but there is also a well-established mix of reclamation grasses. The Bristlecone is experiencing particularly good success and the Dogwood near the creek are taking hold.

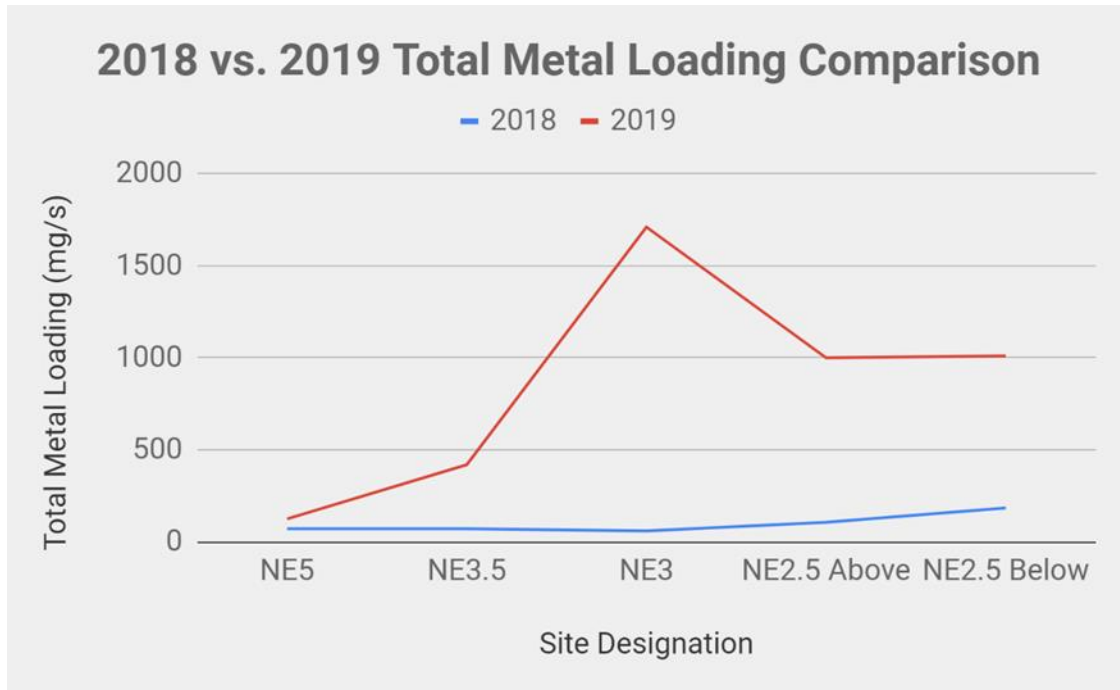
Figure 18 - Total-metals load profile, May 18, 2018, versus May 14, 2019

Figure 18 below indicates a post-restoration profile of the total-metals load in North Empire Creek after all reclamation work had been completed upstream of monitoring site NE-3. The TMs load profile is a “snapshot”, or instantaneous (time-of-sampling) reflection of the cumulative mass loading from all trace metals (TMs) for which there are laboratory results for that one sampling event and time.

In the area addressed by the Lower North Empire Creek Restoration area, it is apparent that the stream already is carrying most of its maximum load of trace metals and acidity. The most interesting observation about the beneficial impact of the lower project is that there is presently only a tiny increase in metal loading through that project area. This is best represented by the total metal loading observed at NE-2.5 above and below the project area, as shown in Table 7. There is a total increase of only 10 ug/L for all 9 metals that were analyzed through the lower project area. This was a highly contaminated area from which 16,660 CY of mine waste and contaminated sediment were removed from the stream-channel bottom and emplaced in a repository.
