WATERSHED PROJECT FINAL REPORT

Upper Uncompahgre Watershed Mine Remediation Project

June 2018

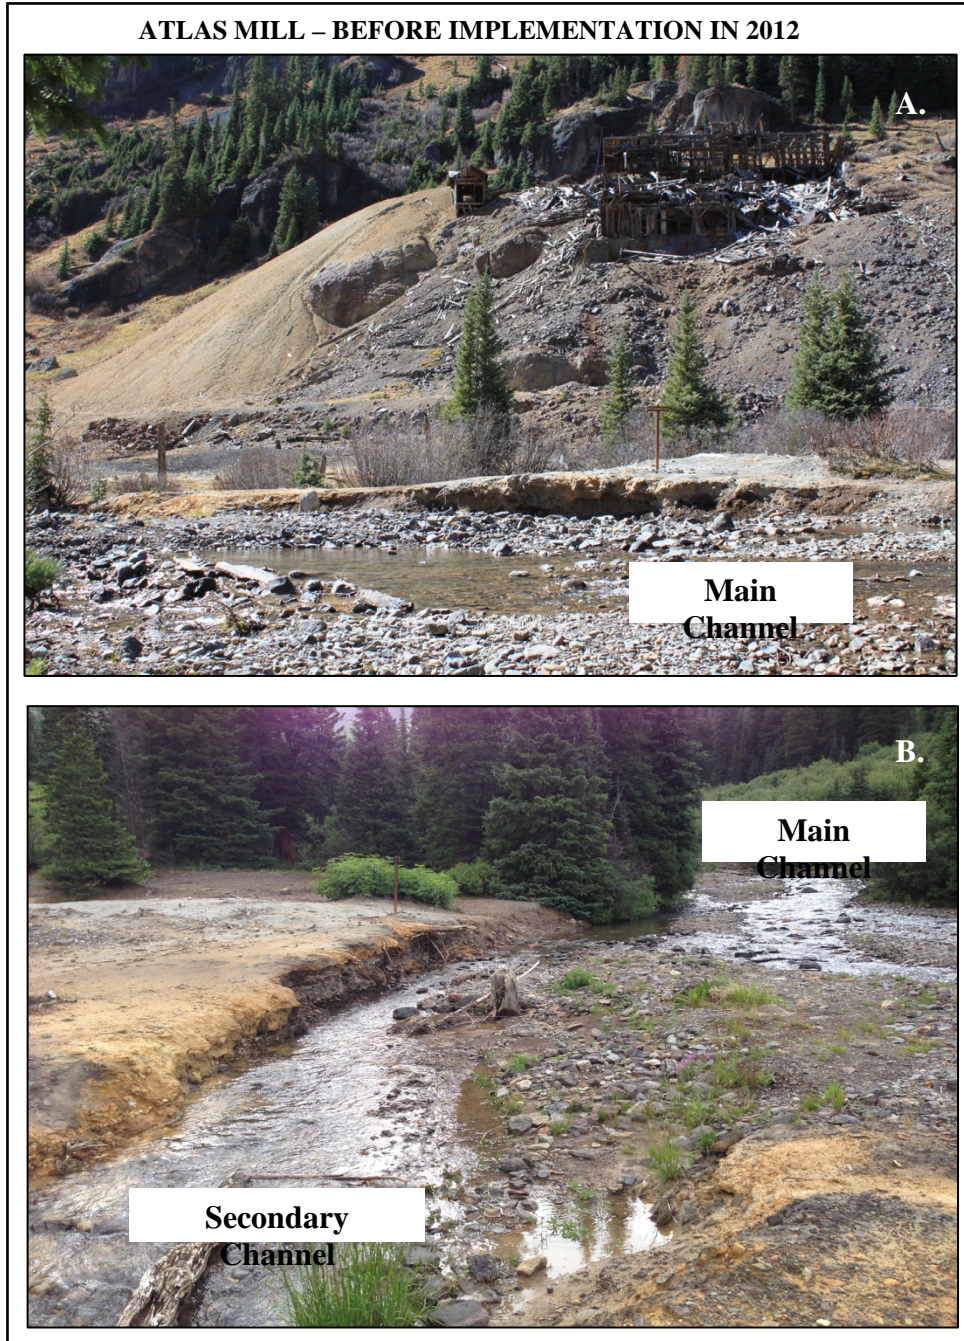
**Figure 3.** Atlas Mill above Sneffels Creek (A) before the bank stabilization project in 2012. Sneffels Creek main channel and secondary channel which cut into the tailings (A, B) were eroding the mill tailings and transporting heavy metal laden sediment into Sneffels Creek.

Original remedial actions considered for the NPS project included 1) removal of the Atlas Mill tailings (estimated at 7 acres, 20,000 cubic yards), their re-milling and reprocessing in the mill of the adjacent Revenue Mine, vegetation of the area and stabilization of Sneffels Creek streambanks or 2) capping and vegetation of the tailings and stabilization of Sneffels Creek. Because of mixed ownership challenges (private and USFS) and grant timeline constraints, the final approach was to mitigate metal loading to the stream by reducing erosion of the mine tailings into the stream

by re-aligning the main channel, closing off the secondary channel that crossed the tailings, and stabilizing the new channel's streambanks with physical in-stream structures and riparian vegetation.

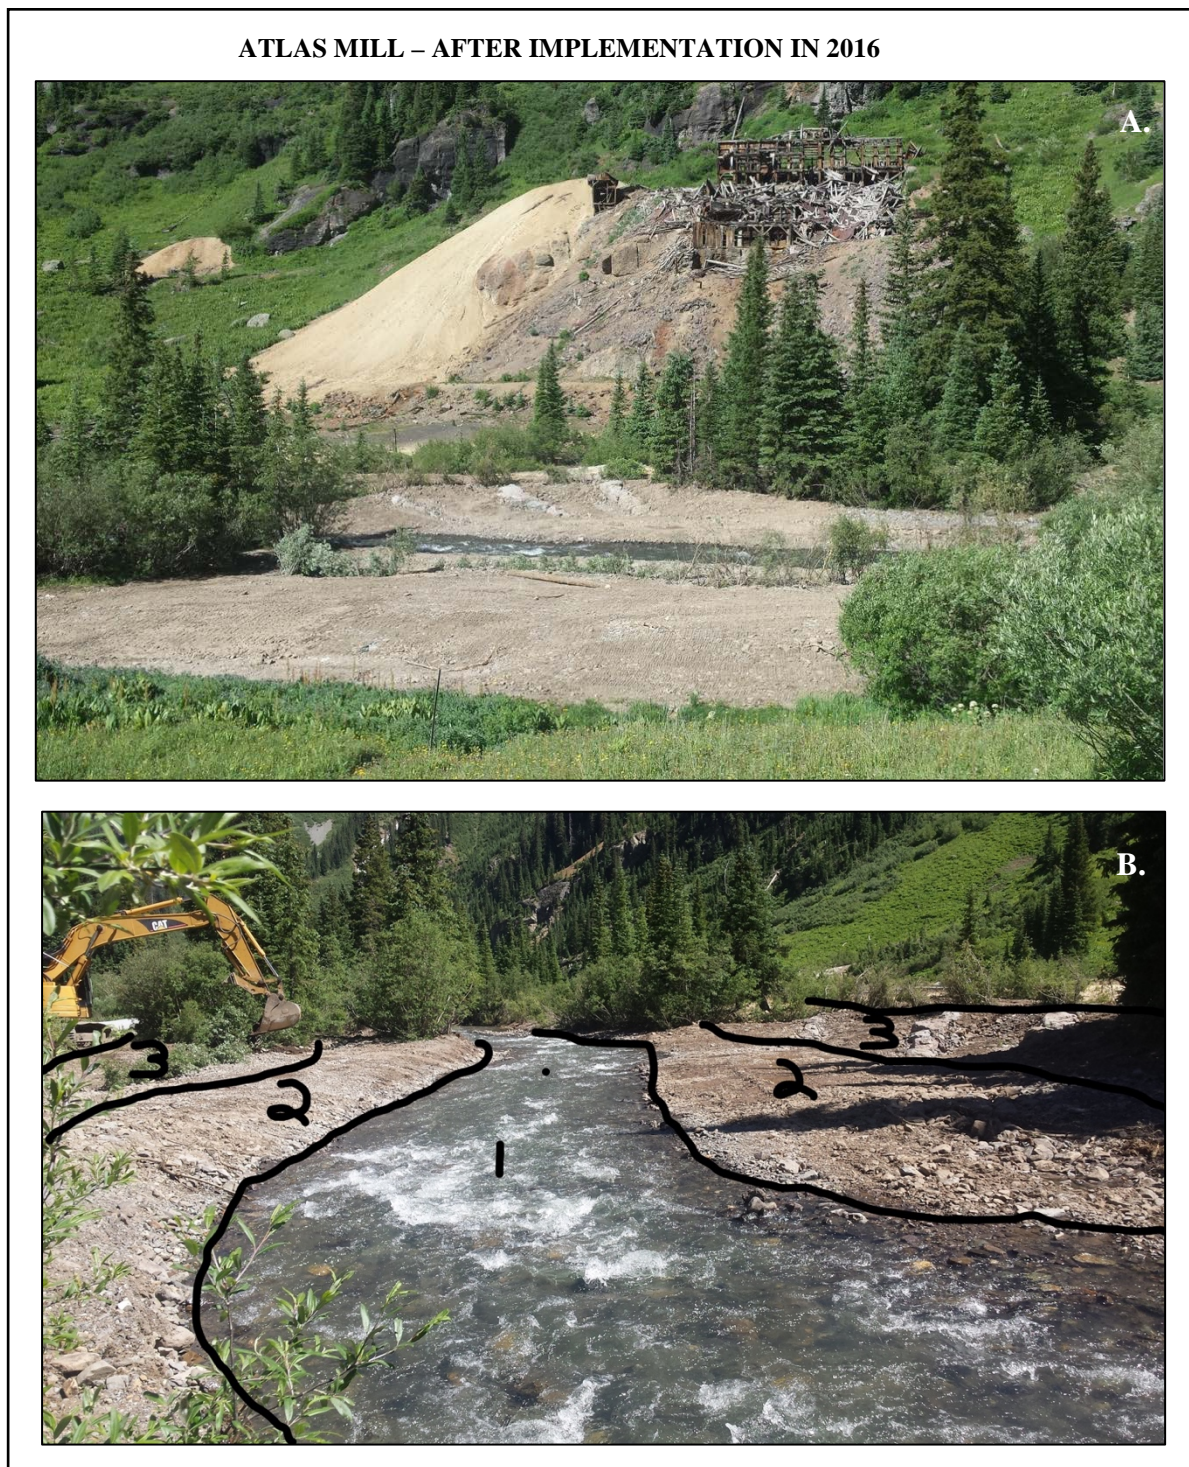
**Figure 4.** Atlas Mill above Sneffels Creek (A) after the bank stabilization project in 2016. **A.** The new channel was stabilized with three constructed vane arms (large, buried boulders on the far bank), log cribbing, willow transplants and pole cuttings on both stream banks. The bare areas were seeded with alpine herbaceous riparian and upland species. **B.** The new multistage channel includes Stage 1: typical low volume discharge (seasonal low flows), Stage 2: higher volume discharge (seasonal bankful flows), and Stage 3: bankful discharge to upper floodplain.

- B) A 450' reach of Sneffels Creek was mitigated. The braided section of the reach was removed by excavating a new, three-stage single channel to prevent the stream from flowing through the tailings area. Streambanks were stabilized with vane arms, willow transplants, willow bundles, and willow stakes. Four acres of disturbed areas were seeded with an herbaceous seed mix.

During high flow, post-project cadmium, lead, and zinc concentrations were approximately 30 percent lower than pre-project concentrations. During low flow post-project cadmium, lead, and zinc concentrations were approximately 75 percent lower than pre-project concentrations. Consistent and uniform reductions in cadmium, lead, and zinc concentrations indicate that the Sneffels Creek Bank Stabilization Project at the Atlas Mill improved water quality conditions in Sneffels Creek.

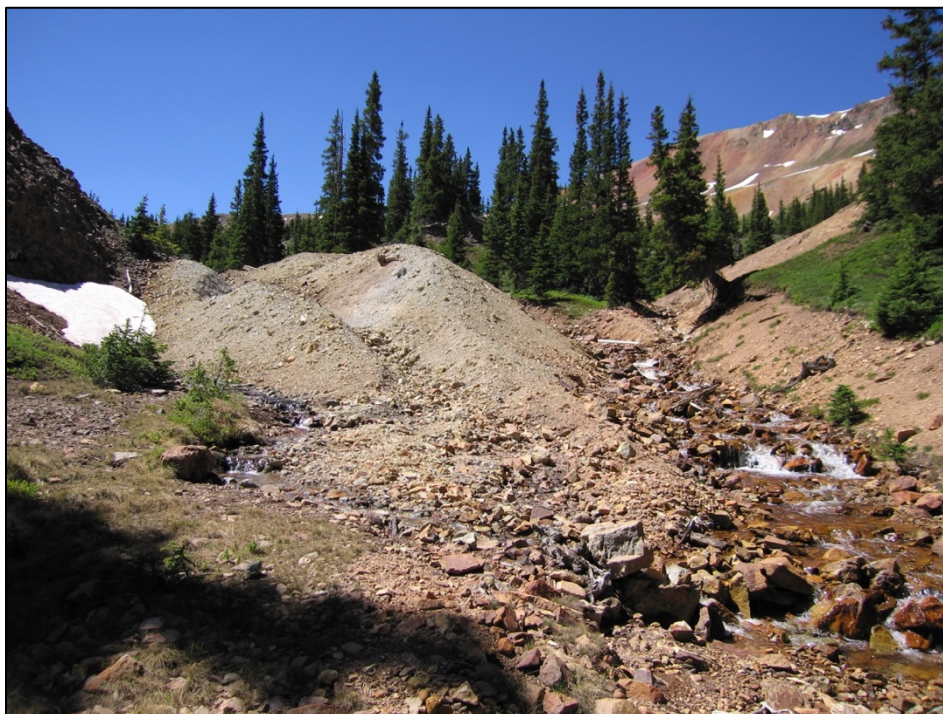
**A. VERNON MINE – BEFORE IMPLEMENTATION IN 2014**

**Figure 5. A.** Waste rock pile in Gray Copper Gulch at the Vernon Mine site in 2014. The 1,500 cubic yards of waste was excavated in 2015 and placed in a repository away from the gulch (upstream view). **B.** The excavated area (upstream view) was amended with woody compost, seeded with high elevation herbaceous species, and covered with aspen blankets in 2015. This photo was taken in 2017, two years after seeding.

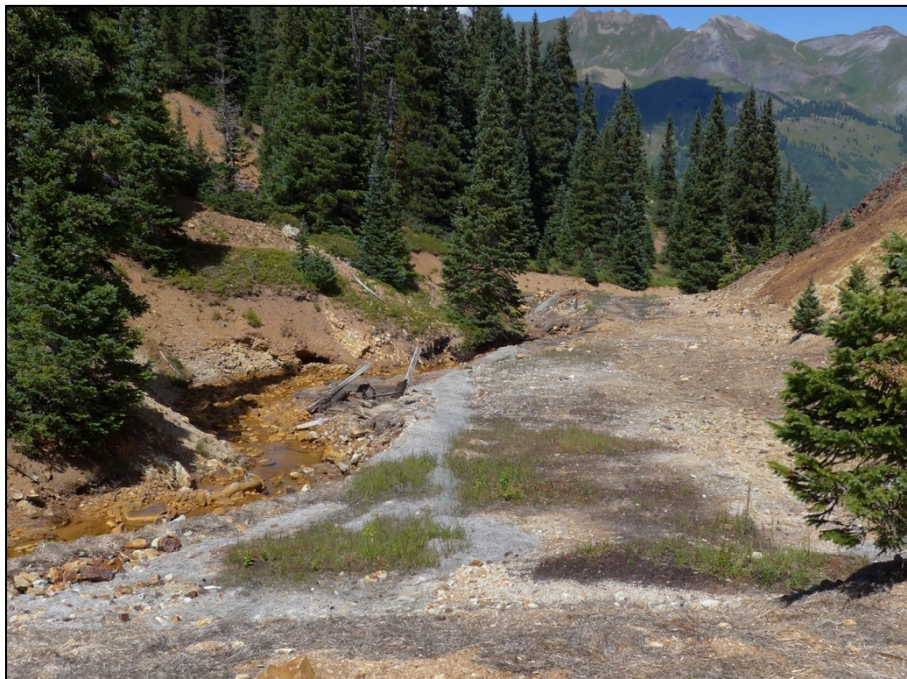
**A. VERNON MINE – VEGETATION COVER IN SUMMER 2017**

**Figure 6.** **A.** Established herbaceous cover in summer 2017 after initial seeding and amendments along Gray Copper Gulch in fall 2015; area excavated of waste rock at Vernon Mine site (downstream view). **B.** Barren areas were treated with more soil amendments (biochar, mycorrhizal inoculum, and nitrogen fertilizer), seed and hydromulch in fall 2017 (downstream view).

The area excavated of the waste rock was amended with 10.5 cubic yards of woody compost, delivered to the site in super sacks and spread manually across the area. The woody compost was a by-product from manufacturing aspen excelsior erosion control blankets; its breakdown produces calcium carbonate which helps to neutralize acidic soil conditions. The entire area was broadcast seeded with a native seed mix comprised of Rock Mountain fescue, columbine, slender wheatgrass, American vetch, Lewis flax, blue wildrye, western yarrow, tufted hairgrass, Rocky Mountain penstemon, chick starter, aspen daisy and fringed brome. Excelsior aspen bales, blankets and mulch were used to cover the seeded areas. The repository area was left in a roughened state at the surface to prevent potential runoff. On Sept. 29, 2015, Jeff Litteral (DRMS), Agnieszka Przeszlowska and Dennis Murphy (UWP) seeded the repository with the same native seed mix used in the excavated area. It was covered with excelsior aspen bales and straw leftover from erosion bales.

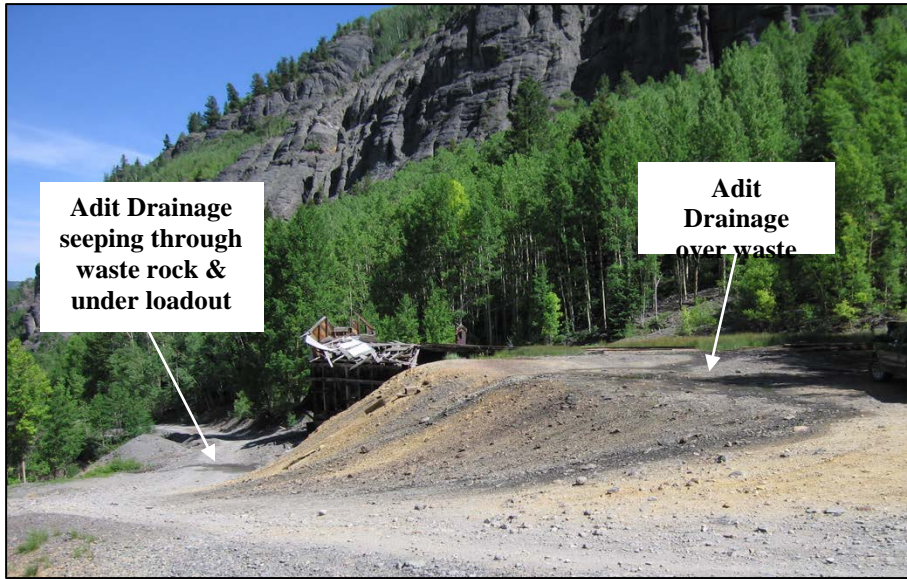
**A. MICHAEL BREEN MINE – BEFORE IMPLEMENTATION IN 2014**

**Figure 7.** **A.** Michael Breen Mine site before implementation in 2014. The adit discharge flowed over and seeped through the waste rock pile and loadout structure before crossing the county road and draining into the Uncompahgre River below. **B.** A diversion ditch was constructed in fall 2014 to route the adit discharge around the waste rock and into an existing drainage behind the load out structure. The waste rock was amended with biochar, seeded with a high elevation herbaceous seed mix and covered with aspen mulch shown in this photo. **C.** Photo-point of waste rock pile in 2017 showing that very little vegetation established after treatments in 2015 (photo B.)

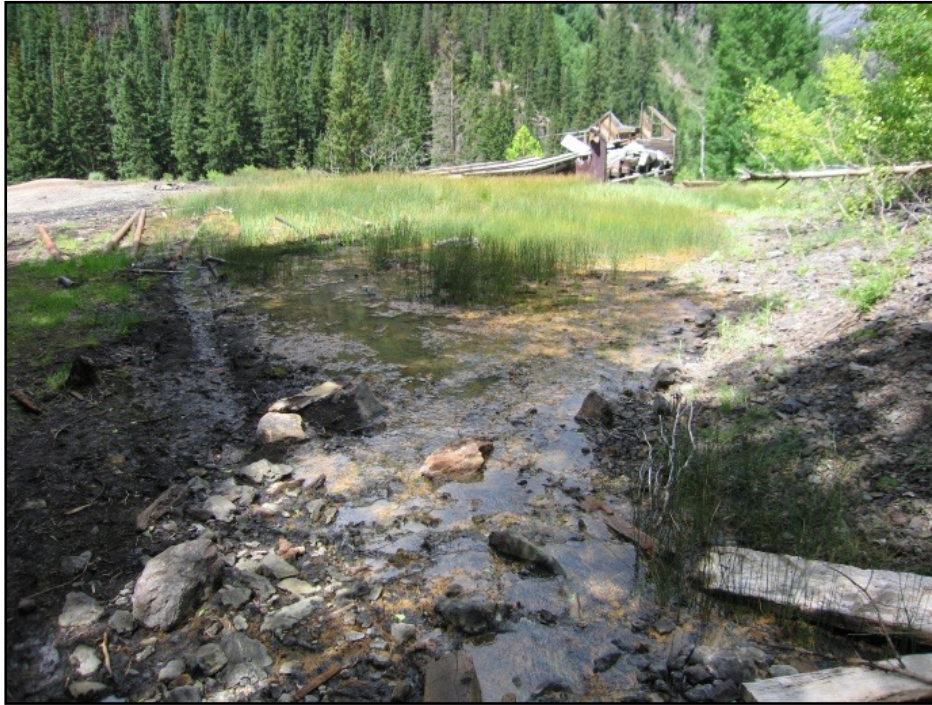
**A. MICHAEL BREEN MINE – BEFORE IMPLEMENTATION IN 2014**

**Figure 8.** A. Adit discharge flowing onto, over and through the waste rock pile at the Michael Breen Mine before implementation in 2014. The top of the load out structure is in the background. B. The diversion ditch was constructed in fall 2014 and routes the adit discharge around the waste rock and the load out.

Work was completed by Mountain Region Corporation of Grand Junction, CO and supervised by Jeff Litteral of DRMS. The main goal was to divert adit waters around the waste rock and load out structure. Specific steps aligned with Cultural Resource Inventory recommendations above and most of the following were completed between Oct. 20 and Nov. 3, 2014:

6. The southern section of the roof that was overhanging the top of the wall and roof remnants from the catwalk area on the top of the structure were removed. The framed, gable end on the western side of the bin was found to be structurally sound and was not removed because the sill of the wall extended downward into the structure's timber wall supports. Removing the wall would have required extensive cutting, and may have weakened the external frame on the western side of the structure.

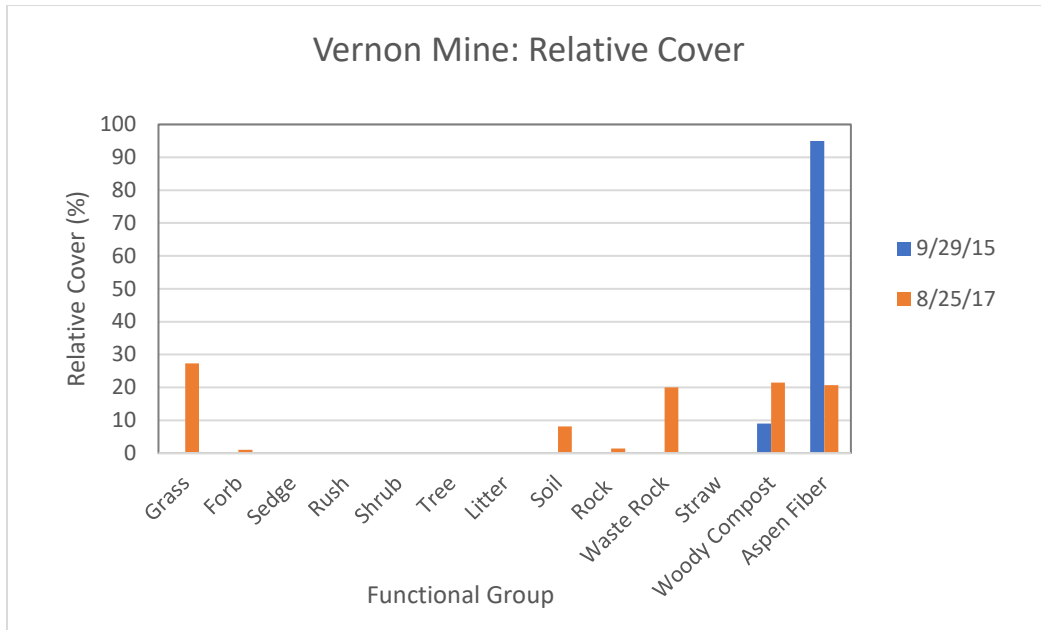
Seven 1-m<sup>2</sup> plots were randomly established in September 2015 in the area excavated of waste rock along Gray Copper Gulch. At this time, average relative cover was 5% woody compost and 95% aspen fiber. Two years later in August 2017, average relative cover comprised of 32% grass, 4% forb, 29% soil, 3% rock, 47% waste rock, 25% woody compost, and 48% aspen fiber (Fig. 9). The grasses and forbs established best in areas amended with deeper layer of woody compost. Target herbaceous cover was 40%-60% which was not met but should increase after additional amendments, seeding, and mulching were implemented in October 2017.

**Figure 9.** Average relative cover by functional group measured in seven, 1-m<sup>2</sup> plots before seeding and amendments on 9/29/15 and two years after prescriptions on 8/25/17.

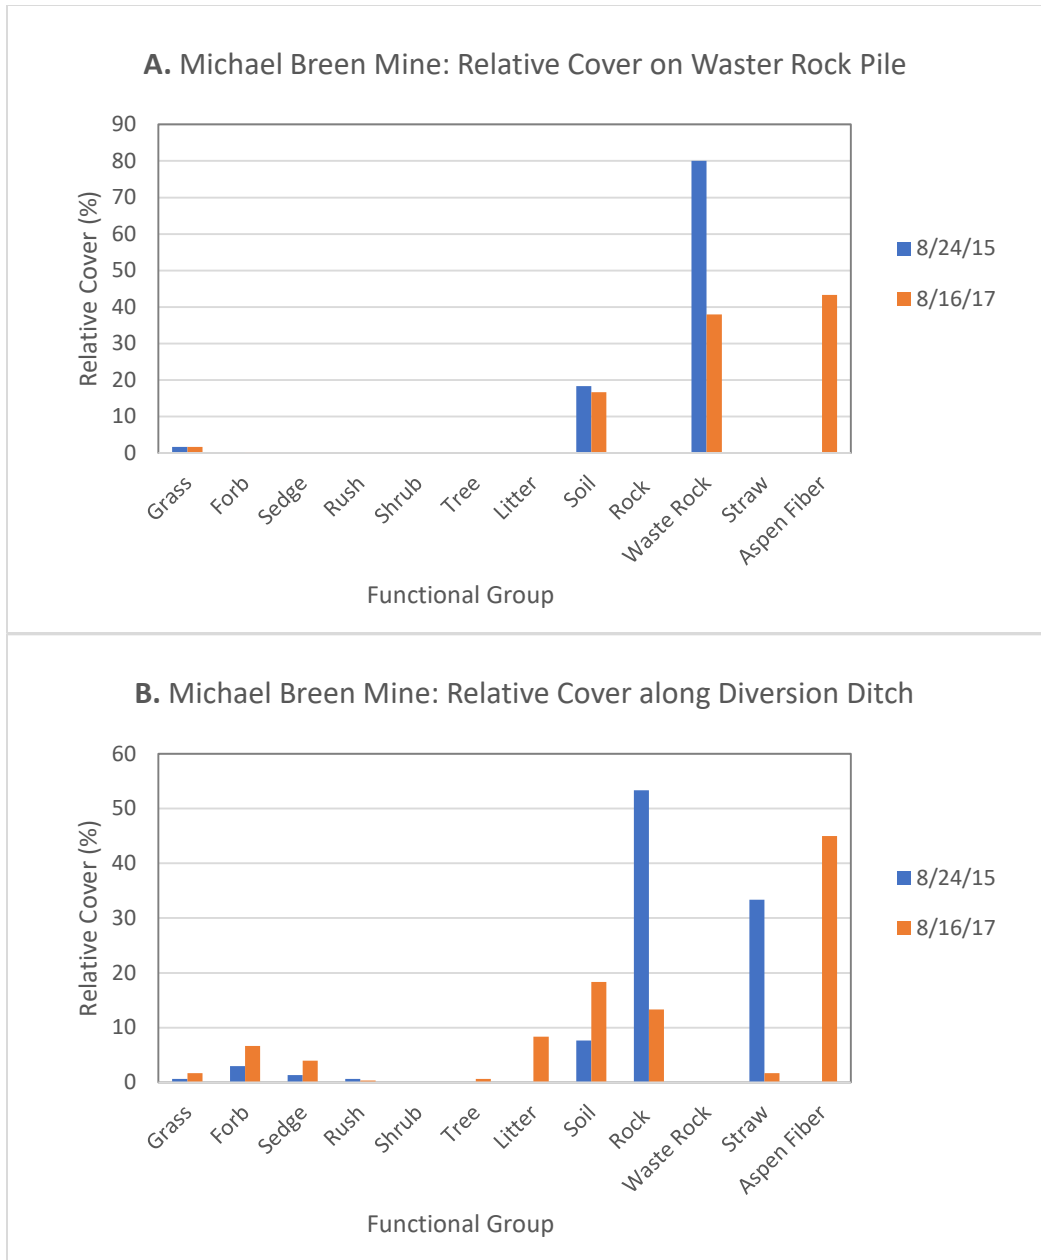
Three 1-m<sup>2</sup> plots were randomly established on the waste rock pile in August 2015 and three 1-m<sup>2</sup> plots were established along the diversion ditch. Before seeding prescriptions, average relative cover on the waste rock pile consisted primarily of waste rock (80%) and some soil (18%, Fig. 10A). Vegetative cover on the waste rock pile did not increase significantly two years later and target 40%-60% herbaceous cover was not met. Instead, some of the soil and waste rock remained covered by decomposing aspen fiber. Soil and rock cover in the three 1-m<sup>2</sup> plots along the diversion ditch collectively decreased by 29% (Fig. 10B). This could be attributed to a 22% increase in litter cover (senesced litter, straw, aspen fiber) and 7% increase in herbaceous cover (grass, forb, sedge, rush, shrub, tree functional groups); see Figure 10B.

**Figure 10.** Average relative cover by functional group measured in **A.** three, 1-m<sup>2</sup> plots on waste rock pile and **B.** three, 1-m<sup>2</sup> plots along the diversion ditch before seeding and amendments on 8/24/15 and two years after prescriptions on 8/16/17.
