EXECUTIVE SUMMARY

Project Title:	Evans Gulch Restoration Project
Grant Number:	FAAA2016 1427
Project Start Date:	August 11, 2015
Project Completion Date:	February 15, 2019

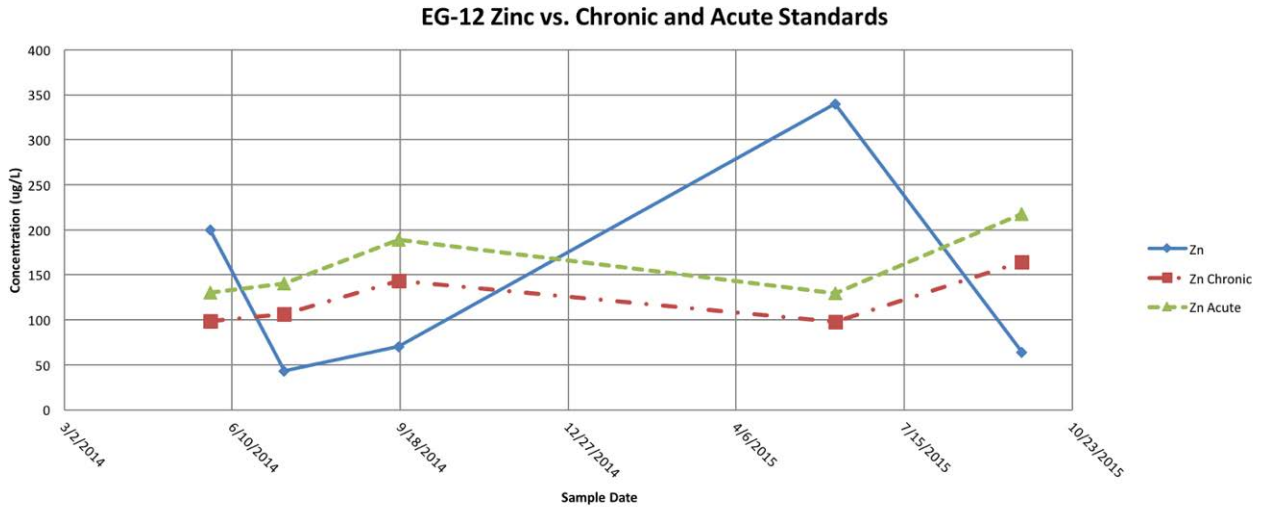
Above the Lincoln Gulch influence and immediately below the input of South Evans Gulch is site EG12. Zinc concentrations of 200 µg/L and 340 µg/L were recorded at EG12 during high flow monitoring in 2014 and 2015, respectively. Both of these values were above both chronic and acute standards (Figure 4.2). Specifically, the acute standard in 2015 was exceeded by 211 µg/L, which is a large increase from 2014 data. However, 2015 fall sampling at EG12 fell inline with 2014 low flow data yielding zinc concentrations below both chronic and acute standards. This seemed to be a trend for all other sites in the watershed, and follows the TMDL exceedances associated with spring runoff and summer rainfall events.

Figure 4.2: Zinc concentrations at EG12 showing influence of Iron Springs.

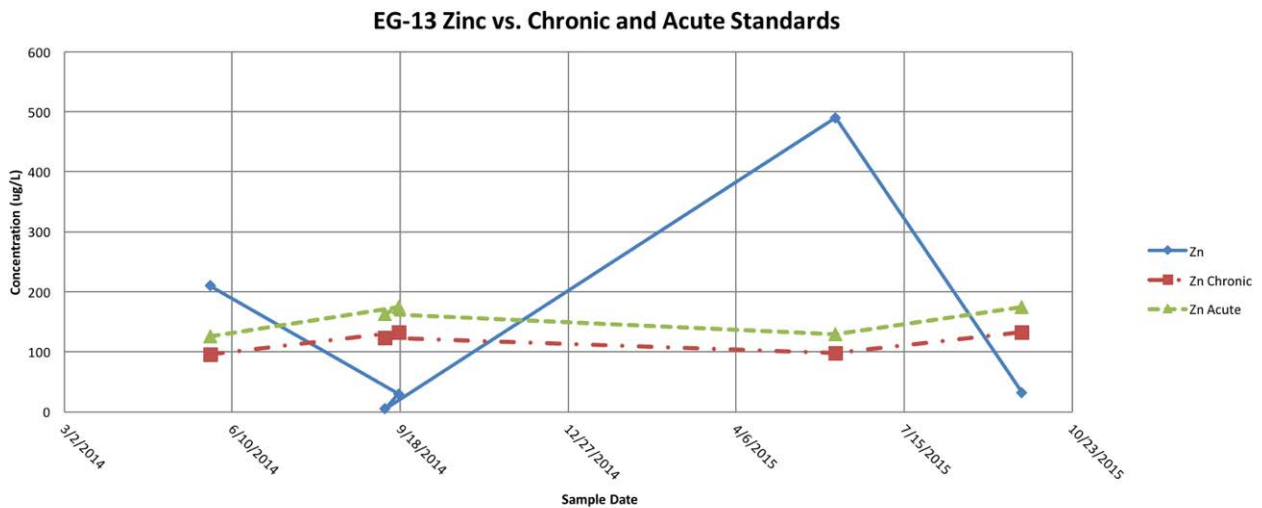
Site EG13 is upstream of the South Evans input, but below the streamside tailings and Valley Mine input that abut the creek and line the floodplain. Of all Evans Gulch mainstem sites, zinc high flow data produced the highest concentration of 210 $\mu\text{g/L}$ and 490 $\mu\text{g/L}$ in 2014 and 2015, respectively. Both chronic and acute standards were again exceeded during this sampling timeframe with the zinc concentration 361 $\mu\text{g/L}$ above the acute standard in 2015 (Figure 4.3). Low flow 2015 sampling saw zinc concentrations at EG13 drop significantly to 32 $\mu\text{g/L}$, which fell below both chronic and acute standards.

Figure 4.3: Zinc concentrations at EG13 above Iron Springs confluence. Note reduced concentrations.

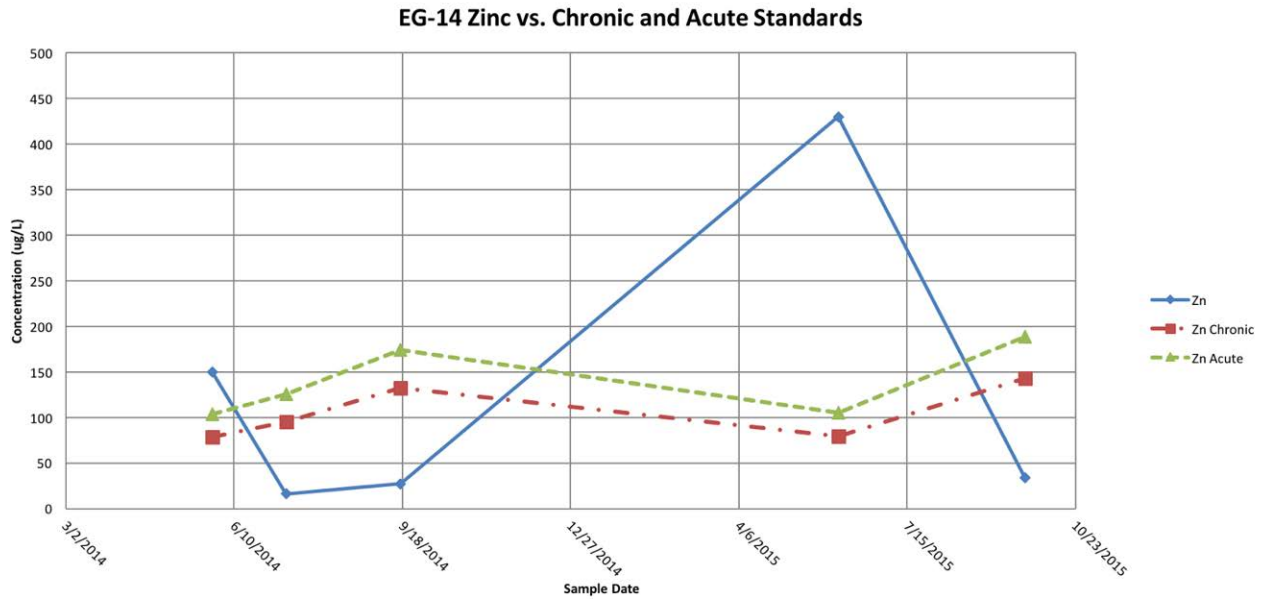
Site EG14 is upstream of EG13 and was created to show the input of several mine tailings/waste piles that compose the floodplain between the two sites. A zinc concentration of 430 $\mu\text{g/L}$ was observed during 2015 high flow sampling, which was above both chronic and acute standards (Figure 4.4). This

value was approximately 325 µg/L above the acute standard. All other sampling events besides high flow 2014 saw reduced concentrations of zinc and attainment of both chronic and acute standards.

Figure 4.4: Zinc concentrations at EG14 below the Laurium Mine.

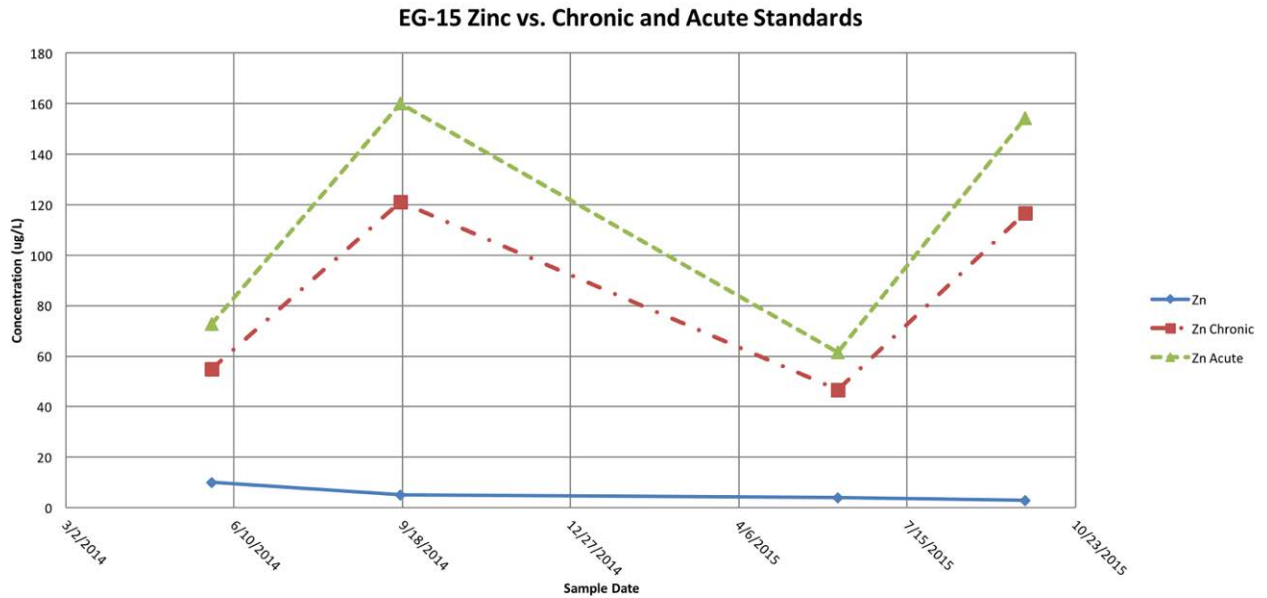
Above most of the historic mining influence is site EG15, which represented the control site for Evans Gulch. Both high and low flow data yielded values well below chronic and acute standards, and did not exceed a zinc concentration of 10 µg/L (Figure 4.5). However, a 140 µg/L increase in zinc concentration was observed between sites EG15 and EG14 during 2014 high flow leading to the creation of site EG14A.

Figure 4.5: EG15 zinc concentrations showing exceedance of chronic standards.

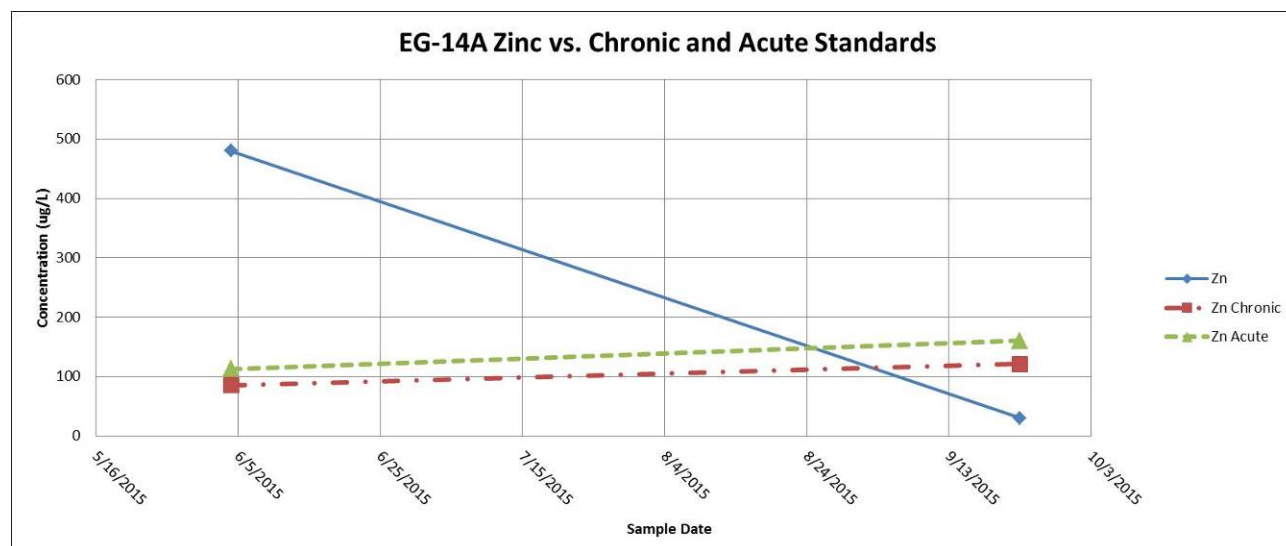
Site EG14A was added to the 2015 set of sampling sites because of the aforementioned increase in observed zinc concentrations between EG15 and EG14 during 2014 high flow conditions. The goal of this site was an attempt to identify the source between these two sites. A significant increase above chronic and acute standards was observed during 2015 high flow conditions at site EG14A (Figure 4.6). Specifically, a concentration of 480 $\mu\text{g/L}$ was recorded during high flow, which was the second highest concentration behind EG13.

Figure 4.6: EG14A zinc concentrations showing exceedances of chronic and acute standards during high flow 2015.

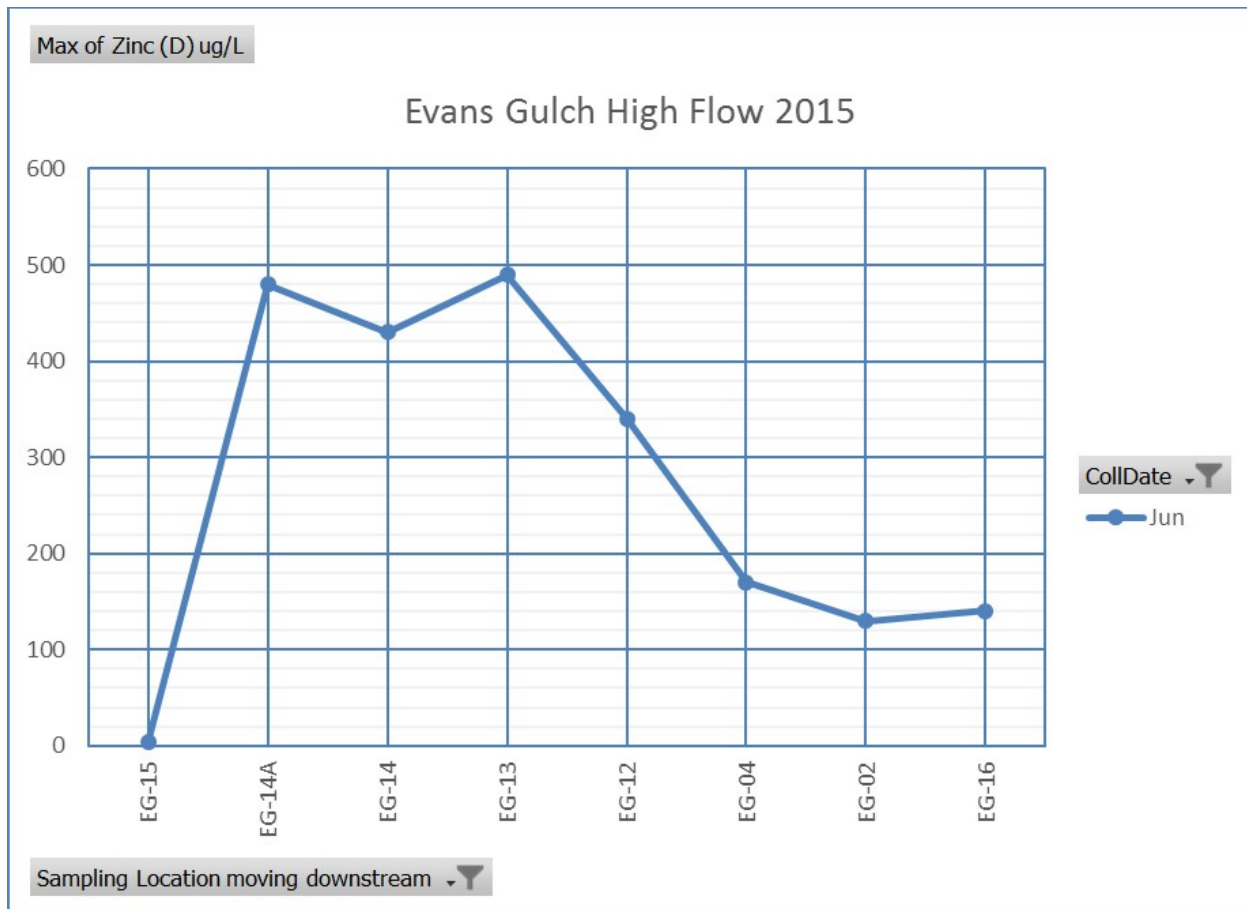
To further evaluate the variability of zinc concentrations moving from upstream to downstream, a max zinc concentration graph was developed for the high flow sampling event that took place in June 2015 (Figure 4.7). The purpose of this Figure is to show how concentration of dissolved zinc varies between the most upstream control site (EG-15) to the most downstream site (EG-16) located immediately upstream of the confluence with the East Fork of the Arkansas River. At almost negligible concentrations at EG-15, zinc spikes up to nearly 500 $\mu\text{g/L}$ at EG-14A, which is located downstream of the Famous Mine/Dolly Varden claims. Levels of zinc are maintained between 400-500 $\mu\text{g/L}$ through sites EG-14 and EG-13 that are adjacent to the Valley Mine and Streamside tailings area. Levels then continue to fall below 300 $\mu\text{g/L}$ and 200 $\mu\text{g/L}$ at downstream sites EG-12 and EG-04, respectively. Zinc concentrations level out to 130 $\mu\text{g/L}$ at the most downstream site (EG-16) before the confluence with the East Fork. This graph indicates that high concentrations of zinc are maintained between upstream sites EG-14A and EG-13 due to their proximity to mining features. Once non-point source begin to diminish, and after the input of South Evans Gulch at EG-12, water quality begins to improve and zinc concentrations start to level out approaching Big Evans Reservoir.

Figure 4.7: Maximum concentrations of zinc (ug/L) during the high flow sampling event in on June 4th, 2015. Moving left to right on the x-axis are sampling locations beginning at the most upstream location (EG-15) and moving downstream to EG-16 at the confluence with the East Fork of the Arkansas River.

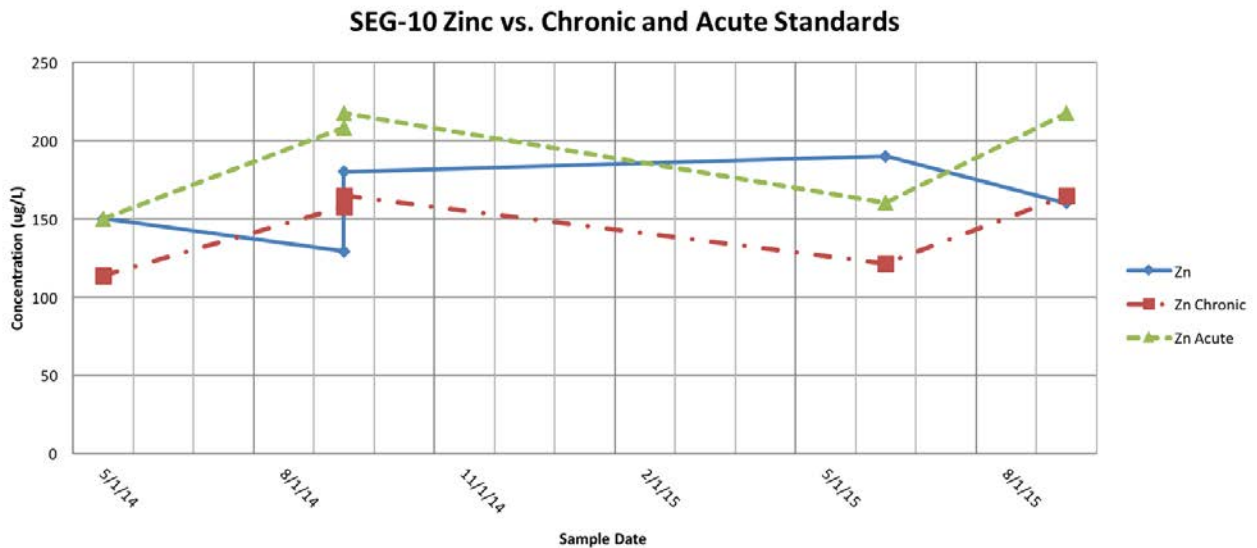
mainstem Evans Gulch, which saw significant decreases (> 50%) in zinc concentrations between high and low flow measurements.

Figure 4.8: Zinc concentrations at SEG10 above both chronic and acute standards.

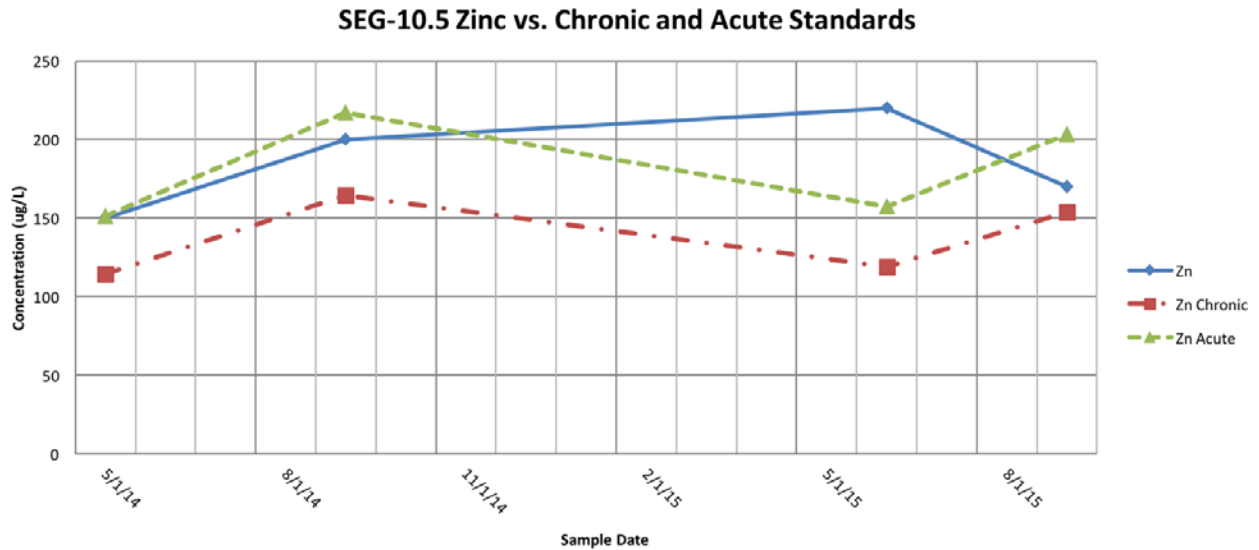
Upstream of SEG10 and below the outlet of the mine tailings pond is the location of SEG10.5. Site SEG10.5 was created in the field as an opportunity sample to evaluate the input of the mine tailings pond between the roadway and South Evans Gulch. Water in this pond is constantly in contact with fine grained tailings that make up the banks and pond bottom. High and low flow measurements yielded zinc concentrations above chronic standards and acute standards. (Figure 4.9). A 10 µg/L increase in zinc concentrations during the low flow sampling was observed between SEG10.5 and SEG10. Site SEG10.5 saw decreases in zinc concentrations from high to low flow measurements.

Figure 4.9: Zinc concentrations at SEG10.5 relative to chronic and acute standards.

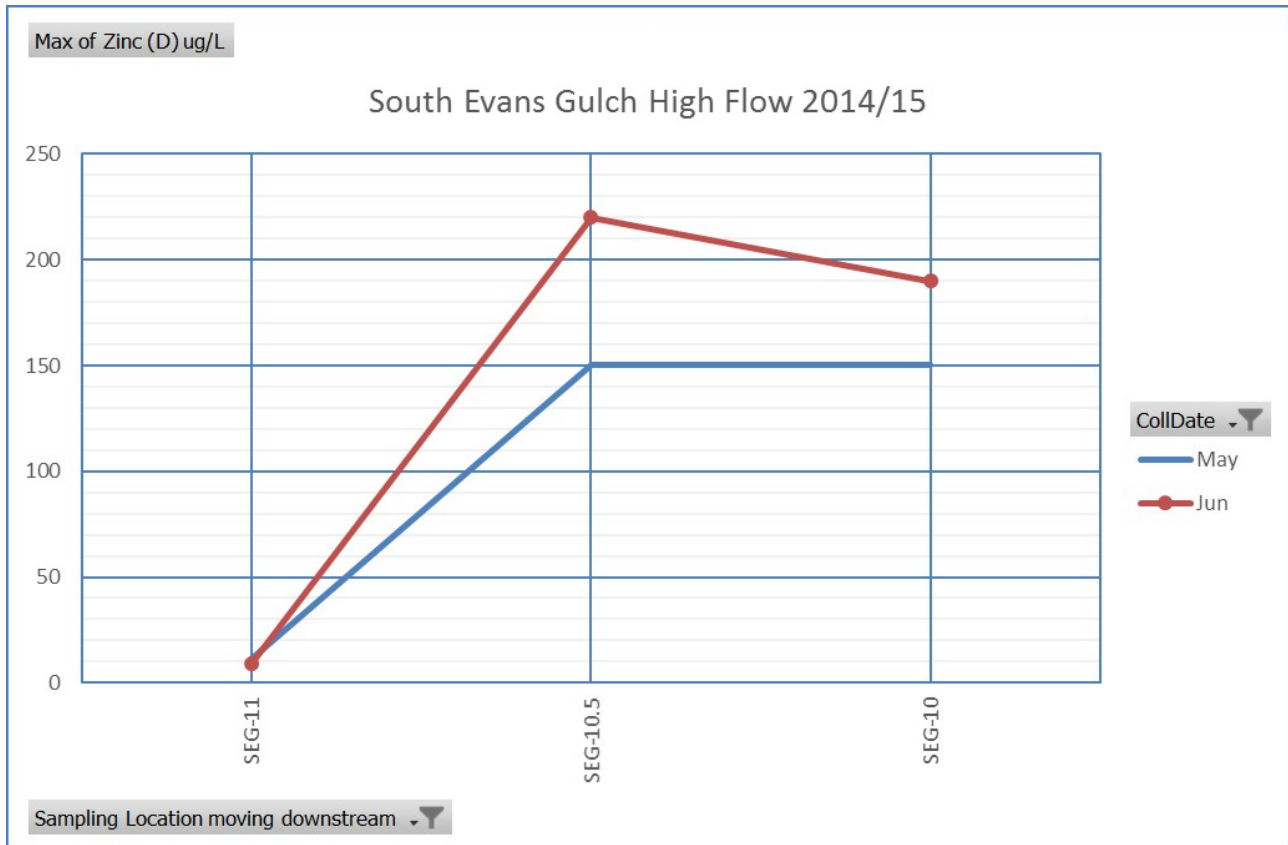
To further evaluate the variability of zinc concentrations moving from upstream to downstream, a max zinc concentration graph was developed for the high flow sampling events that took place in May 2014 and June 2015 (Figure 4.10). The purpose of this Figure is to show how concentration of dissolved zinc varied between the most upstream control site (SEG-11) to the most downstream site (SEG-10) located upstream of the confluence with Evans Gulch at site EG-12. Almost negligible concentrations were observed in both years at SEG-11, while zinc spikes between 150 and 225 ug/L were recorded at site SEG-10.5, which is located downstream of the discharging mine pool. Levels of zinc slightly decreased between 150 and 190 ug/L once making it to site SEG-10. There seemed to be a small dilution effect during the June 2015 event between site SEG-10.5 and SEG-10. However, once zinc concentrations spike at SEG-10.5 due to the mine pool outflow, they maintain above chronic and acute standards moving downstream to site SEG-10. This graph indicates that high concentrations of zinc are maintained between upstream sites SEG-10.5 and SEG-10 due to their proximity to mining features.

Figure 4.10: Maximum concentrations of zinc (ug/L) on South Evans Gulch during high flow sampling events of May 2014 and June 2015. Moving left to right on the x-axis are sampling locations beginning at the most upstream location (SEG-11) and moving downstream to SEG-10, which is upstream of the confluence with Evans Gulch at EG-12.

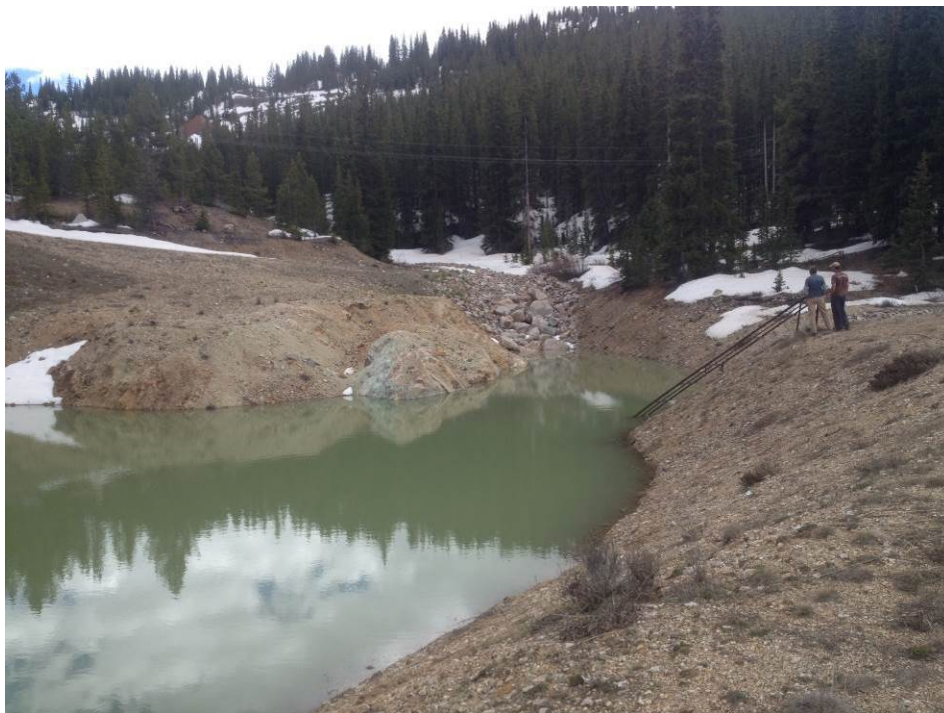
flood event. This site will help further quantify the potential effect of Lincoln Gulch on downstream Evans Gulch.

Figure 4.11: Sedimentation pond at the termination of the riprap lined section of Lincoln Gulch.

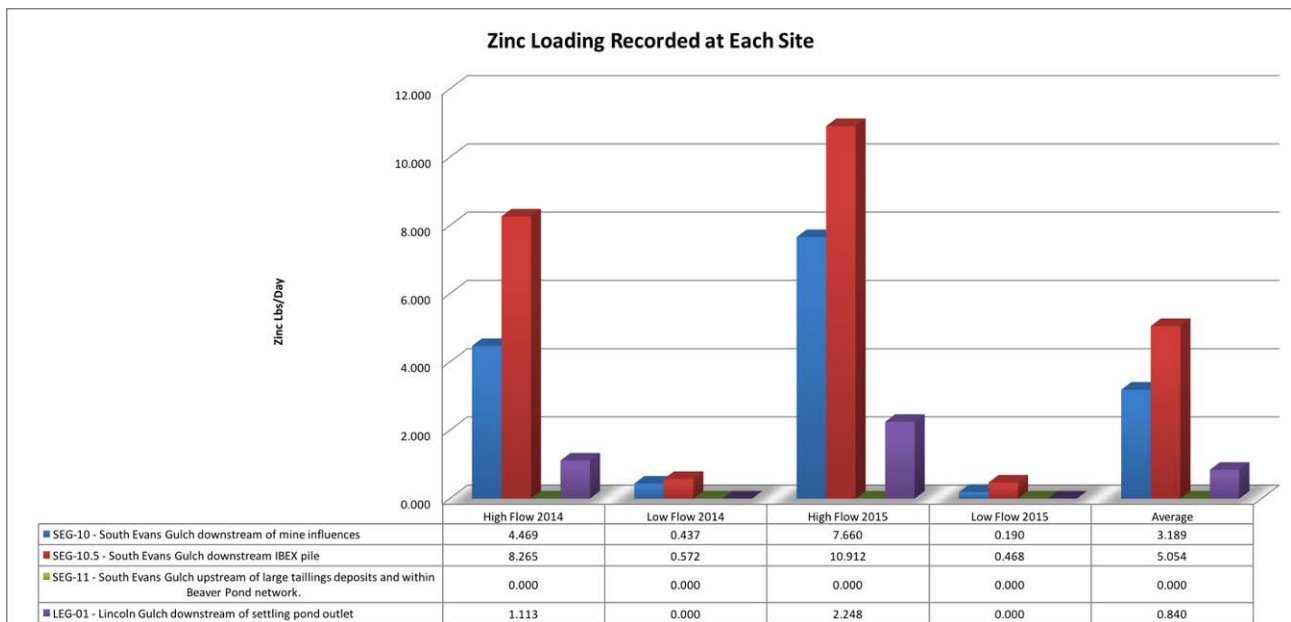
Both contributing drainages are combined on one bar chart for the simplicity of analyses. Site SEG10.5 yielded the highest loading rates for all sampling intervals in 2014 and 2015, followed by SEG10, LEG01, and SEG11, respectively (Figure 4.13). The 2015 high flow loading rate for SEG10.5 was 10.912 lbs/day, followed by 7.660 lbs/day at site SEG10, and 0.00 lbs/day at the control site, SEG11. The influence of the mine tailing pile and pond discharge is evident by the large increase in load between SEG11 and SEG10.5. Site LEG01 had a high flow loading rate of 2.248 lbs/day, which is indicative of the low flow value rather than the 8,900 ug/L observed zinc concentration. Site LEG01, and Lincoln Gulch, have the ability to severely degrade downstream water quality given a prolonged flood event.

Figure 4.13: Zinc loading rates for sites in South Evans Gulch and Lincoln Gulch

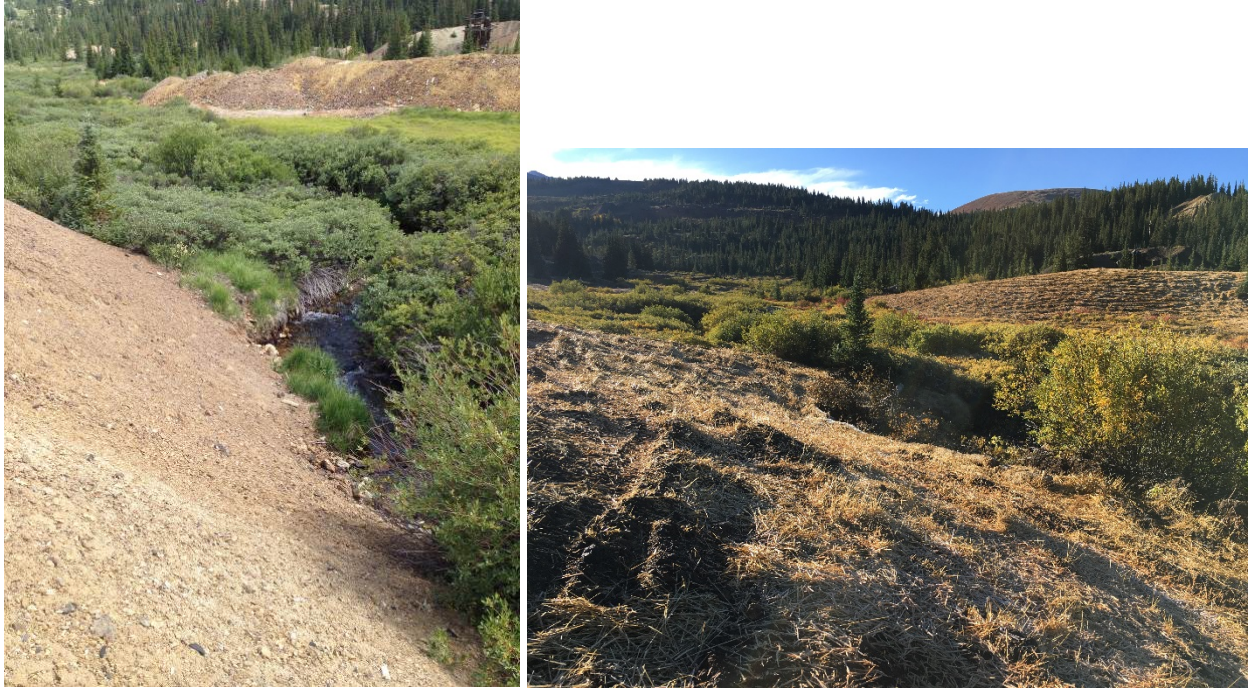
The discussion of loading rates primarily focused on the high flow time period when Evans Gulch does not commonly meet TVS. The sites of SEG11 and EG15 yielded very low loading rates, as well as concentration values, thus verifying their “control” status within the watershed. Loading rates between control site EG15 and EG14 saw a 26.8 lbs/day increase in 2015, which is much higher than the 7.6 lbs/day increase in 2014. This significant jump in loading between sites was unexpected, and was quantified by the addition of site EG14A between the two locations. The result of this addition was approximately a 22.468 lbs/day increase between EG15 and EG14A. A definitive rise of 16.8 lbs/day was observed moving downstream between sites EG14 and EG13. This type of increase was anticipated due to the mine tailings/waste piles that are located in this area along the creek and in the floodplain (Figure 4.14).

Figure 4.14: Mine tailings/waste piles located between sites EG14 and EG13. The left photo represents before conditions and the right photo shows re-graded and re-vegetated piles of Streamside in the foreground and Valley in the background. The active erosion in the left photo was on reason for including this site in the reclamation plan.

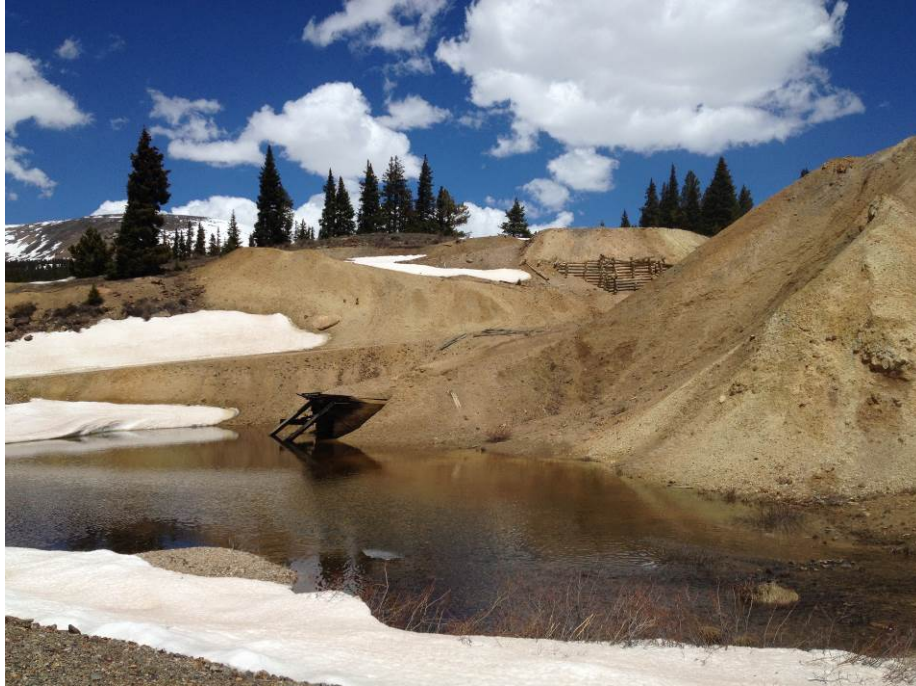
A 3.38 lbs/day decrease was observed between sites EG13 and downstream site EG12 in 2015. Last year there was an increase in loading between these sites, which was unexpected because of the lack of mine structures between the locations. The data from 2015 is more indicative of the surrounding conditions. However, EG12 is downstream of the confluence with South Evans Gulch, which saw a loading rate of 7.66 lbs/day at the most downstream site (SEG10). Even though this loading rate at SEG10 was almost 3.0 lbs/day higher than the 2014 value, a direct correlation to EG12 loads was unattainable. However, in 2014, this additional load from South Evans Gulch almost equaled the difference between EG13 and EG12 and could explain the rise between sites. It is possible that zinc loads from the large mine tailings/waste piles and tailing pond adjacent to site SEG10.5 could be affecting water quality downstream in Evans Gulch during periods of low flow due to its continual drainage (Figure 4.15)

Figure 4.15: Mine tailings/waste piles and tailings pond adjacent to South Evans Gulch. The outflow of the pond flows left out of the frame and into South Evans Gulch above site SEG10.5.

deemed the top three most important project sites. The methodology behind the top ranking stems from consistently high load values from site EG-14A, as well as the accessibility of the two suspected loading sources adjacent to site EG-14 and EG-13. The number one ranked site is EG14A, which captures loading from the Dolly Varden/Annie C claims and its associated waste piles. These piles sit near the edge of Evans Gulch and have shown to be a significant loader to the watershed, as evidenced by the 22.468 lbs/day value observed in 2015. Since access for this site was never gained due to ownership by Leadville Corp., priority focus moved to sites where ownership was granted. Therefore, sites EG-13 and EG-14 were ranked second and fourth, respectively and see loading input from the Valley Mine area and Streamside tailings that abut Evans Gulch immediately upstream of EG-13. Landowners in this vicinity were cooperative, which made these sites a high priority for cleanup opportunities. Site SEG10.5 was ranked number three because of its continual loading via the discharge of the mine pool that bordered by mine tailings/waste. It also was a fairly easy conceptual first clean-up step, which would involve draining the pond to prevent future discharge into South Evans Gulch.

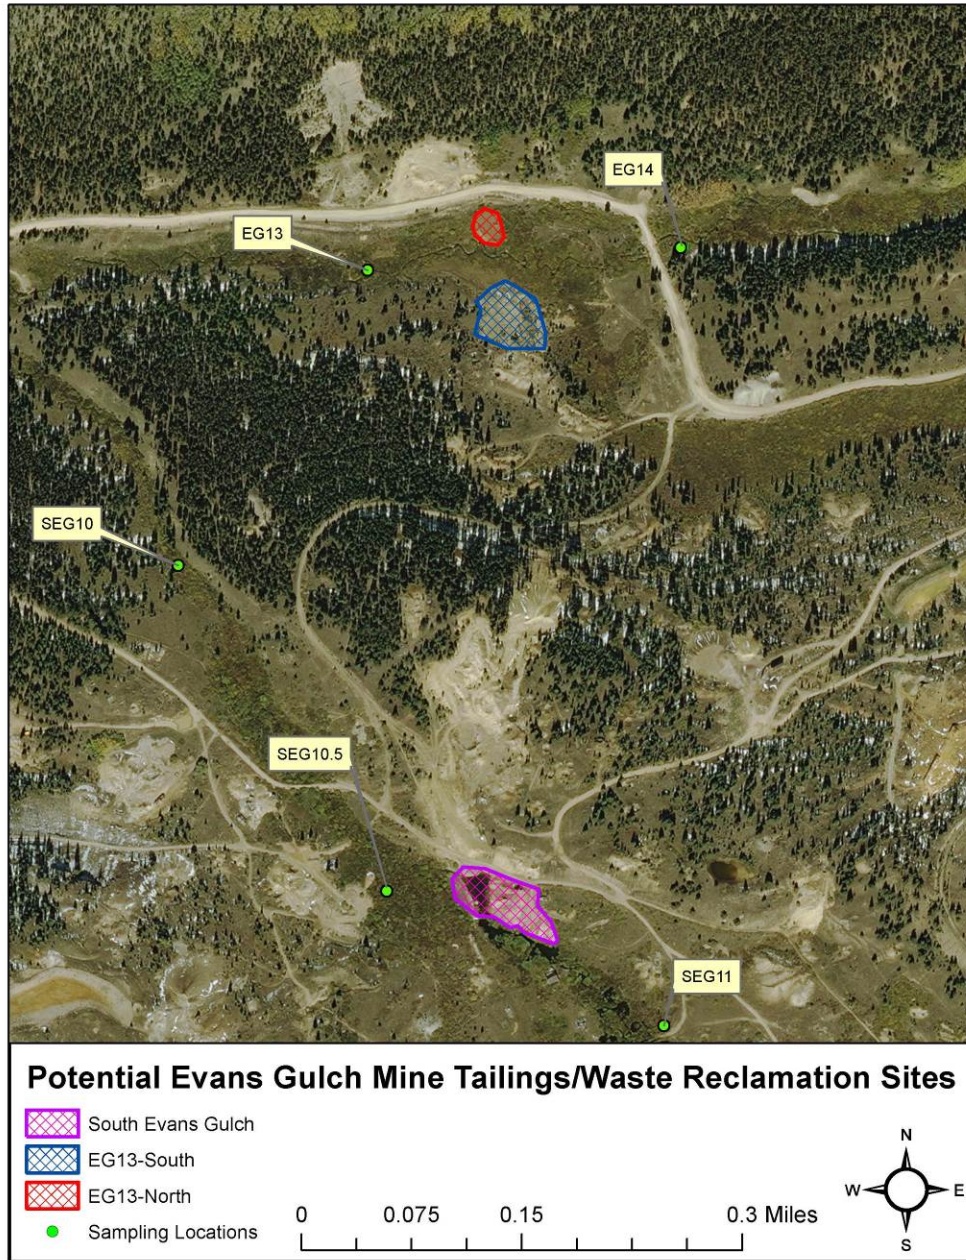
Through the 2014-15 water quality sampling efforts and subsequent data investigation, four mine tailings/waste piles were identified as non-point source loaders in the watershed (Figure 4.16). The pile associated with EG13 North is referred to as the Streamside tailings and has an area of 0.24 acres. Across the drainage is EG13 South, which is considered the Valley Mine complex. This site has a footprint of 1.10 acres and shows evidence of stained drainage into Evans Gulch during high flow. The South Evans Gulch drainage source is a large pile and pond discharge representing 1.23 acres.

Additionally, 2015 sampling revealed a new source upstream of EG14 and EG14A at the Dolly Varden/Annie C mine waste pile. This site was ranked number one on the priority ranking and was briefly investigated during 2016 soil sampling, but not considered for reclamation due ownership issues. Not shown on the map was an additional site selected during talks in early 2018 with the landowner of the Streamside and South Evans Gulch sites. This site was called the Silver Spoon and is directly north and across the road from the Streamside site shown on the map below.

Figure 4.16: Identified non-point source locations in the Evans Gulch Watershed

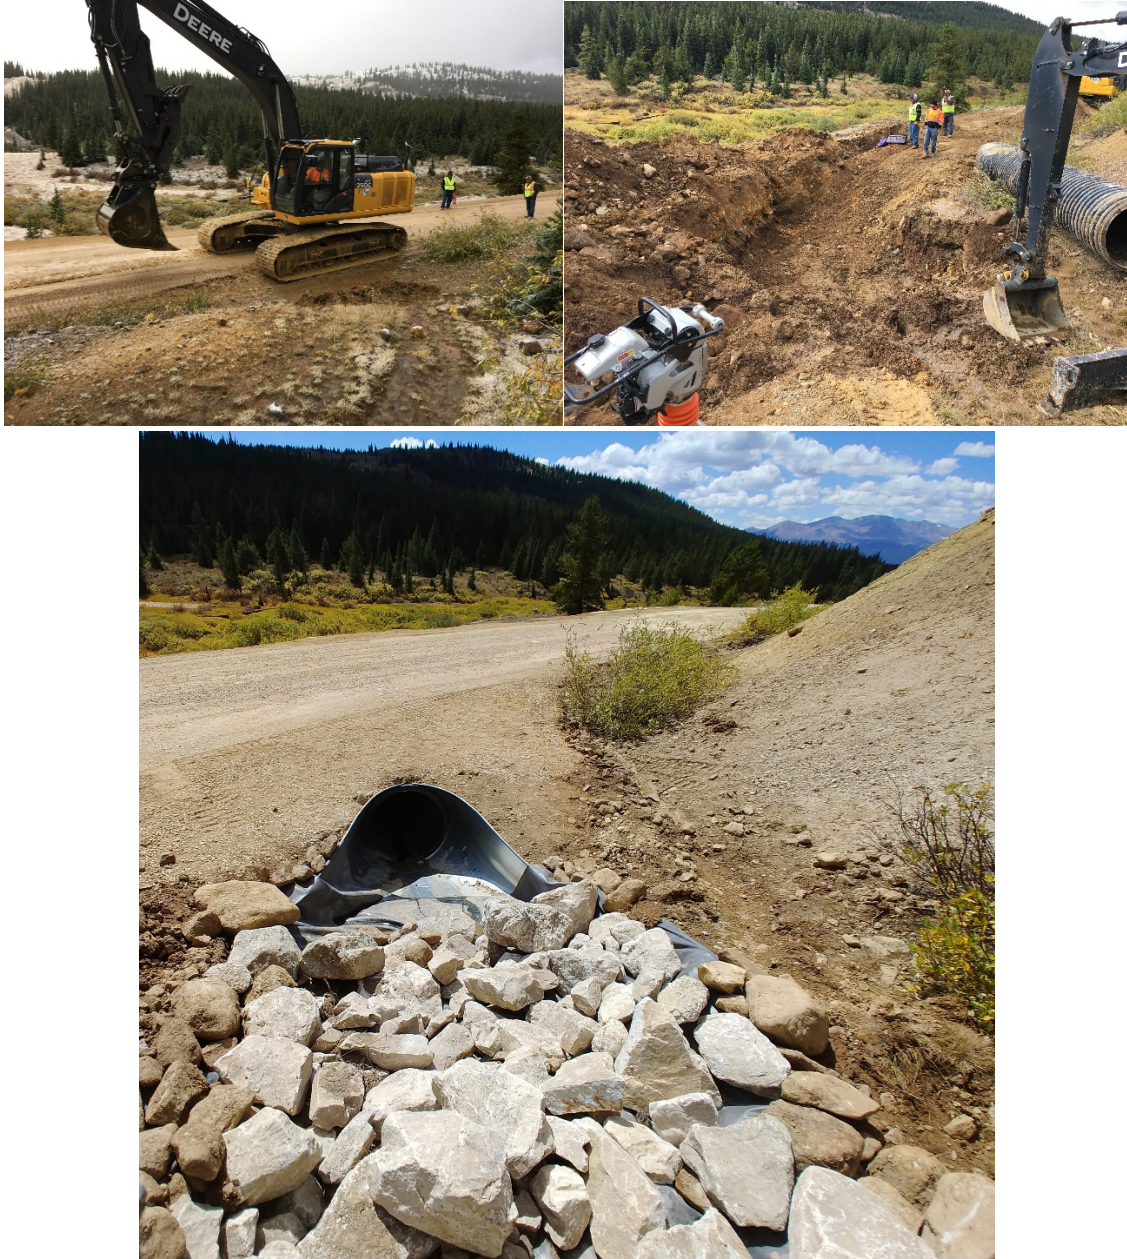
Although the Silver Spoon site was closest to Co. Rd. 3, work was completed last due to the culvert installation and ongoing DRMS work at the site to safeguard a collapsed stope where the former head frame was located. As discussed in the design sections, work at this site was focused on reducing the interaction of seep flow with existing mine waste. Prior to construction, the perennial seep flowed across mine waste and along the toe of a steep slope next to the road. Not only did this pick up heavy metals along the way, but it also created an ice flow across the road in the winter. TU staff worked with the contractor to install 30 feet of 2.5 ft. diameter reinforced HDPE culvert beneath the road so seep water would have a better route to flow during the winter (Figure 6.1). Proper precautions were taken by the crew and the full section of culvert was installed in one day to minimize traffic issues. After proper compaction of road base material and collar installation, a 100 ft. section of EPDM lined channel was excavated from the seep source to the edge of the culvert collar. This process allowed for seep water to be immediately turned into the culvert to minimize saturation of mine waste along the roadway. Following placement of EPDM liner, approximately 50 tons of 9-15 inch riprap was placed throughout the length of the channel up to the collar. As seen in Figure 6.1, a rock apron was constructed between the channel and culvert collar on the upstream side to capture flow into the culvert. In addition to rock apron placement, riprap was also placed on the downstream side of the culvert in the form of a rock lined channel that will help disperse and attenuate flow over the fill slope below. After successful installation of the culvert and channel, the slope of the mine waste piles was reduced through grading and compaction, followed by installation of wattles for erosion control. The top two to three feet of the steepest portion of the mine waste piles was taken off to reduce the slope and promote a more dispersed flow regime. To conclude work at the site, the crew assembled over 200 feet of buck and rail fence to preclude site access, while providing a more refined parking and turn-around area.

Figure 6.1: Before (upper left) conditions showing excavator and seep flow trending towards the mine waste pile on the edge of the frame and during (upper right) showing depth of excavation and road disturbance necessary to install the culvert. During this excavation, water was diverted around the culvert in the right of the photo. The after conditions (bottom) show installed culvert with collar and interface with lined section of channel. Note that former seep path to the right is dry because water is flowing through culvert in the photo.

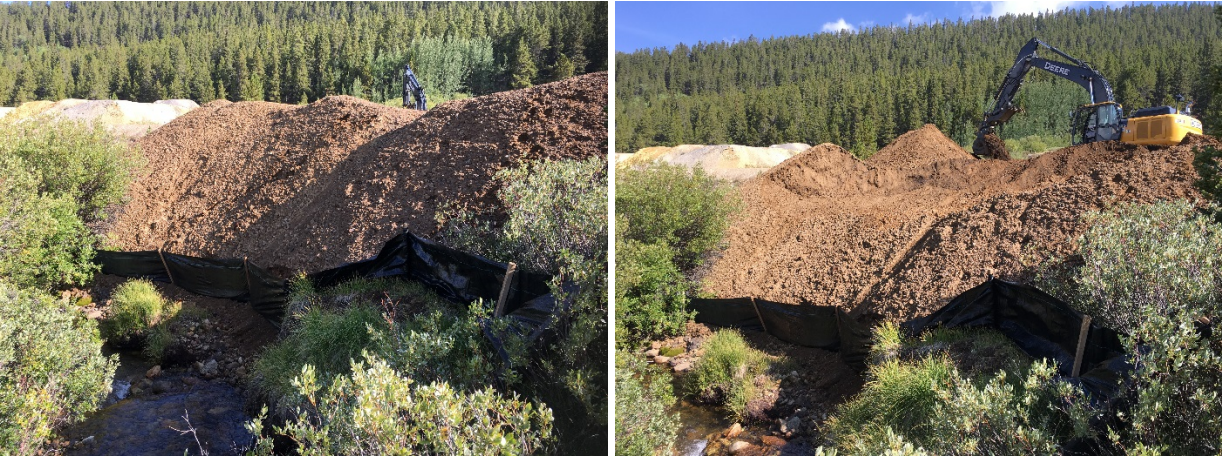
The proposed design at the Streamside site had the most direct correlation to mine waste and Evans Gulch. The 40 ft. long, 20 ft. high mine waste pile that abutted Evans Gulch was excavated and consolidated with the rest of the pile. This was accomplished by first installing a silt fence to reduce sediment loading to Evans Gulch during construction (Figure 6.2).

Figure 6.2: (Left) Before conditions showing Streamside tailings pile abutting Evans Gulch; (Right) During construction conditions with part of pile removed and graded as excavator benches its way down towards the bankfull elevation.

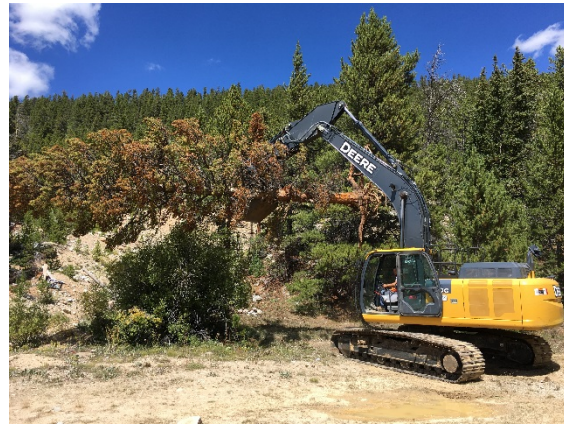
Once a majority of the waste was removed from the stream edge, the installation of three root wads took place to promote bank stability and trout habitat. Root wads were locally harvested from behind the Silver Spoon site and placed perpendicular to flow to help dissipate bank velocities (Figure 6.3). These features were set below the water surface elevation and then anchored with several feet of compacted fill material. Four live willow transplants were installed between each root wad to provide immediate stability prior to vegetation establishment (Figure 6.4).

Figure 6.3: Photo showing excavator transporting root wad from Silver Spoon to Streamside area.

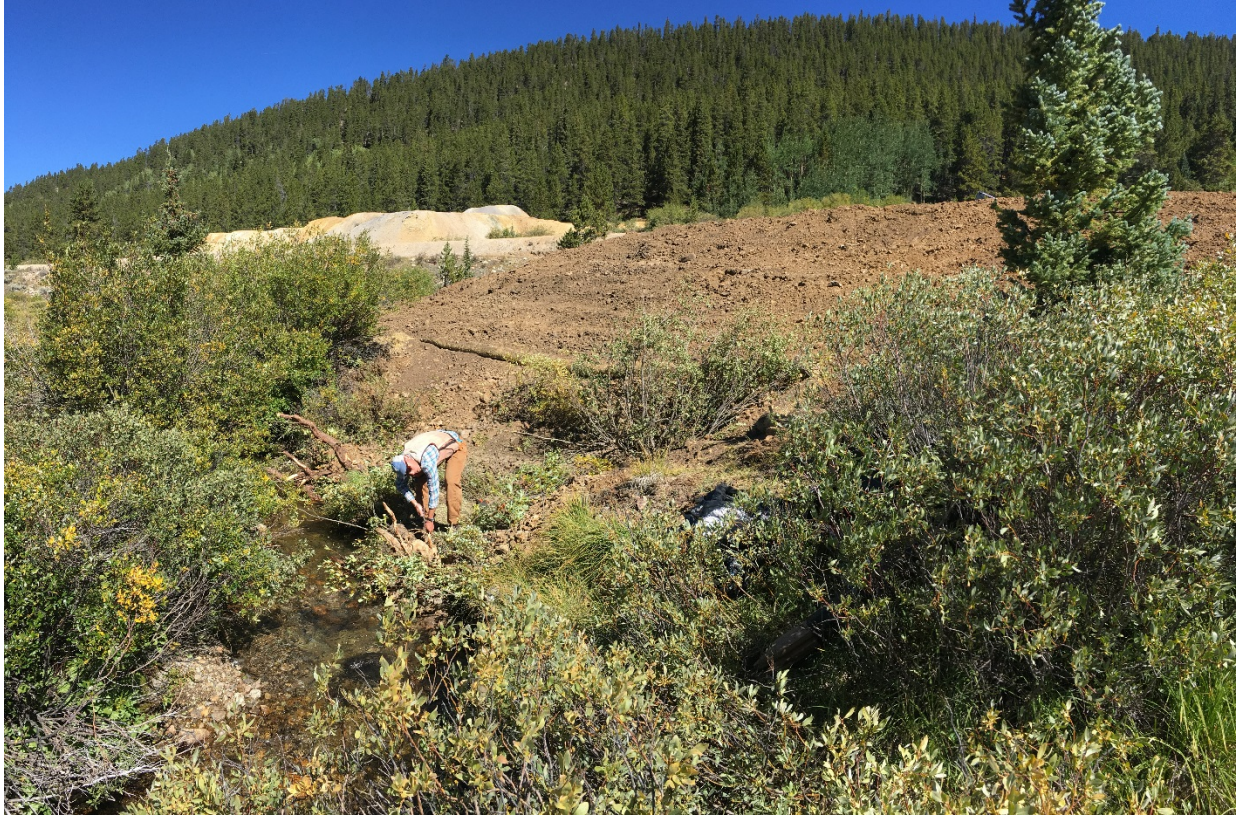
Several sedge mats and live willow stakes were also utilized along the bank for additional stability. These features will help reduce erosion during next year's runoff. Following completion of bank work, the remainder of the main face was benched to a 3:1 slope and hummocked with the excavator bucket to reduce sheet flow. Following the re-grading process, the entire pile was amended in place with 1,000 pounds of 3-6-3 fertilizer and 50 CY of compost to facilitate vegetation growth and reduce erosion. To finalize revegetation, a mixture of wood straw and weed-free agricultural straw was crimped into the top of the cap and all disturbed surfaces. As a last series of steps, tree branches were scattered across the site to add diversity and facilitate micro-community development, while a couple large boulders were placed to close the reclaimed access road.

Figure 6.4: After conditions showing graded and amended pile with establishment of clean floodplain bench. A total of three root wads were installed in the bank in conjunction with 12 whole willow transplants and six sedge mats to provide bank stability and trout habitat. TU staff is shown in the photo installing live willow cuttings into the bank.

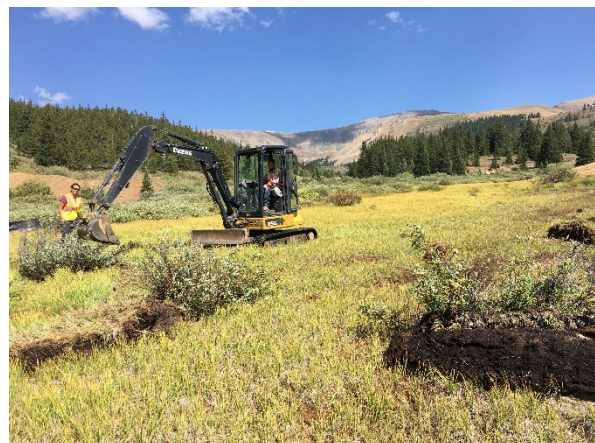
The largest phase of work on the Evans Gulch project was at the Valley Mine directly across the drainage from the Streamside Site. This site had the largest volume of waste rock with the most acid generating potential. In addition to the large volume of waste rock, a dead zone emanating from the toe of the pile was evident through the adjacent wetland. Since this phase of construction involved the largest quantity of amendments, a staging area was created towards the back of the site where equipment and material could be stored. Construction at this site consisted of re-grading steep slopes of the pile to a minimum of 3:1 and consolidation of waste from wetland edge and steep side slopes to the top of the pile. During grading operations, a mini-excavator was used to harvest and install 40 live willow bulbs to the barren wetland in the dead zone (Figure 6.5). Once willow clumps were specifically placed, the

Figure 6.5: Mini-excavator shown installing whole willow clumps to the dead zone area downslope of the Valley Mine. Over 40 total willows were transplanted.

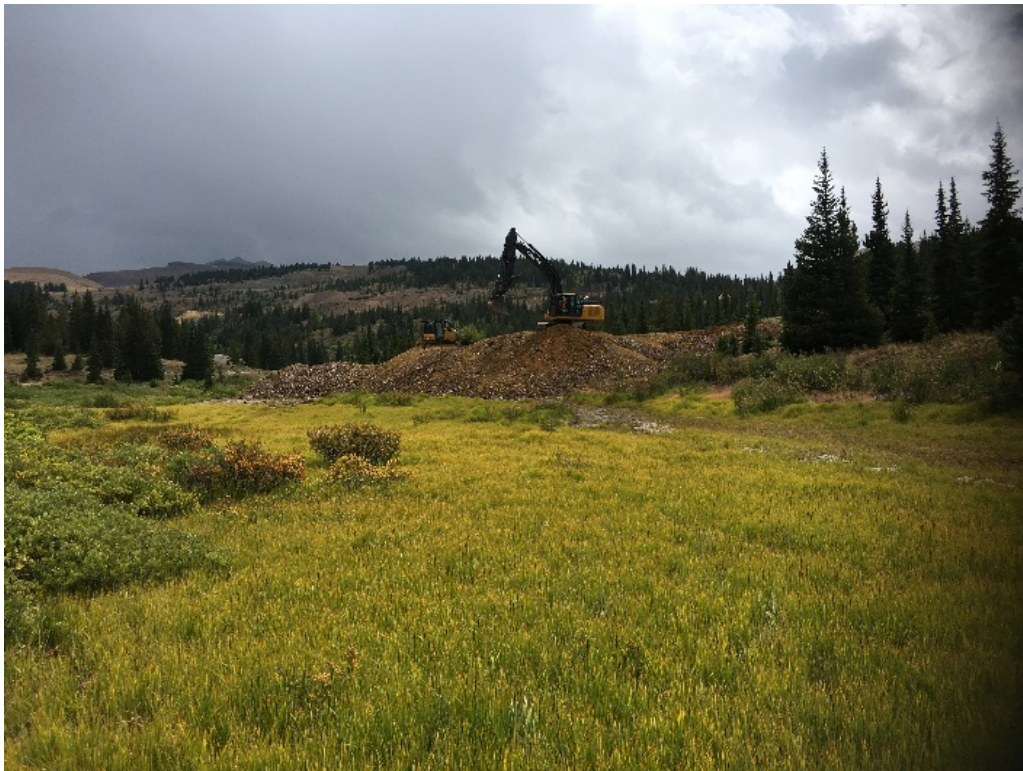
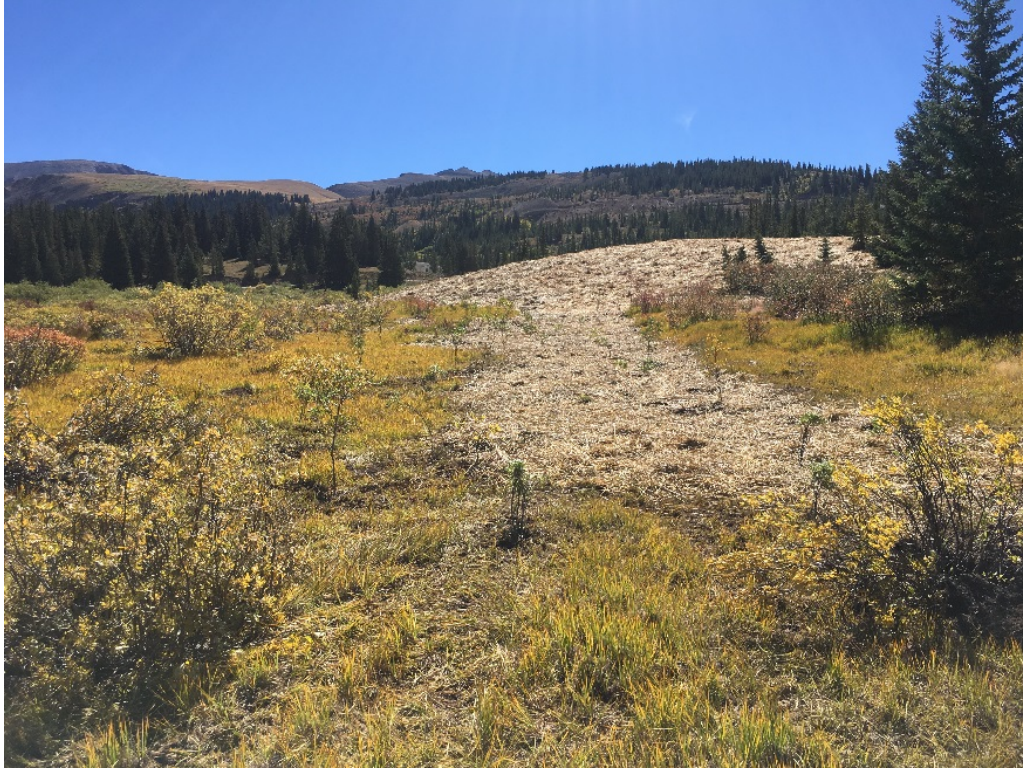
After pile was capped with clean material, the fertilizer and compost were mixed into the soil in a hummocking manner creating undulations in the surface to reduce sheet flow and rilling. The upland seed and straw mixture were hand broadcast and crimped in where applicable.

Figure 6.6: (Top) Before conditions showing steep slopes of Valley Mine waste pile along with wetland and dead zone devoid of willow and other species. (Bottom) After conditions showing freshly reshaped pile along with 40 live willow transplants and 100 willow cuttings in the wetland. After amendments were incorporated into the pile, clean fill material was placed on top, seeded, and mulched to promote vegetation growth.
