SECTION 319 NONPOINT SOURCE POLLUTION CONTROL PROGRAM
WATERSHED PROJECT FINAL REPORT

High Park Bum

Reclamation by

Jennifer Kovceses, Coalition for the Poudre River Watershed
Fiscal Sponsor
Rocky Mountain Flycasters

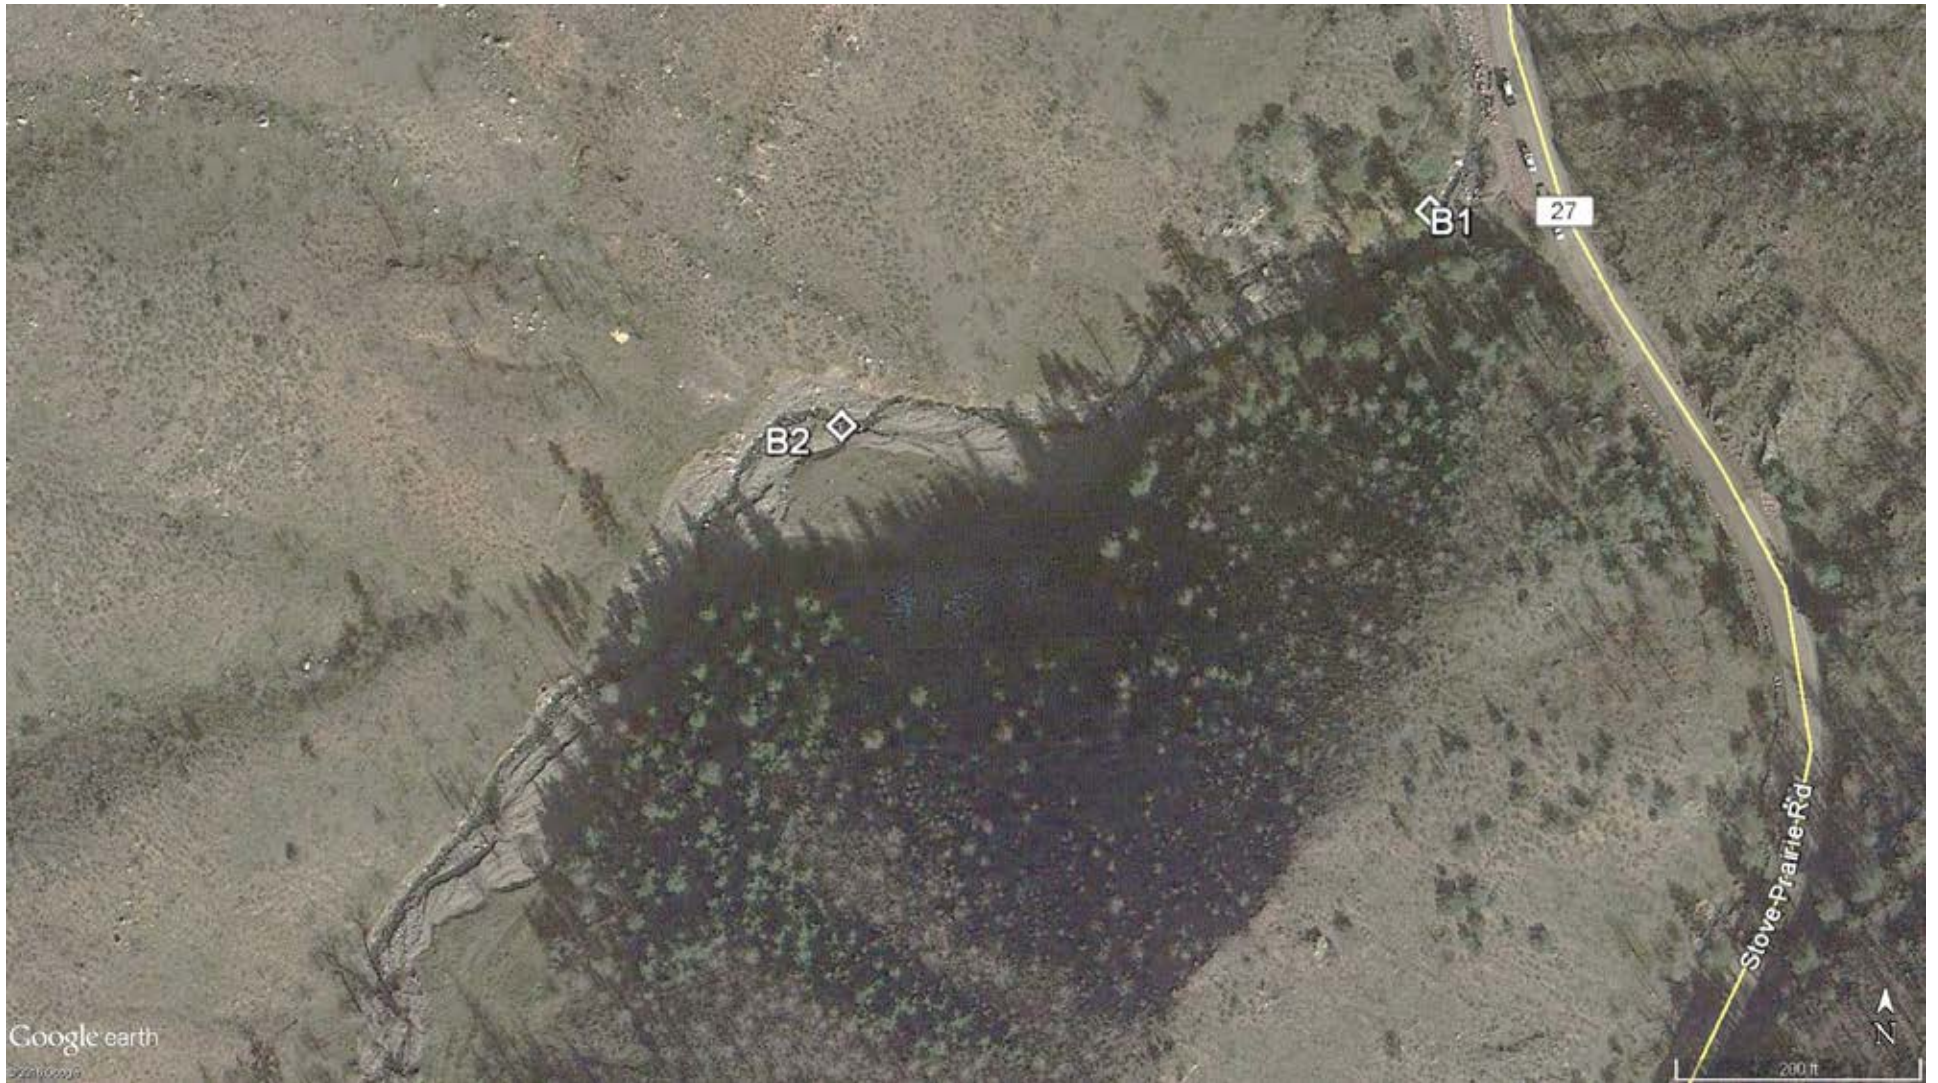
Figure 2. Map of Skin Gulch Reach B. Subreach labels indicate downstream origin of each subreach.

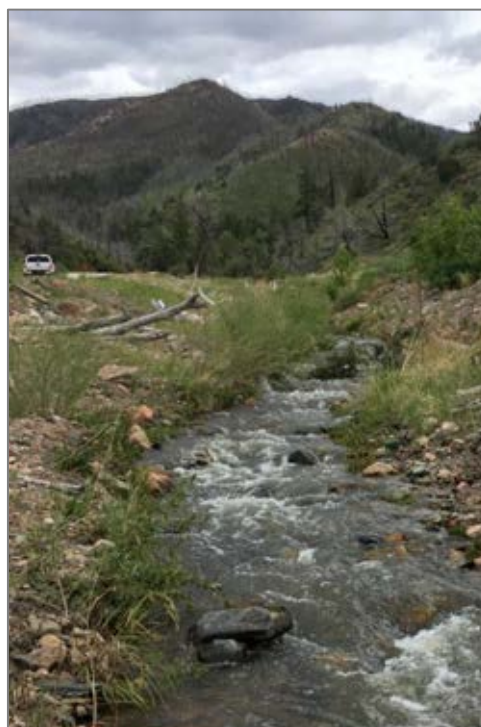
Fig 1. Skin Gulch Stream Restoration Site. View to South along County Road 27 towards the High Park Fire.
