Waldo Fire Recovery

Overview

The Waldo Canyon Fire Master Plan for Watershed Restoration & Sediment Reduction

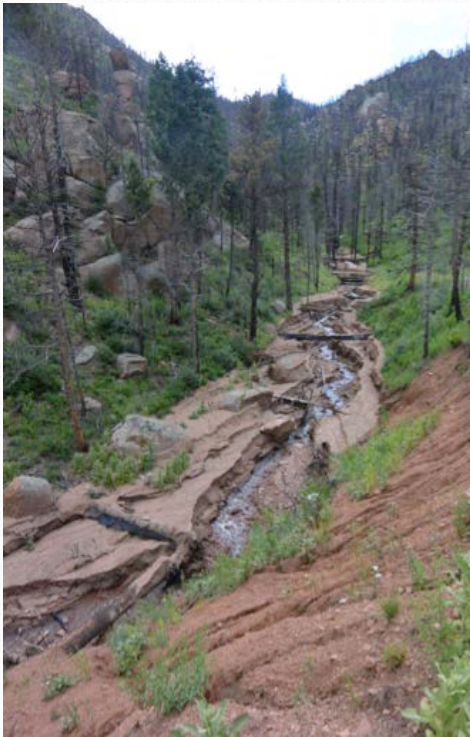
CUSP--Sand Gulch:

Sand Gulch is a small tributary of Fountain Creek located on the west side of the Waldo Canyon burn. Almost the entire basin was severely burned during the fire, and the gulch has seen numerous significant flood events (with a storm event after work was completed that was ~ a 10-year return interval storm) since the burn. Several private homes are within the

flood prone area of the lower portion of the basin. CDOT has installed a permanent sediment basin and box culvert at the bottom of the basin to protect US Highway 24. The lower first mile of the basin is located on private property, and the upper basin is entirely on USFS lands. Work in Sand Creek was limited to the private lands, due to lack of access and the very steep nature of the upper basin on USFS lands. The project reach extends from just above the CDOT basin and trash rack upstream to the USFS boundary. The lower half of the project reach is a depositional channel, while the steeper upper half functions as a transport reach. The primary objective of the project reach was to protect lives and property at the bottom of the basin by stabilizing the channel upstream and creating sediment

and debris detention in the lower part of the reach. Sand Creek has experienced some of the most dramatic flood events in the burn area. During a single event in 2014, the channel in the lower half of the project reach aggraded nearly 15 feet in places, completely burying the much of work done in this segment. Subsequent flood events have cut through the deposited sediments, in several cases down to the original structures. In other segments, the treatments are still buried, and could not be assessed during the course of this study.

Str Type	Functioning	Functioning at Risk	Partially Failed	Failed	Number
Basin Boulder Sill			100%		1
Basin Log Sill				100%	1
Basin Log Crib Wall		50%	50%		2
Sediment Basin		50%		50%	2
Gabion Basket Flood Wall	100%				1
Hardened Water Crossing		100%			1
Boulder Drop Structure		100%			3
Boulder Sill	64%	13%	13%	13%	8
Log Sill	6%	13%		81%	16
Log Vane				100%	3
Total Structures	21%	21%	8%	50%	38

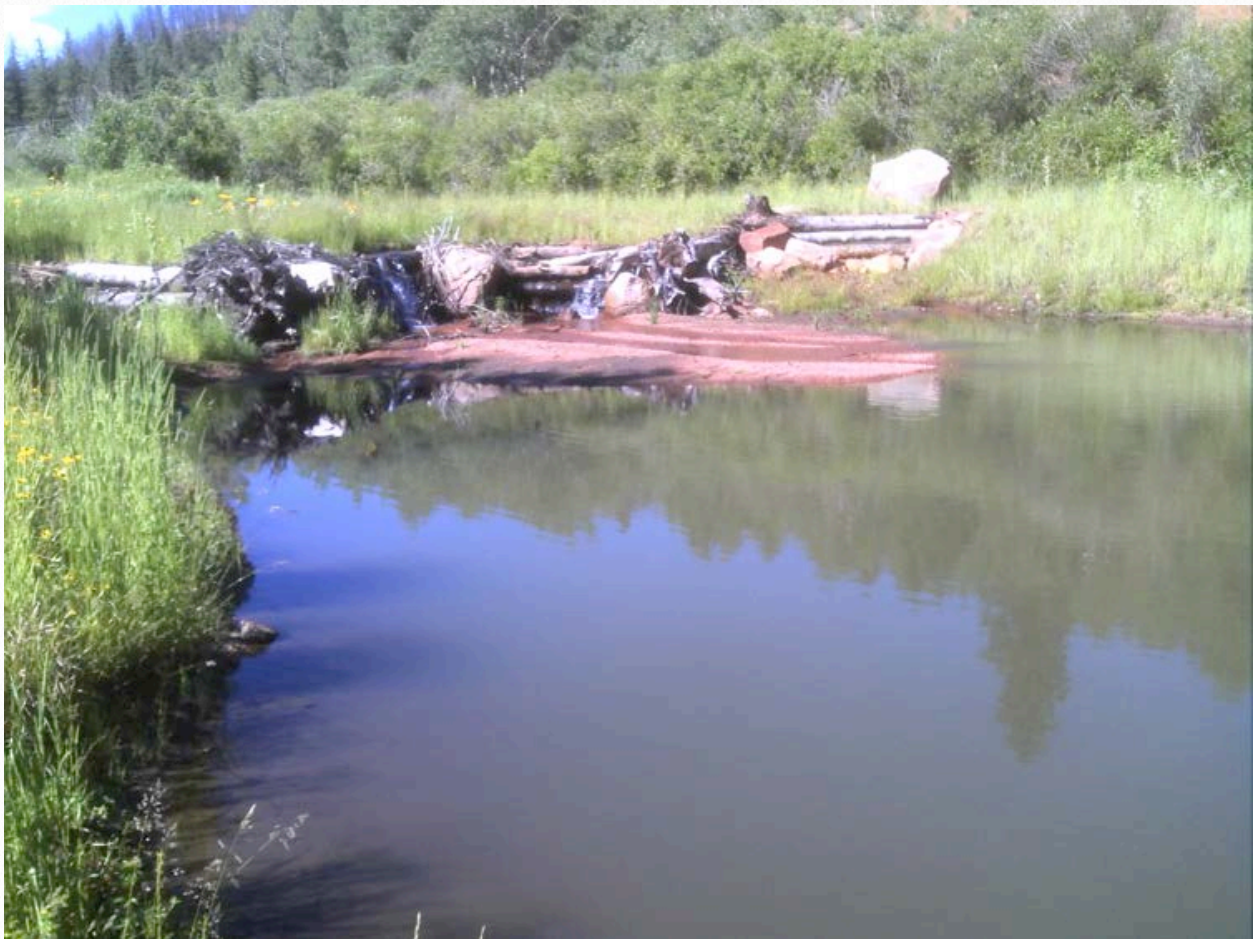
sin log crib walls have failed, typically the result of lateral migration of the channel around the structure. Basin crib walls in this reach are of an older design; typically straight, without wing walls or spur logs embedded into the adjacent banks. Straw waddles were installed along two segments in the middle of the basin, but neither of these features survived the floods in 2013.

Overall, only 25% of the treatments in the project reach were found to be fully functioning and 9% of the treatments were fully functioning but at risk. 60% of the work had failed completely, and 6% of the treatments were partially failed and not function at full potential. All of the treatment failures were in the upper and middle portions of the reach. The downstream boulder step pool channel constructed in 2014 is in good condition however, and is functioning to protect the basin from further unravelling. The sediment basins, although compromised, are still functioning to capture sediment and debris from the upper portion of the watershed. For these reasons, we concluded that the project is functioning as desired, but at risk to future failure as the capacity of the basins decreases over time.

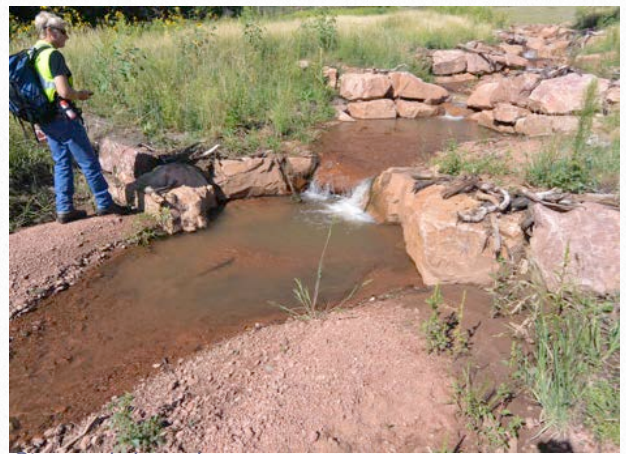
Step pool channel

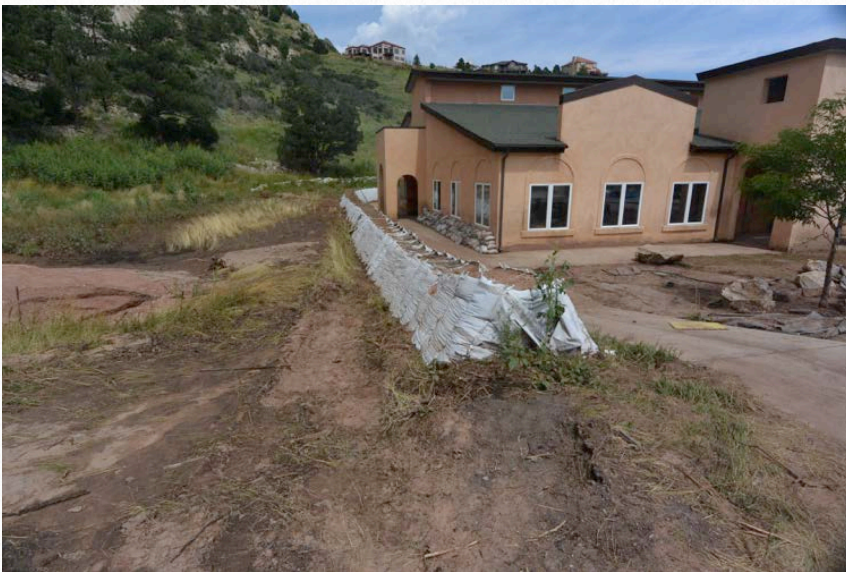
Autism school

The upper part of the reach sustained significant damage during the flood event. 40% of the log sills and 90% of the whisker sills sustained damage and were no longer fully functioning. Several of the whisker sills, which are constructed of PVC plastic pipe, had shattered, likely due to the large boulders and cobbles that were mobilized in the channel during the flood. The sediment basin, although damaged, was still functioning, and was being excavated by the City of Colorado Springs during the course of our survey. The trap bag walls surrounding the school were still fully intact, but flood was high enough to allow water to enter the building around these features.

The overall project reach sustained total failure of 44% of the treatments, mostly in the upper half of the reach. Critical structures, such as the sediment basin, are still functional, and continue to protect the school and neighborhoods downstream from catastrophic flooding. The sediment basin will continue to need periodic maintenance to ensure full function, therefore we considered the entire project reach as functioning at risk at this time.

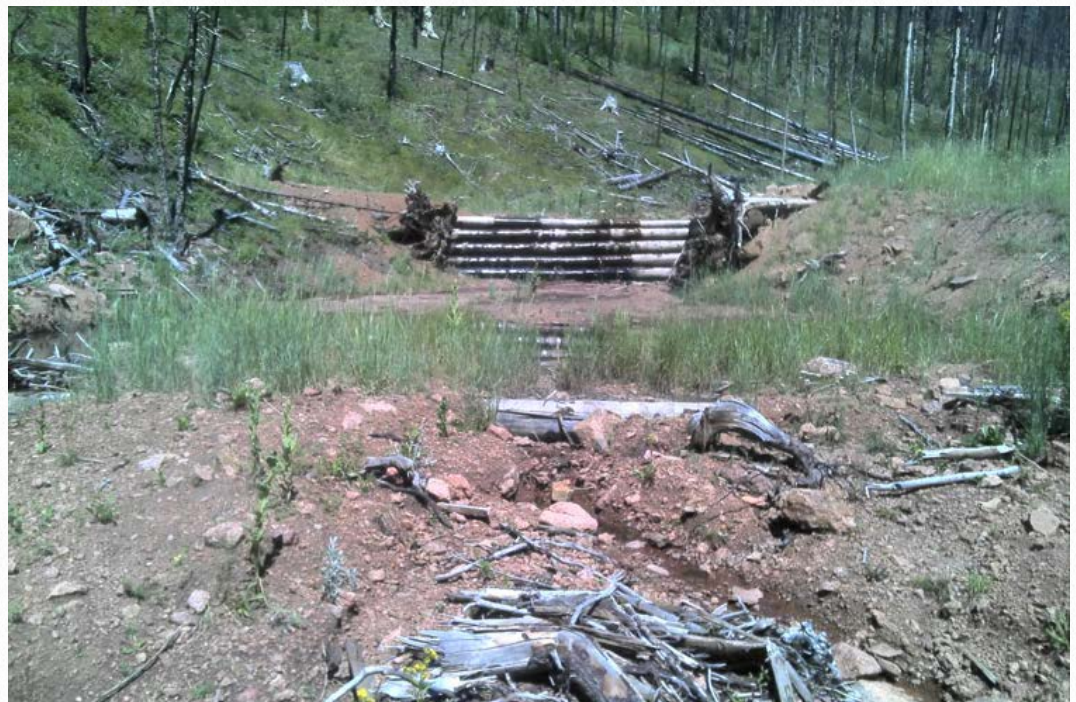
All of the sediment basins in the upper reach were functioning as designed, despite damage sustained in half of the basin crib walls in the reach. All of the basin sill logs were intact and functioning, which significantly contributed to the resilience of the sediment detention basins.

Seventy-five percent of the log sills in the project reach were in good condition, which represented some of the highest survival rates for log sills in the entire Waldo Canyon burn area.

Overall, 86% of the treatments in the project reach were found to be functioning as designed. Only 12% of the work had failed completely and 3% were partially failed and not functioning at full potential. We did not observe any failures that were catastrophic to the overall function of the reach, however, the three failed basin crib walls will likely limit the lifespan of the sediment detention basins immediately below. In total, the work is performing as designed and is considered successful, although it may be at risk from damage in future flood events.

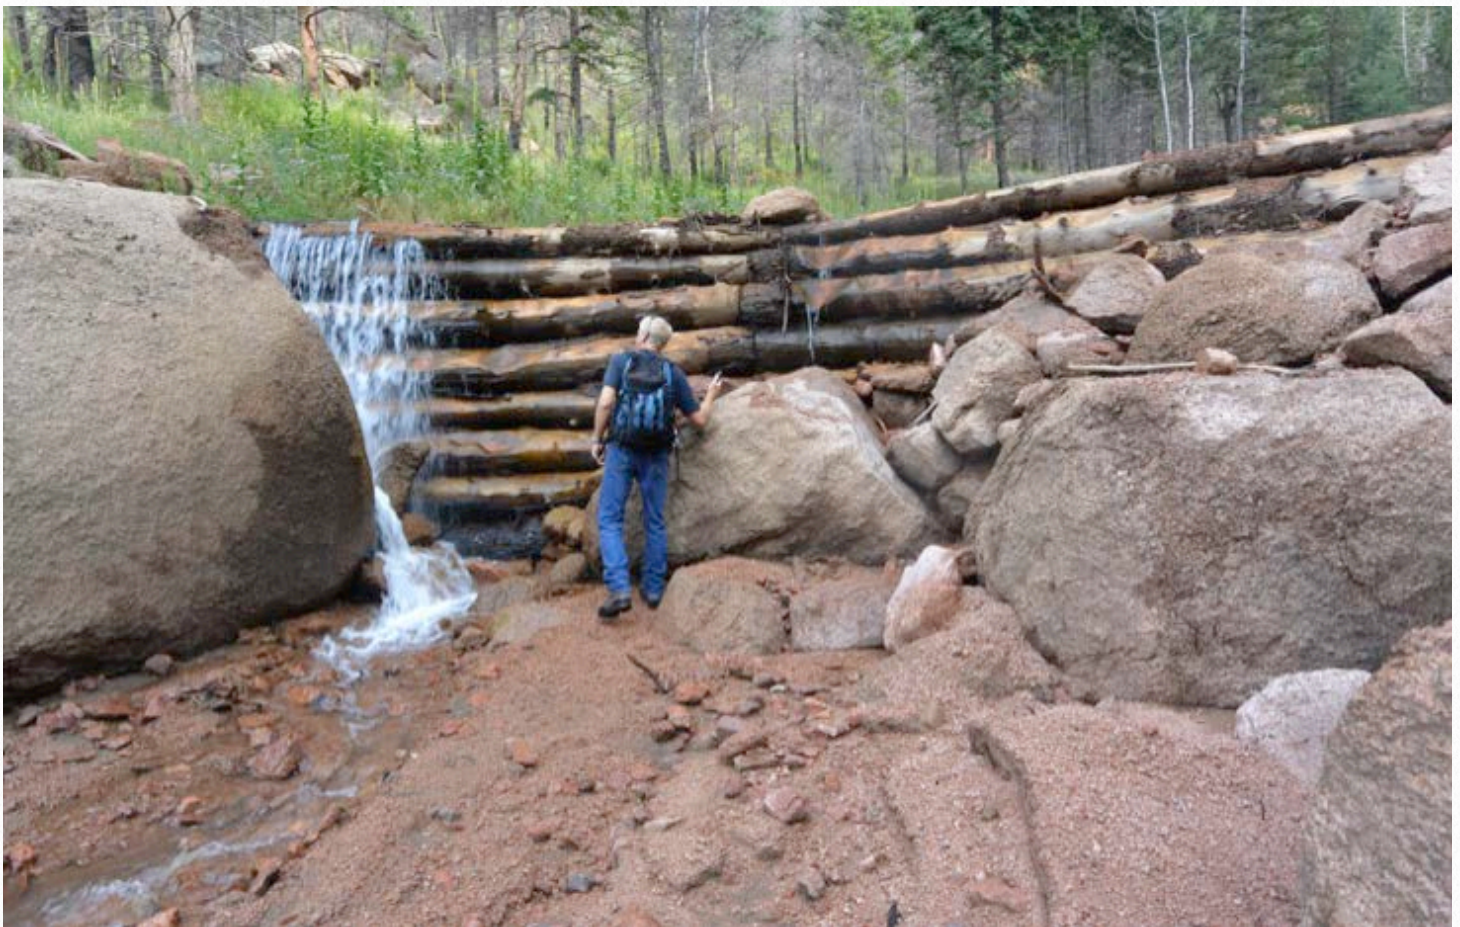
Log basin crib wall failures were relatively high in the Waldo Burn with 47% of these structures being at least partially failed. All of the completely failed structures were of the original design. All of the boulder crib walls were functioning at full potential, however half of these appeared to be at risk, primarily due to failure of the fabric behind the structure, or risk of lateral migration.

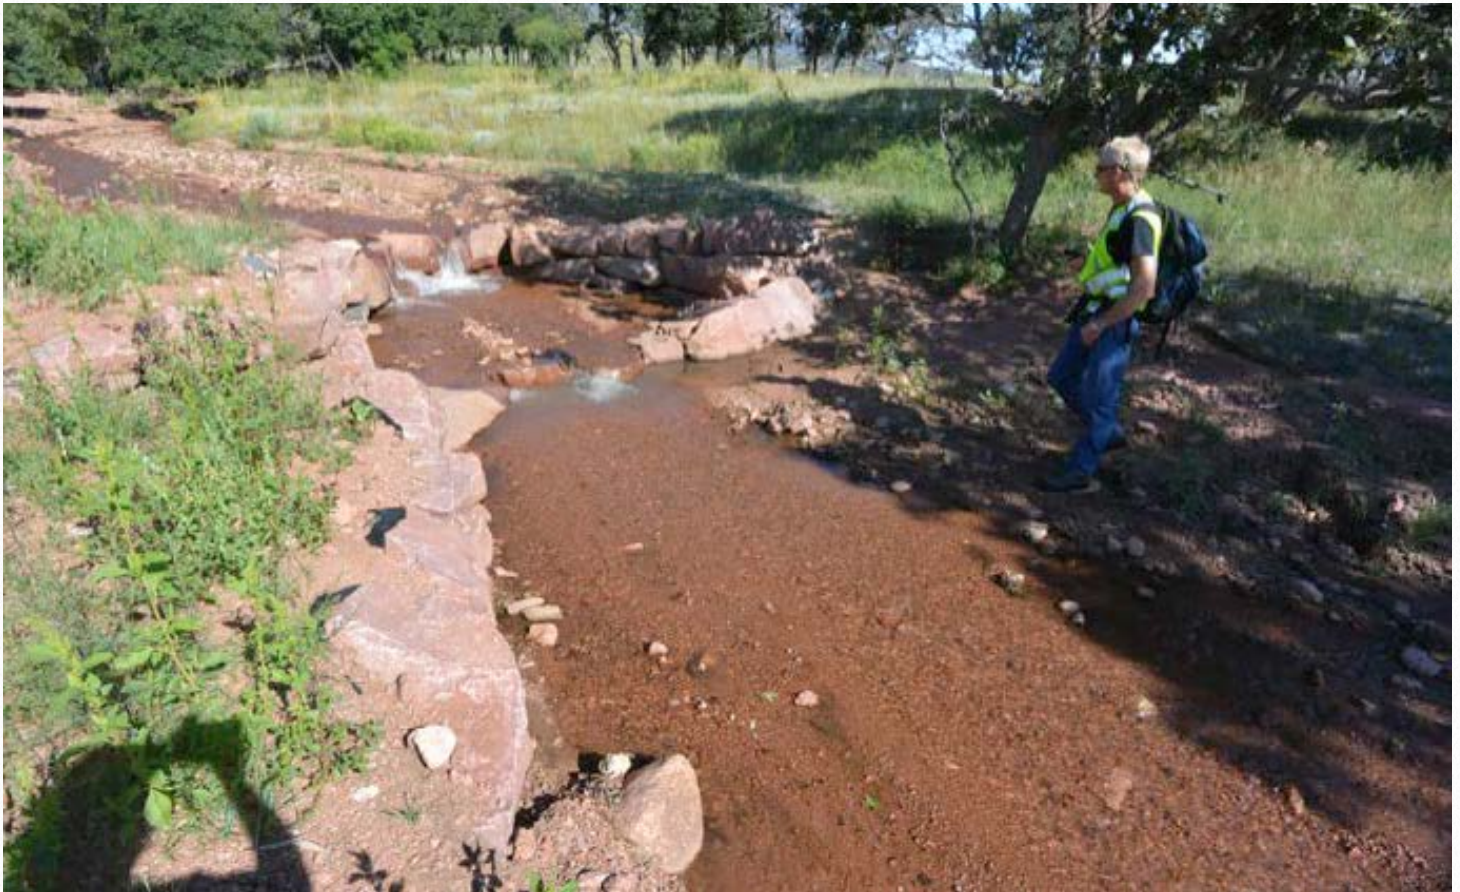
Of the one hundred and thirty-two boulder drop structures assessed in 2015, 73% were still in good condition and fully functioning. 14% of the boulder drop structures had either partially failed, or failed completely. Boulder drop structures typically failed due to tearing of the fabric behind the structure, or lack of adequate footer boulders causing the center of the structure to collapse. We should note here that we commonly observed that drop structure failures occurred at the critical downstream structure, resulting in formation of a head cut that would migrate upstream through the project reach, compromising the other structures. This was likely due to the use of smaller materials as the stockpile of more suitable rock was consumed during the course of construction.

Typical boulder drop structure

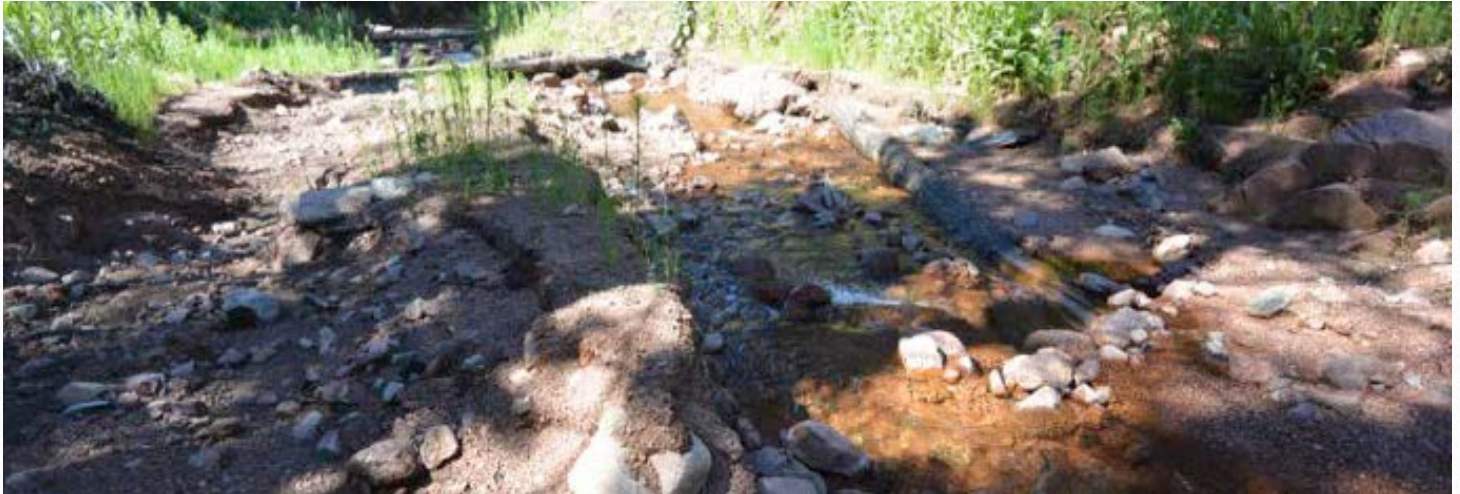
Boulder Log Veins

water surface slope along the stream bank through various flow stages, reducing velocity and shear along the bank. Boulder and log vanes can be very effective in reducing stream bank erosion, but their use is limited in highly erosive channel beds such as found in the Waldo Canyon burn. For this reason, very few of this treatment type were used in Waldo Canyon project reaches. Where this technique was employed, success was limited, with 75% of the log vanes and 50% of the boulder vanes completely failing.

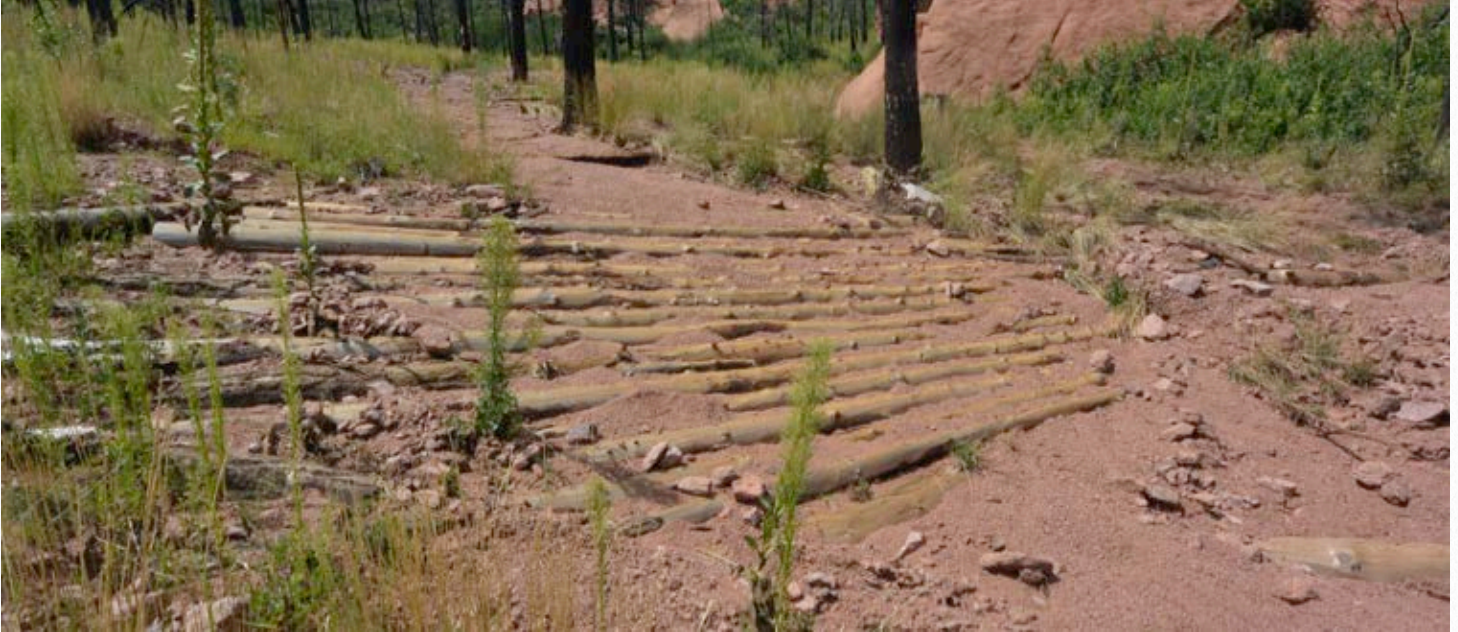
equipment. Unfortunately, the log corduroy treatments we assessed in the Waldo Canyon project reaches were, for the most part, being used in segments of channel that were inappropriate for the technique.
