Stream Management Planning

Lessons Learned From the Rio Grande Basin

Sustaining Colorado Watersheds

October 2019

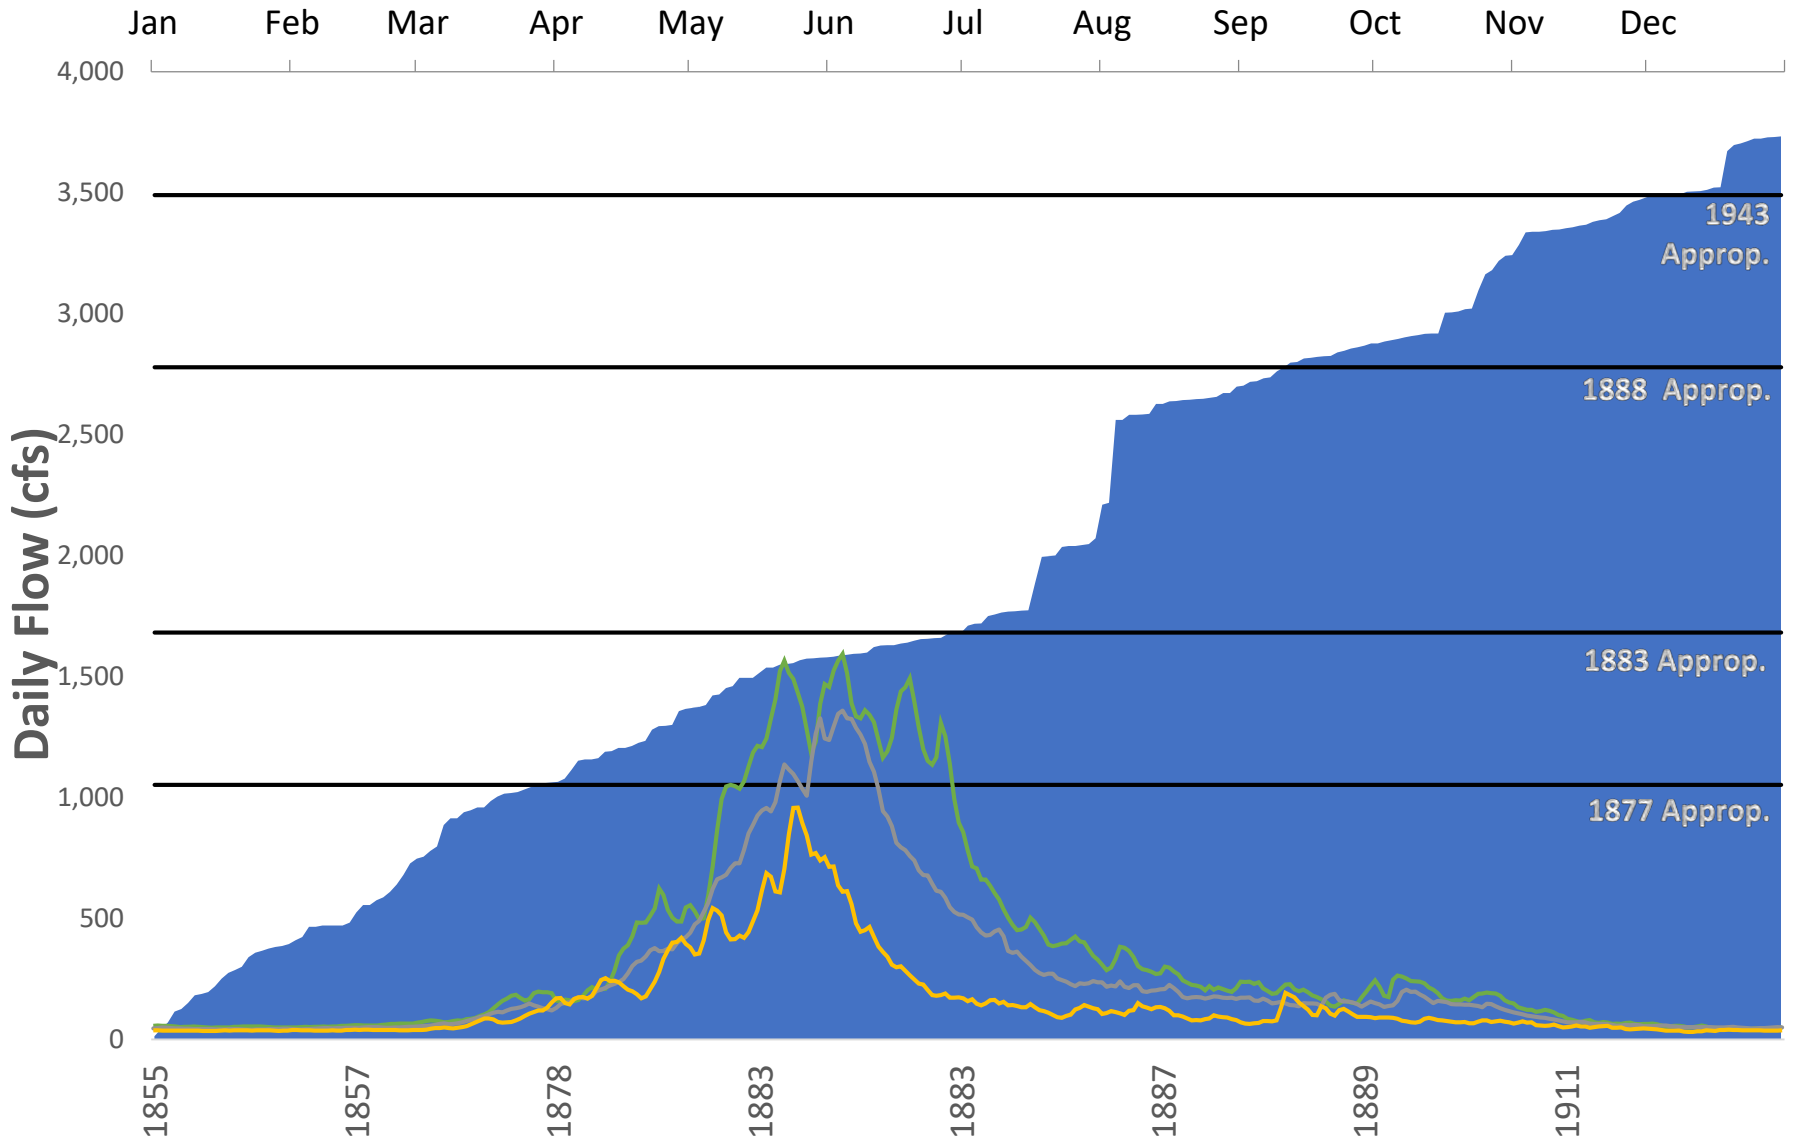
Conejos Basin (Water District 22)

Cumulative Absolute Surface Water Rights vs. Daily Flow

- Cumulative Water Rights
- Conejos River nr Mogote - Average Year
- Conejos River nr Mogote - Wet Year
- Conejos River nr Mogote - Dry Year

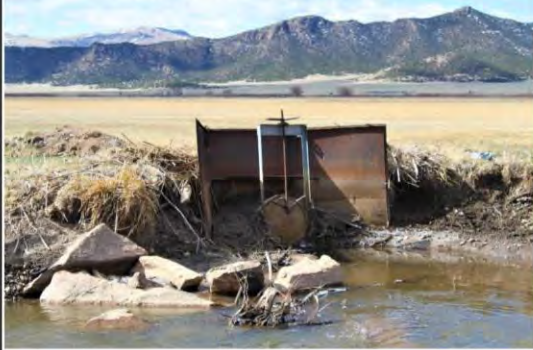
Headgate looking downstream

Headgate Type: Manually operated 2.5' wide screw gate

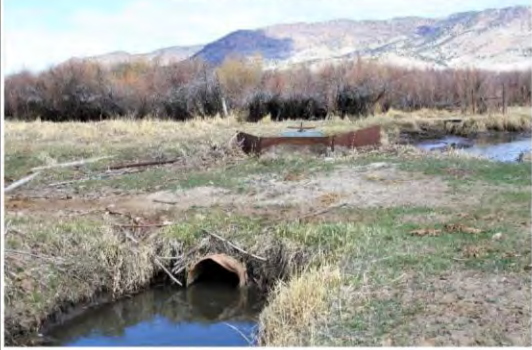
Headgate outlet

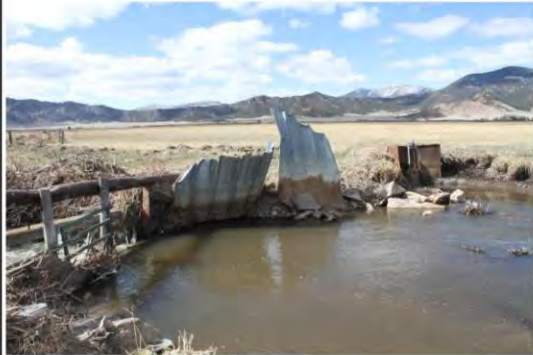
Headgate and diversion dam

Structure Description: The ditch is located on the outside of a meander. The diversion dam is a combination of boulders, sheet metal, fencing, and concrete. The diversion constricts the stream and appears to be causing erosion downstream. Woody debris accumulates at the headgate and on the diversion dam. The headgate is tilted and could be reset.

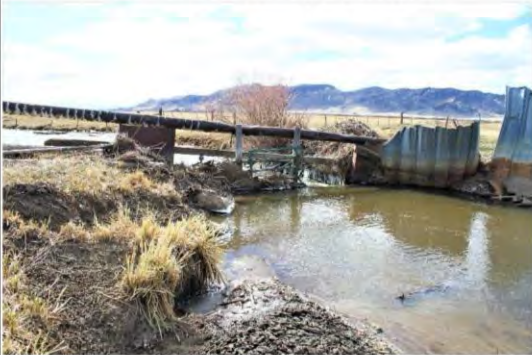
Diversion dam looking downstream

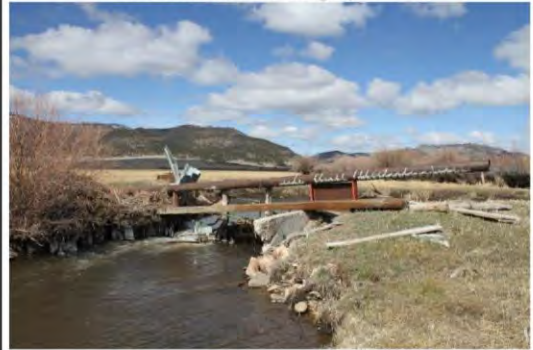
Diversion dam looking upstream

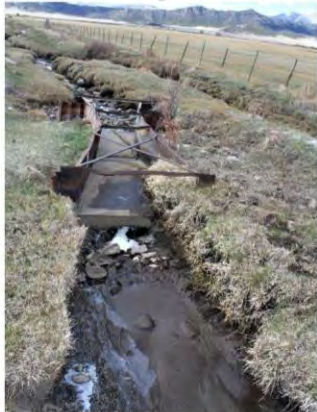
Flume looking downstream

Repair(s) or Improvement(s) Currently Needed: The diversion dam should be improved to mitigate debris accumulation. The flume is aging and may need to be replaced in the near future.

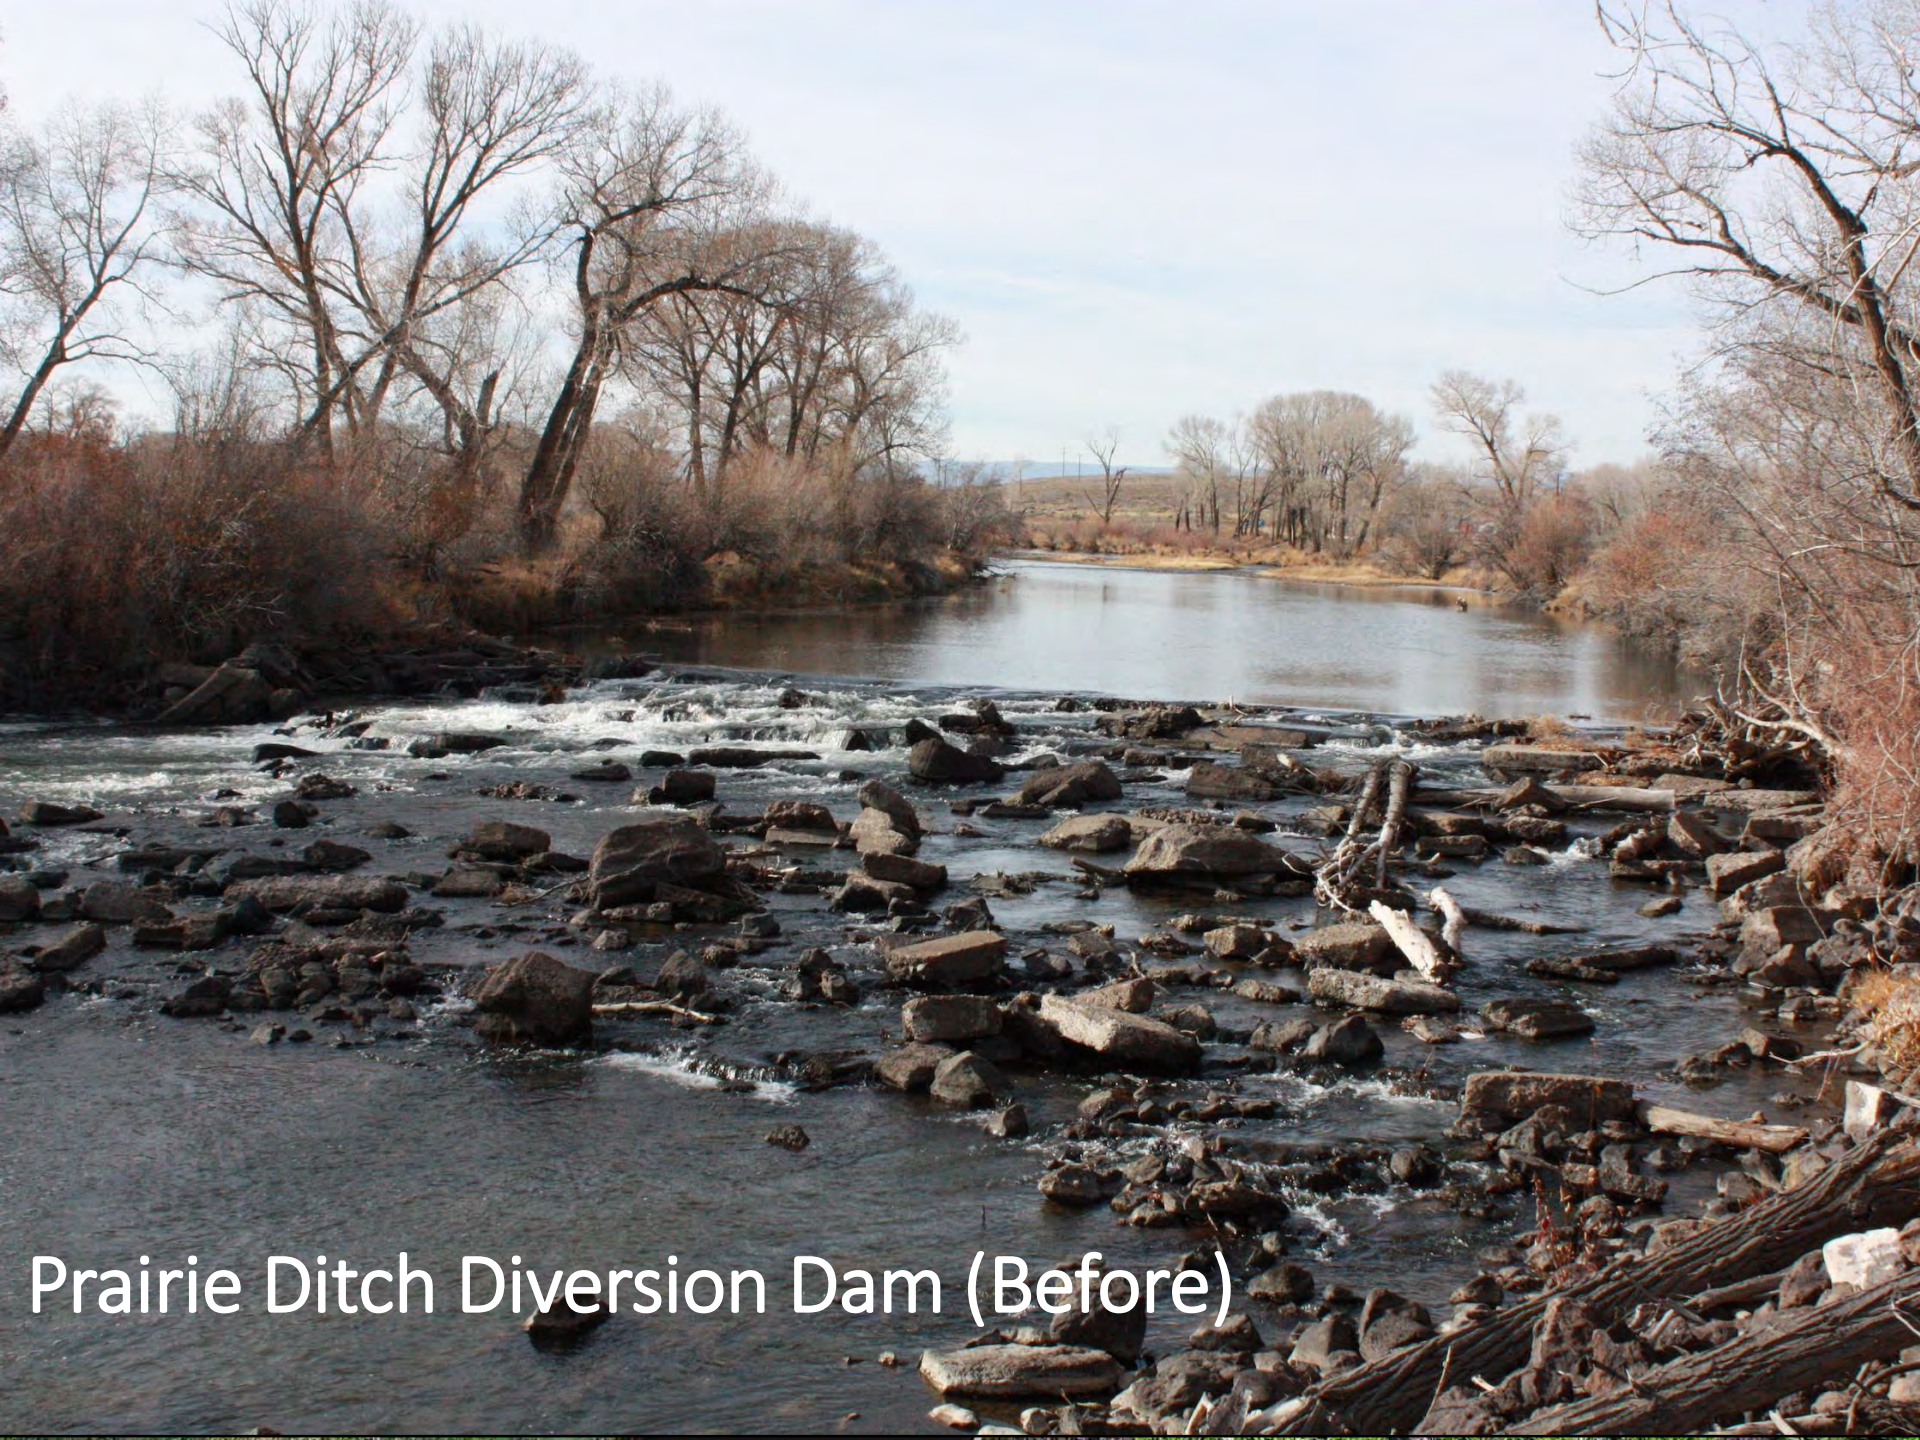
Prairie Ditch Diversion Dam (Before)

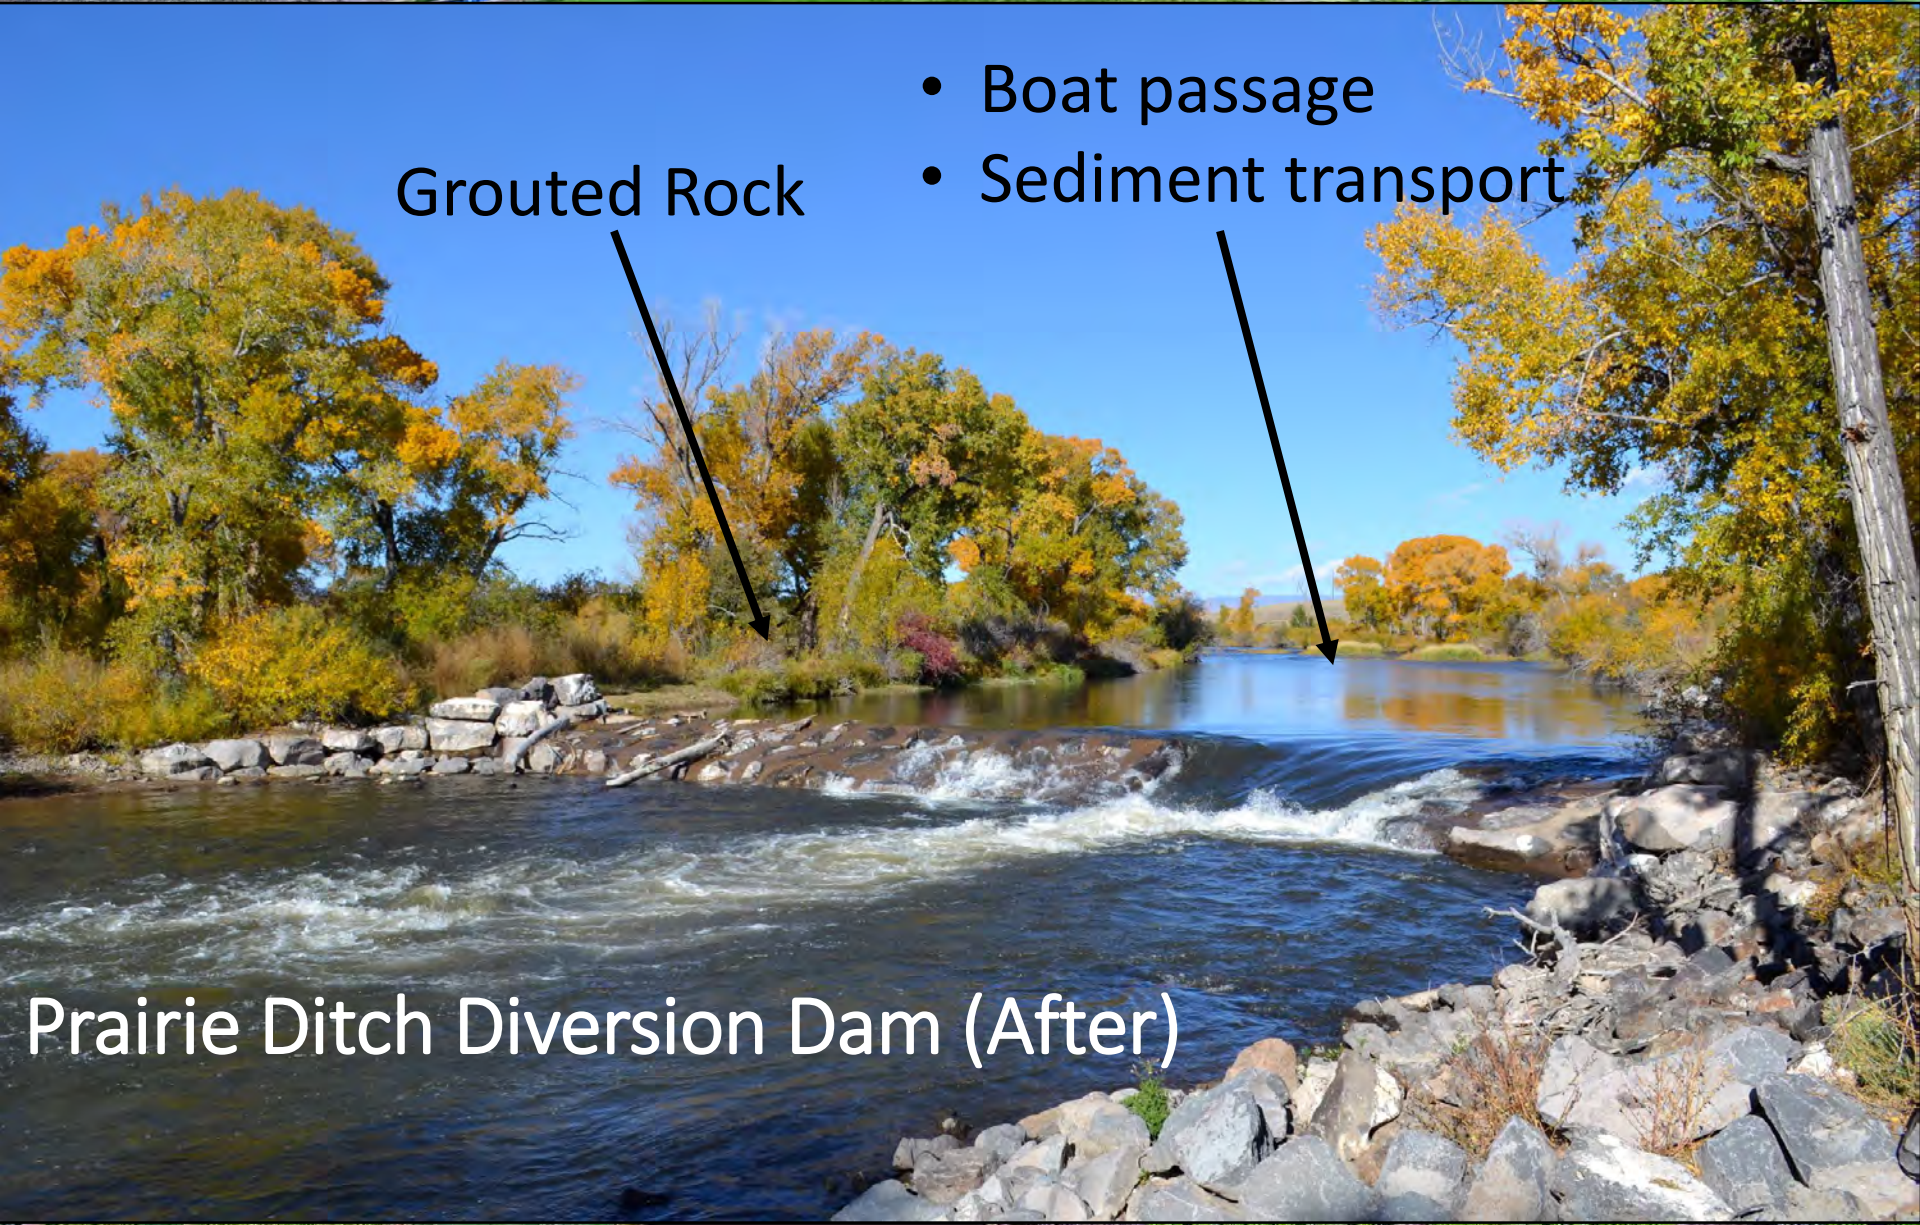
Grouted Rock

- Boat passage
- Sediment transport

Prairie Ditch Diversion Dam (After)
