Bridging the Gap Between Science and Policy in Fluvial Hazard Zones

Cameron Wobus¹, Virginia Gazzetti², Page Weil¹, and Graeme Aggett¹ ¹Lynker Technologies, ²Boulder County Community Planning and Permitting

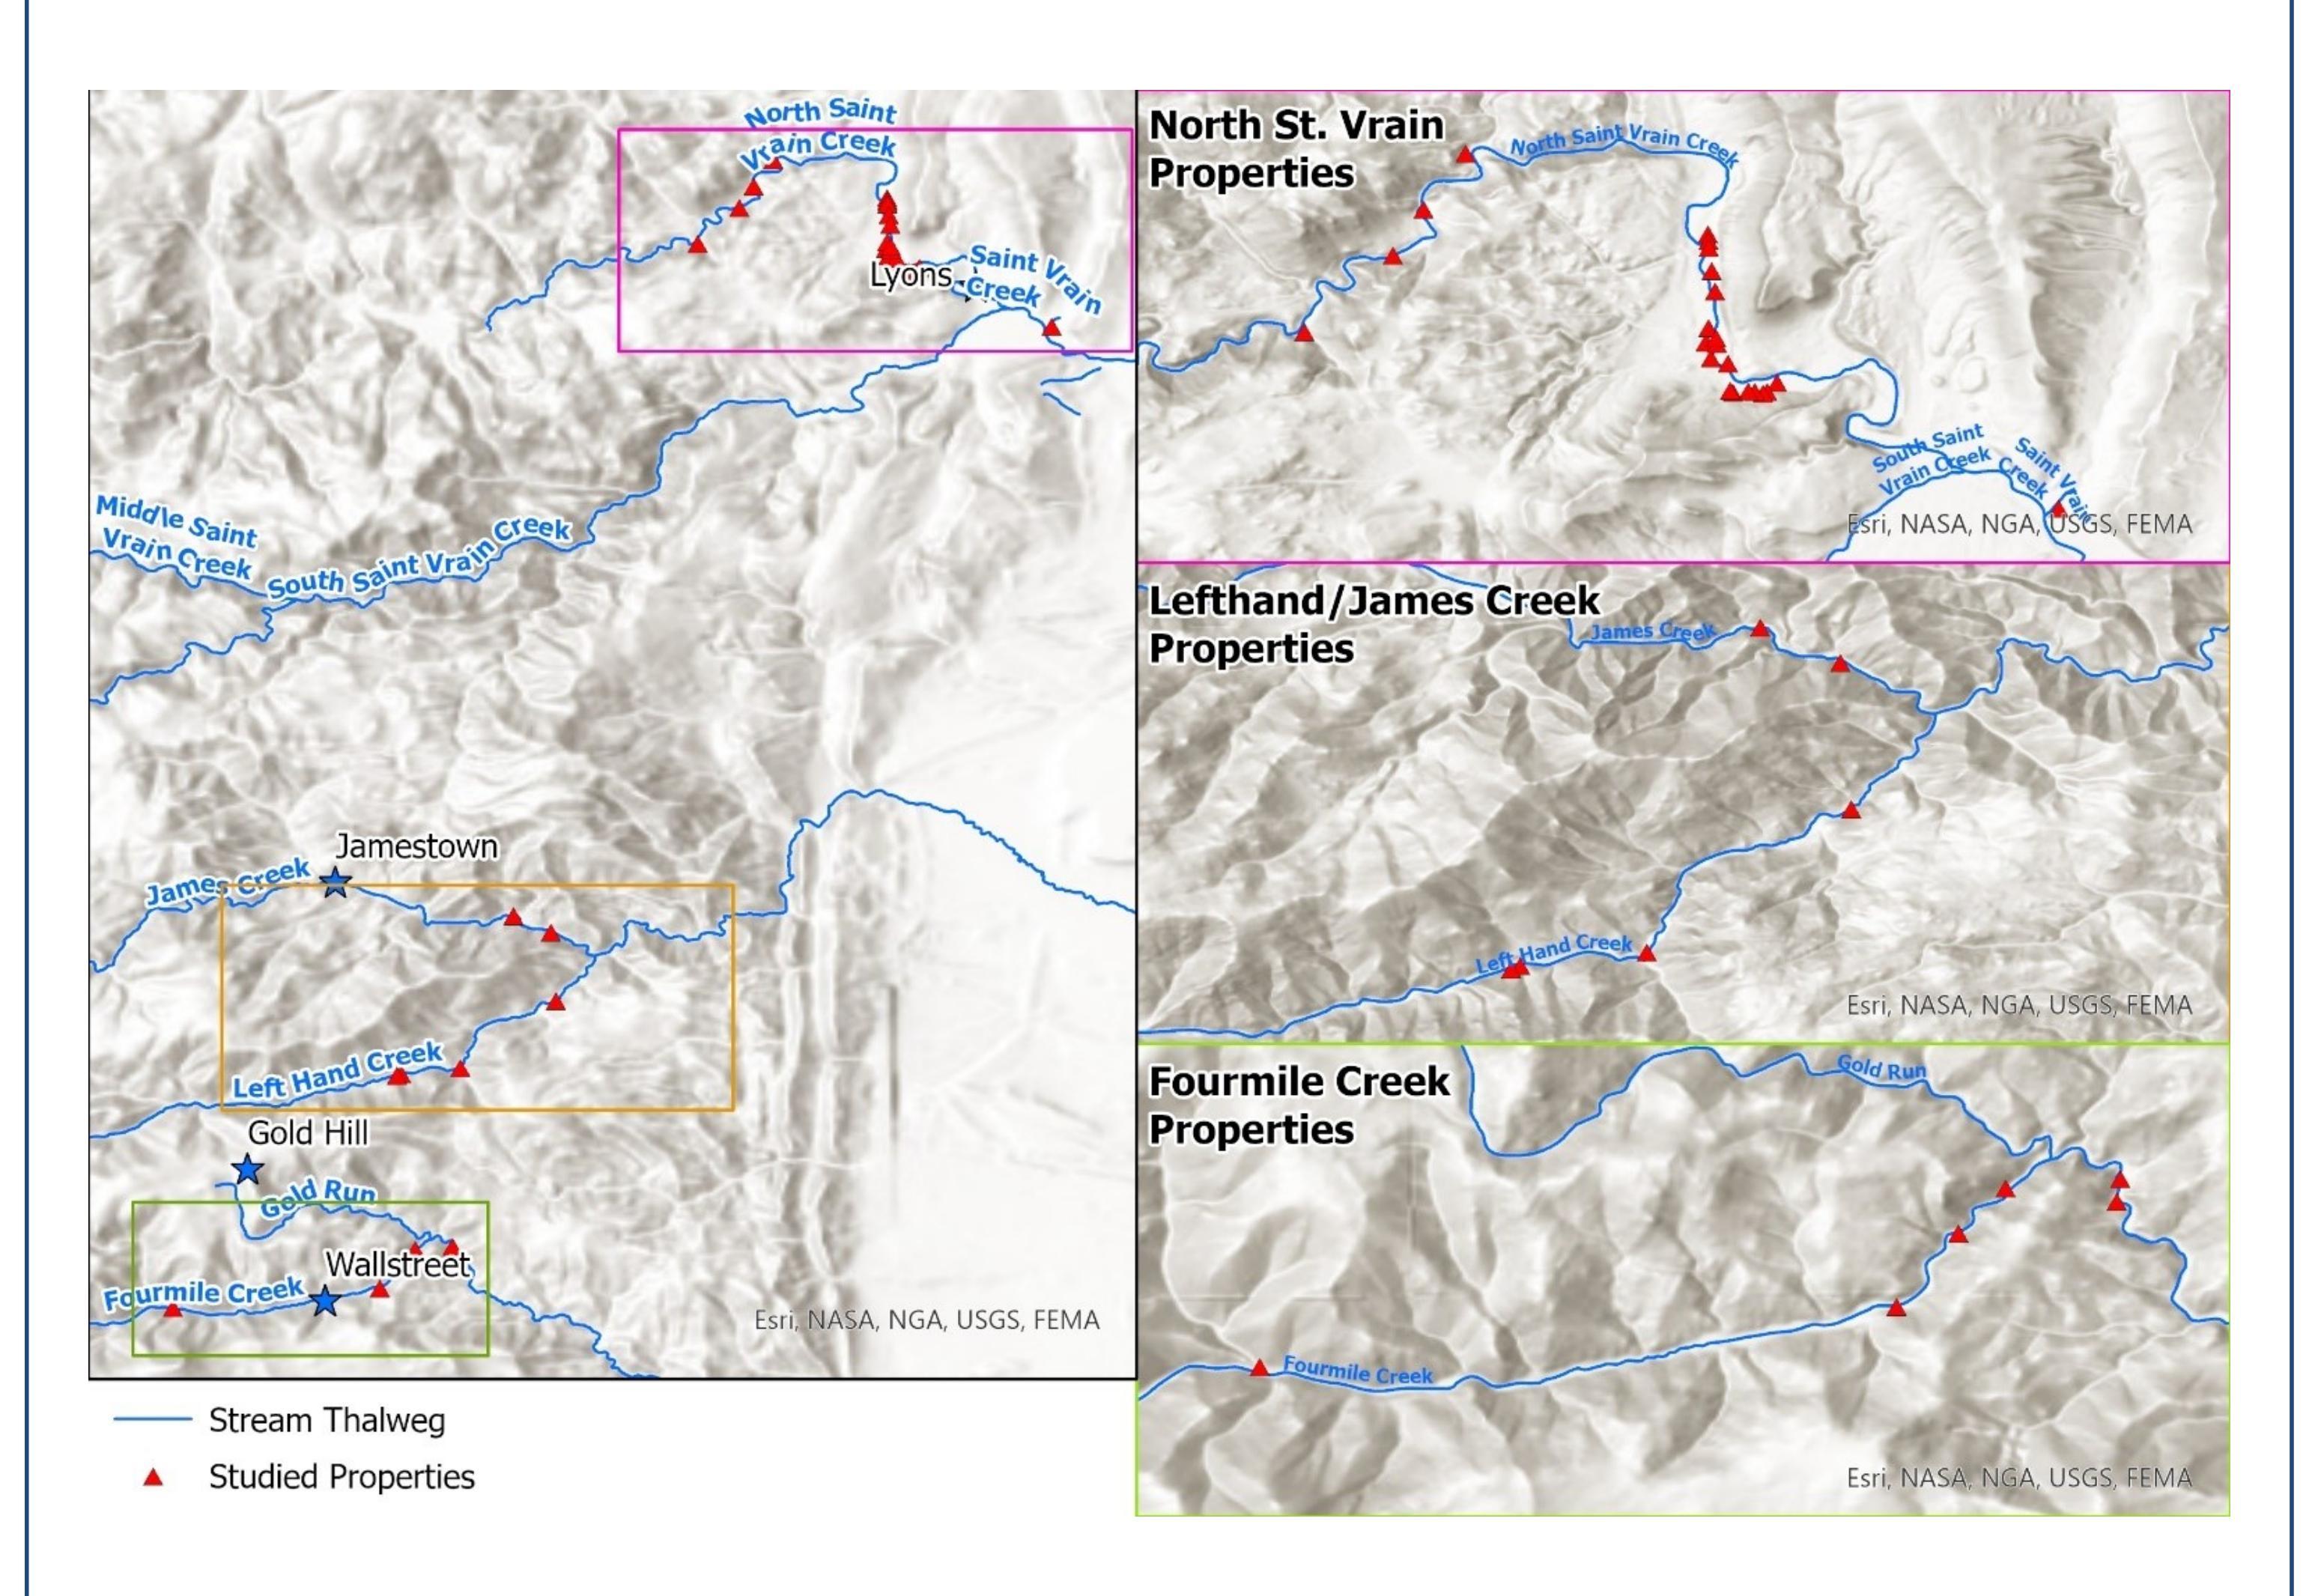
Our core dataset for this analysis was a database of properties in Boulder County that sustained substantial losses in the 2013 flood event. This database contained flood loss information for 35 properties located primarily in mountainous locations of western Boulder County (Figure 1). For each property, we obtained information on the address, the structure design (e.g., 1-story or 2-story), and the fractional loss incurred during the 2013 event as determined by the substantial damage estimation (SDE) method.

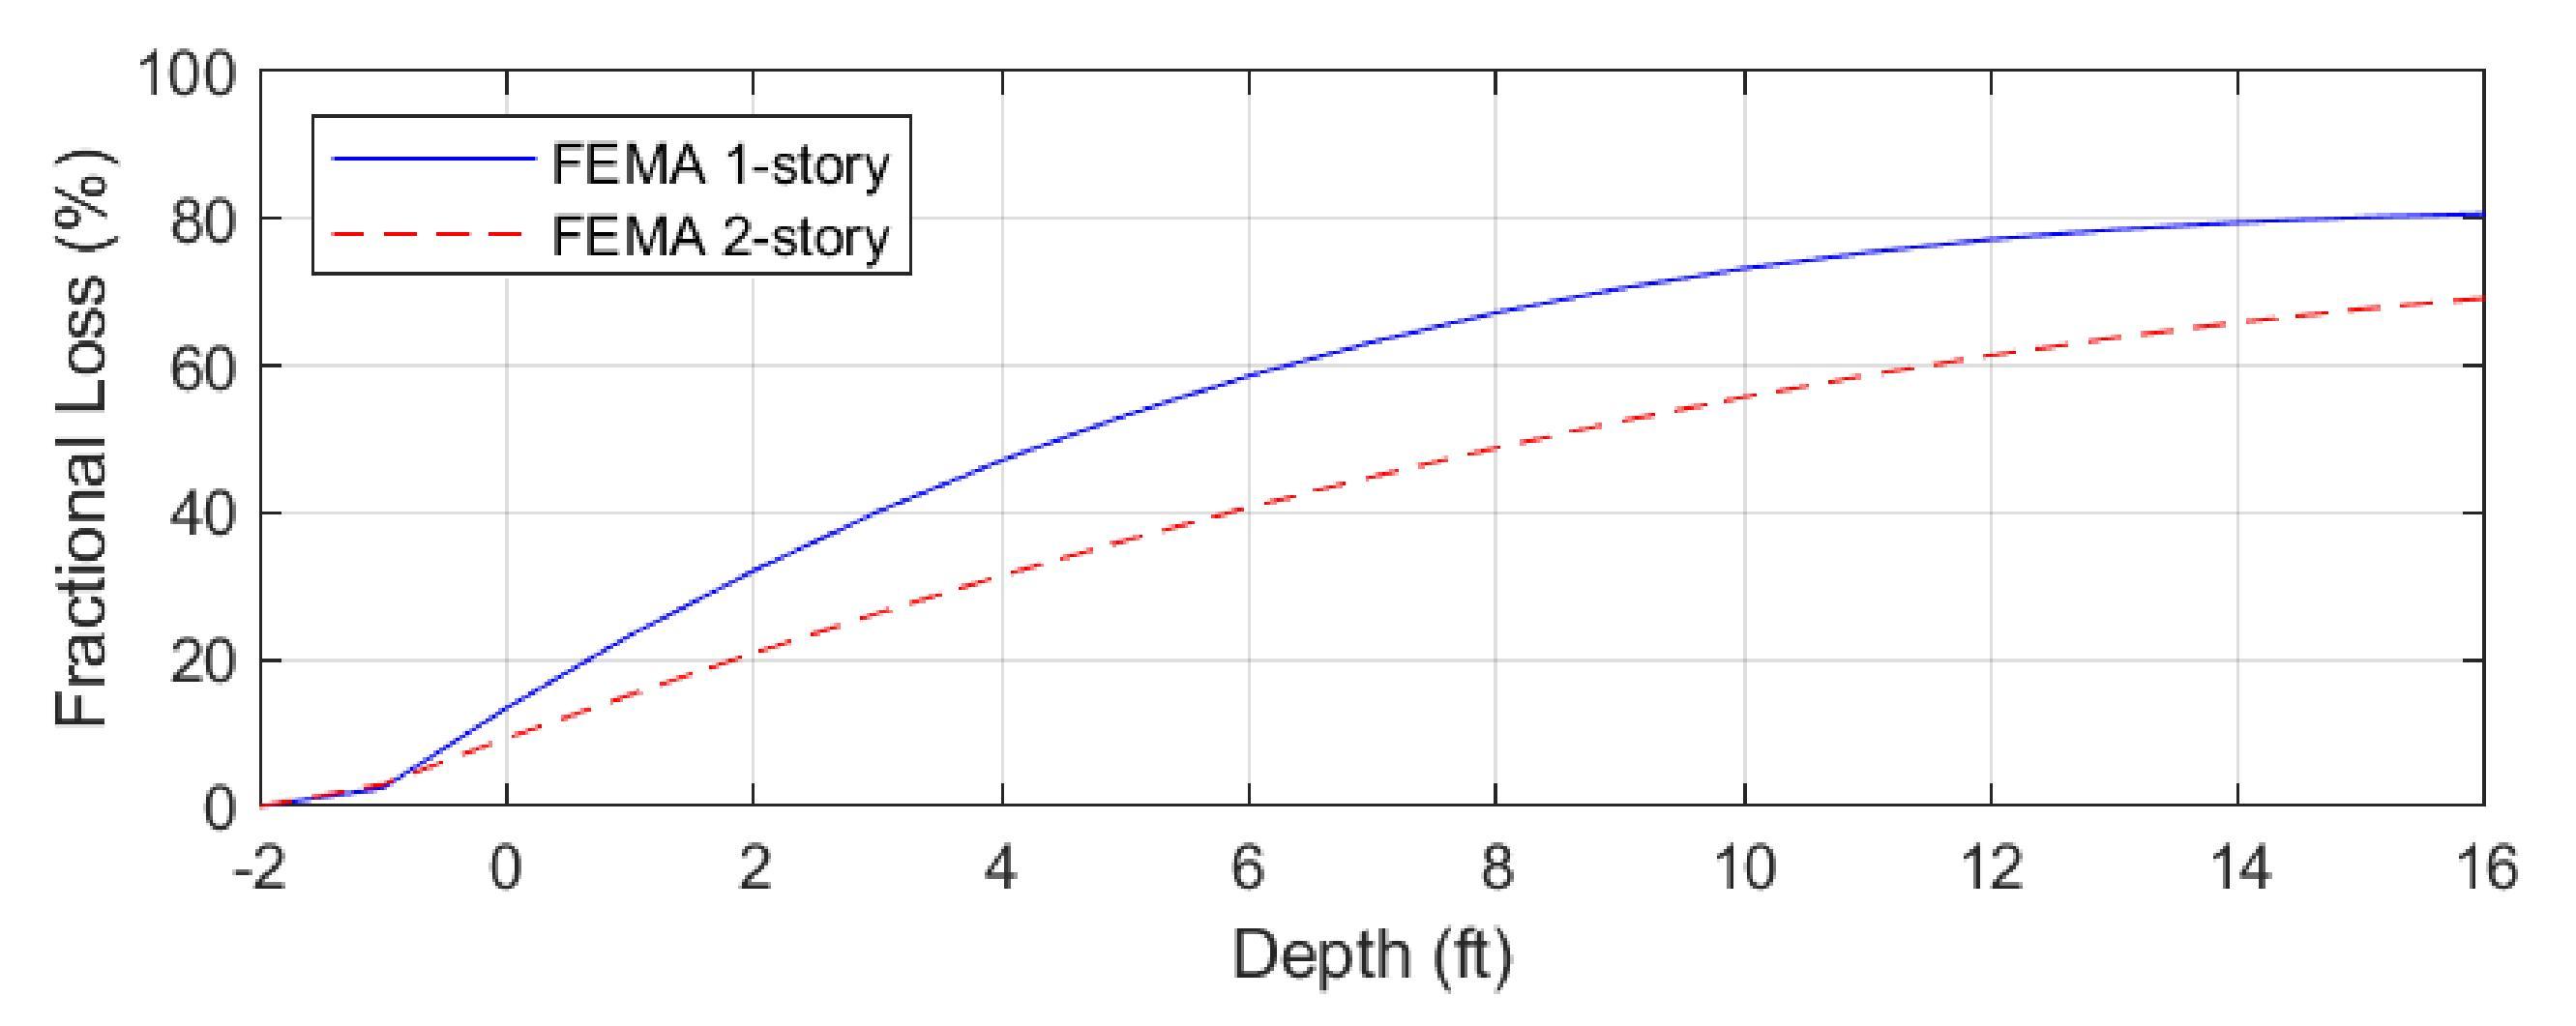
- We used the depth-damage curves embedded in the FEMA benefit cost analysis tool to estimate the fractional loss to the property from a flood with that depth.
- We use the generic depth-damage curves built into the FEMA BCA tool to ensure compatibility with the methods used to evaluate FMA grant eligibility.

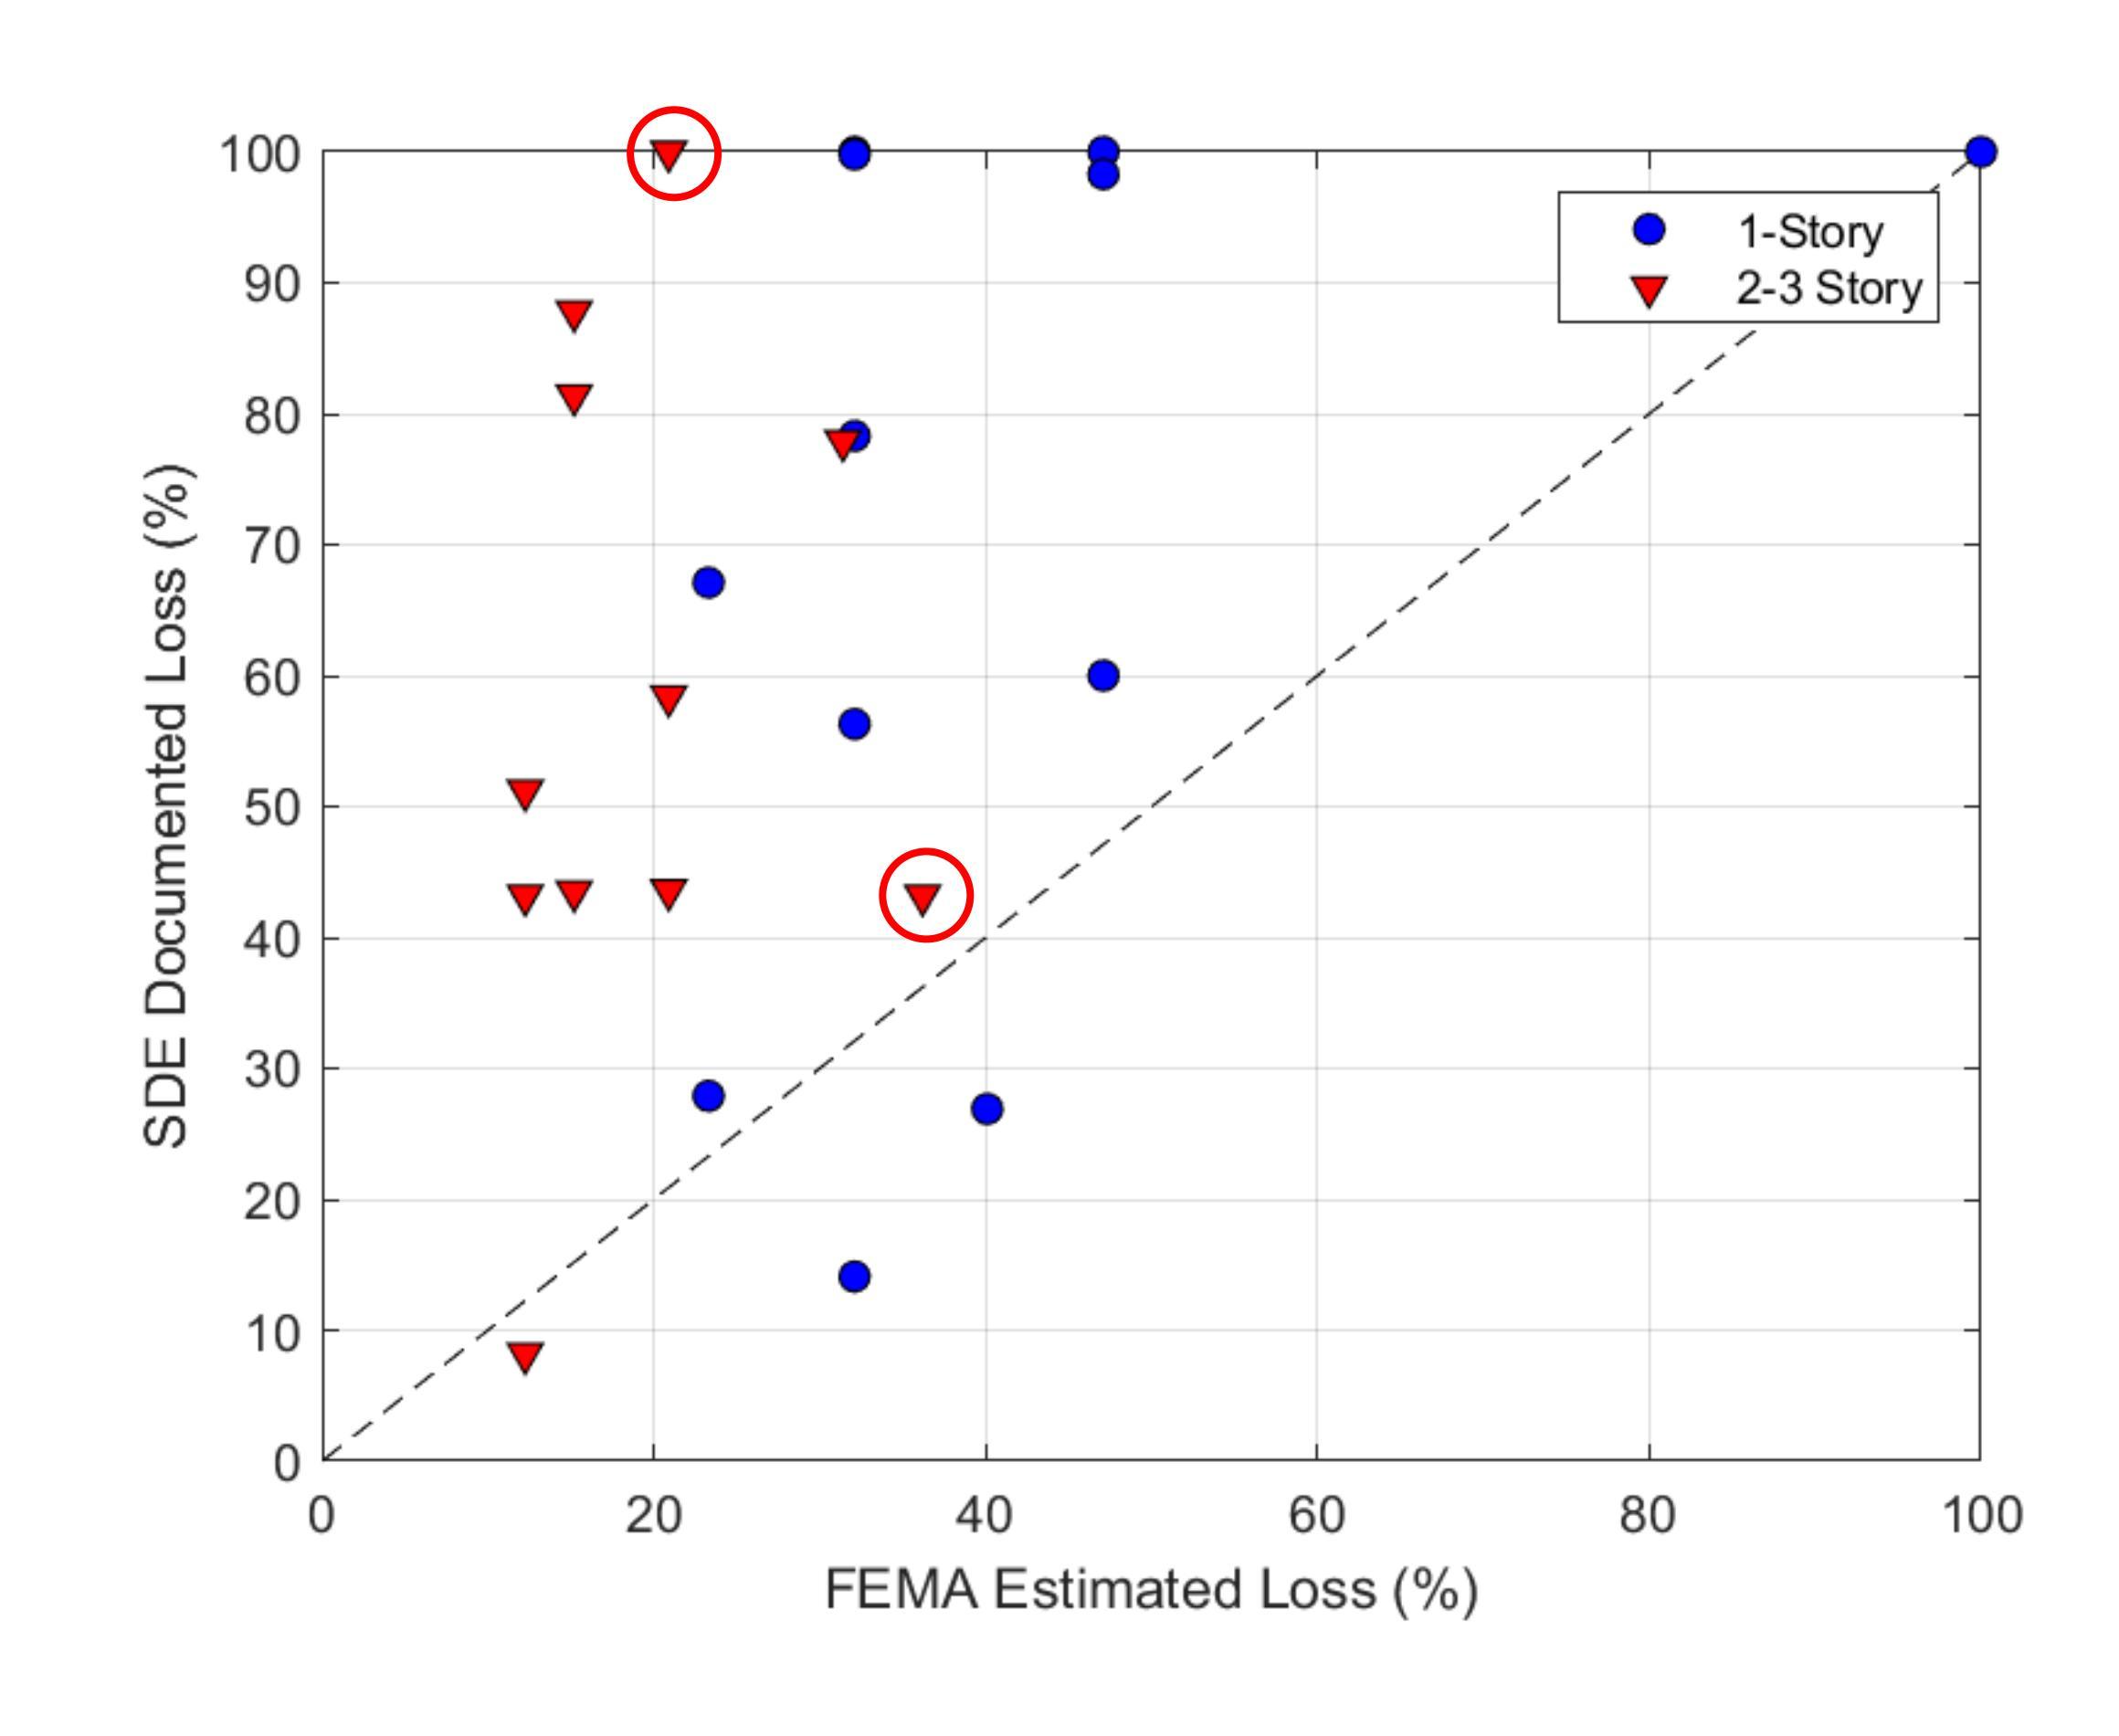
- Of the 24 properties with reliable flood depth data, 20 of them (83%) reported fractional losses greater than the loss predicted using the FMA methodology
- This result was independent of property type

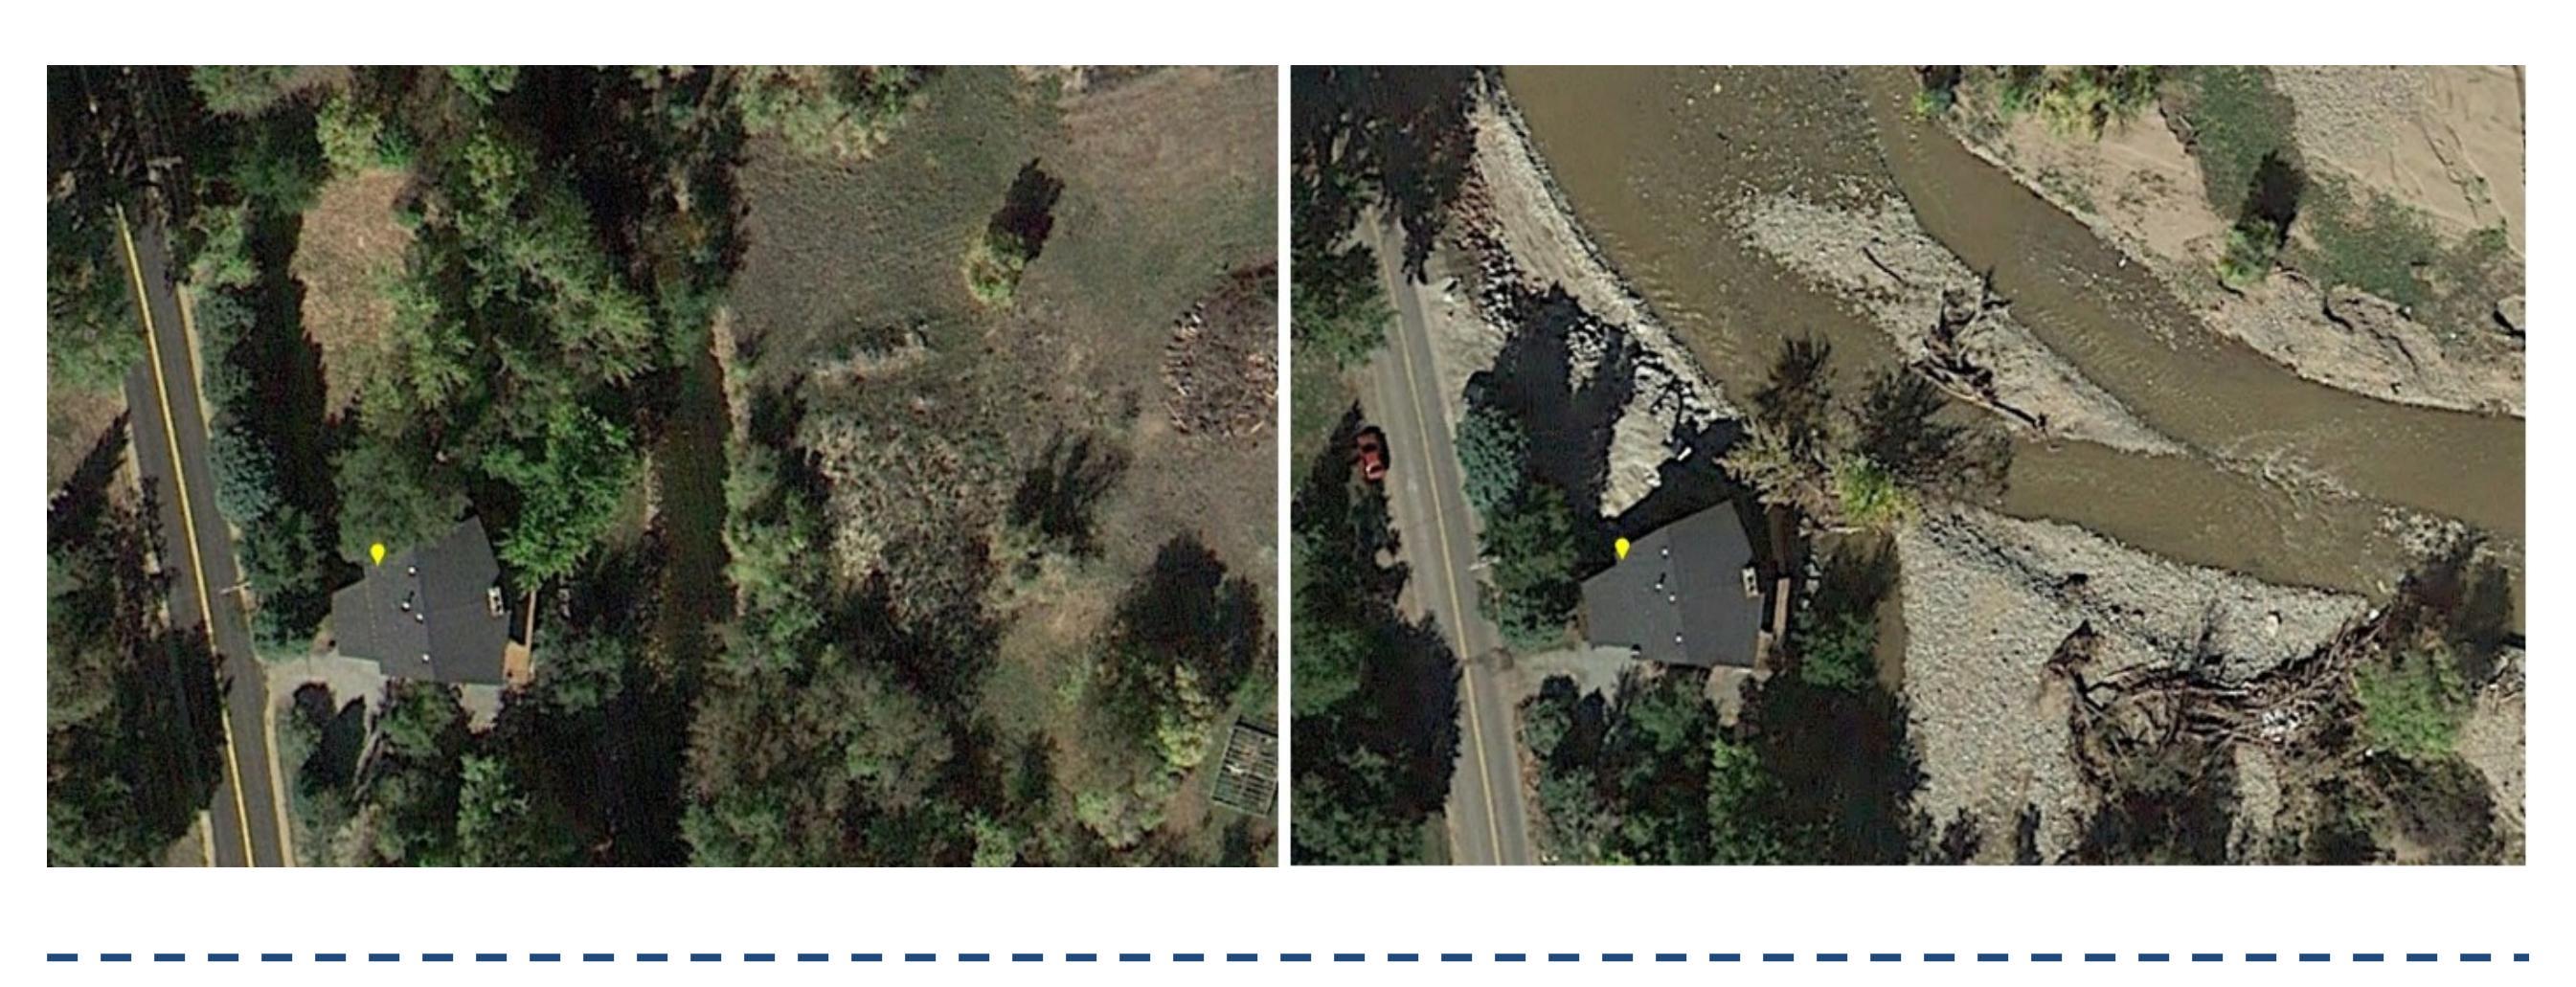
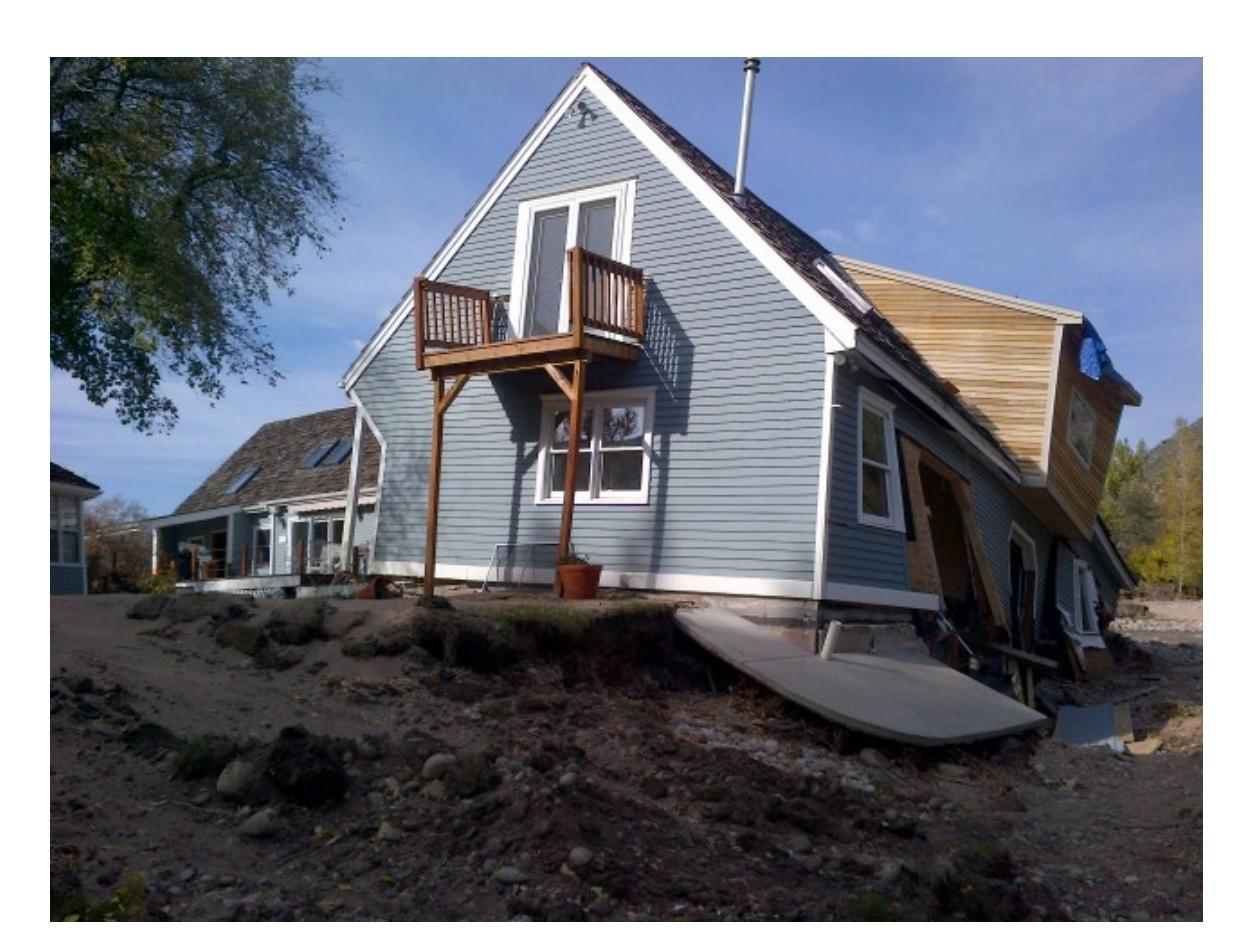
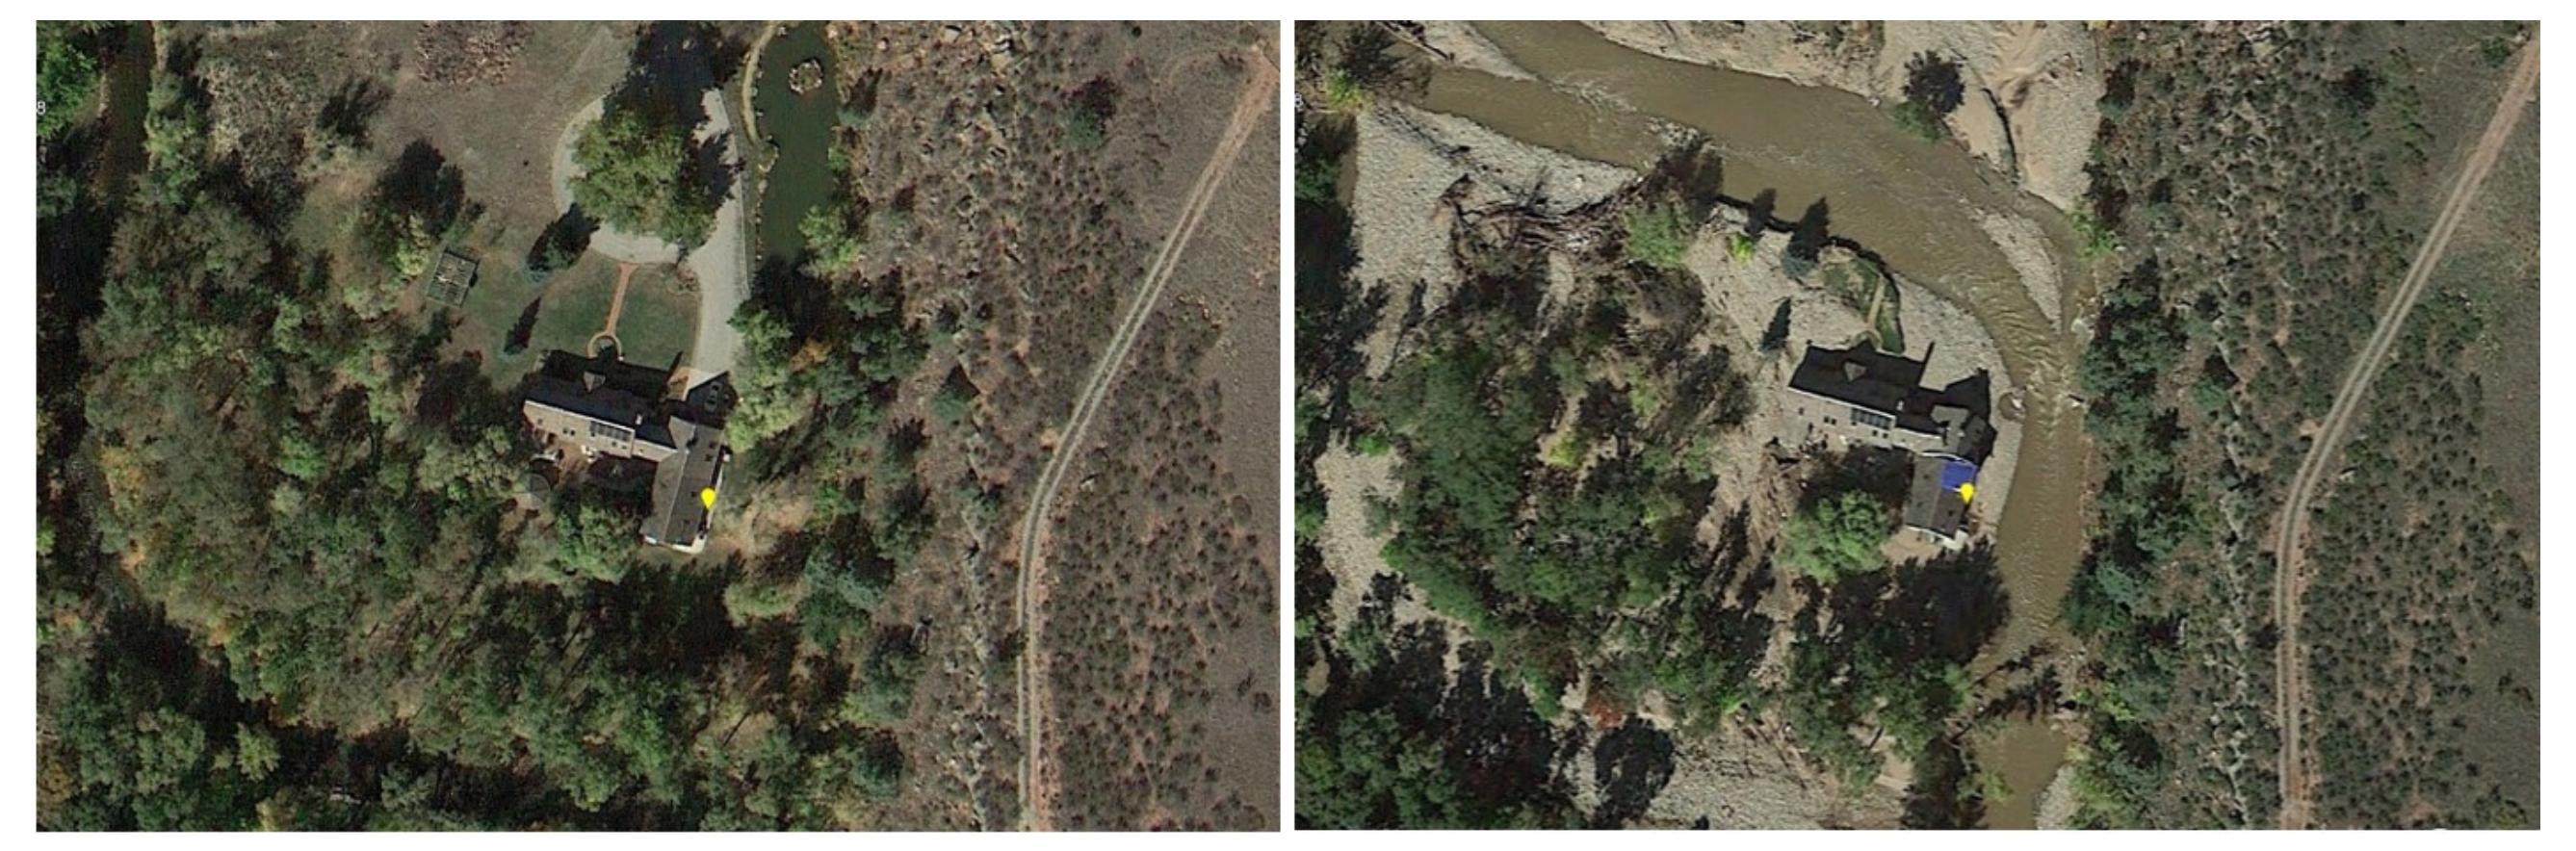
- Properties with SDE reported losses similar to FEMA estimates typically had no evidence of structural damage
- Google Earth imagery for these properties showed that erosion and sedimentation did not infringe on the building footprint

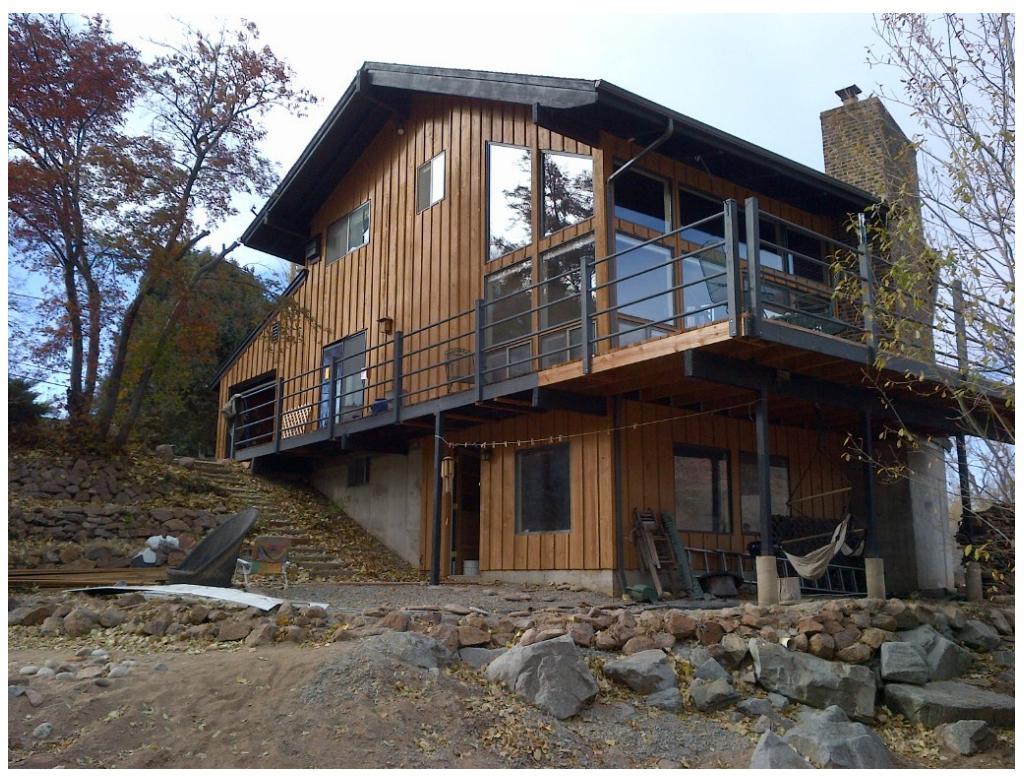
- Properties with SDE reported losses much greater than FEMA estimates typically had clear structural damage
- Google Earth imagery for these properties showed channels migrated through the building footprints
