SECTION 319 NONPOINT SOURCE POLLUTION CONTROL PROGRAM
WATERSHED PROJECT FINAL REPORT

High Park Bum

Reclamation by

Jennifer Kovceses, Coalition for the Poudre River Watershed
Fiscal Sponsor
Rocky Mountain Flycasters

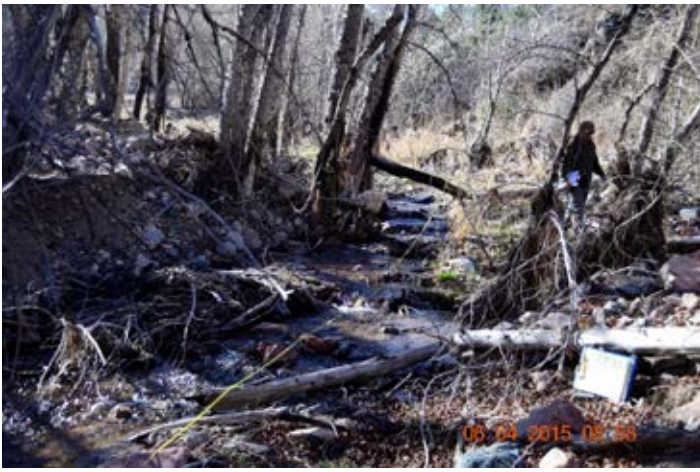
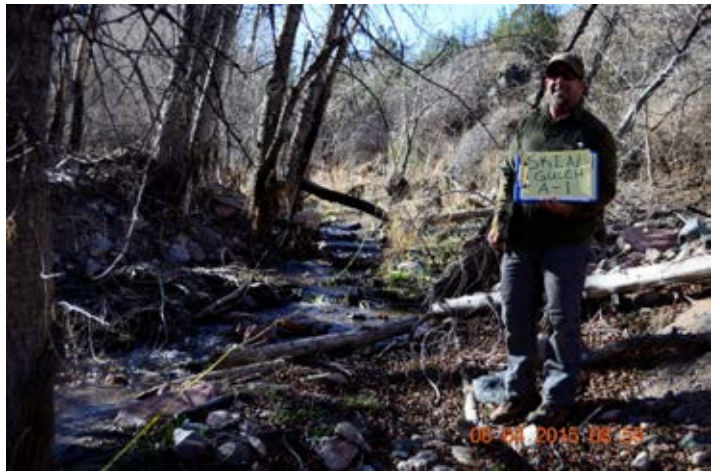
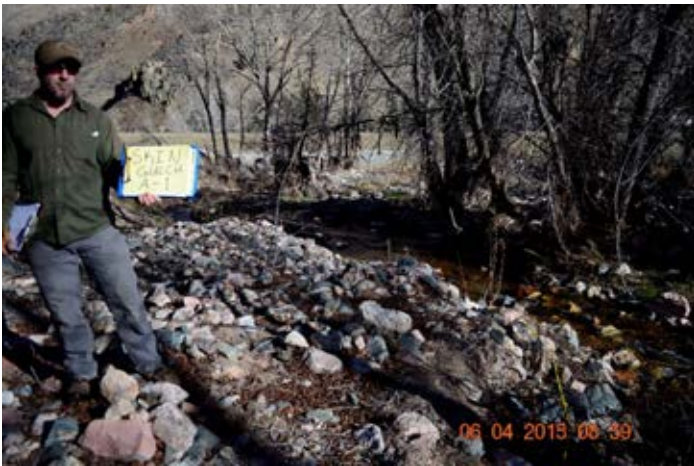
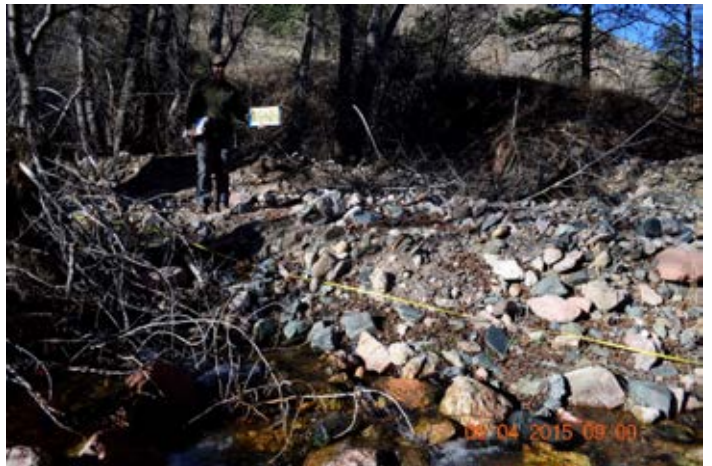
Skin Gulch, Subreach A1

Figure 3. Field photos of Skin Gulch Reach A. Clockwise from top left: Looking downstream at subreach A-1 at deposited sediment piles. Looking downstream on subreach A-2 at relatively stable reach with low banks and low floodplain. Looking upstream on subreach A-4 at loose sand, gravel, and cobble material on both banks. Looking upstream on subreach A-6 at large riprap along right bank and eroded hillslope toe on left bank.

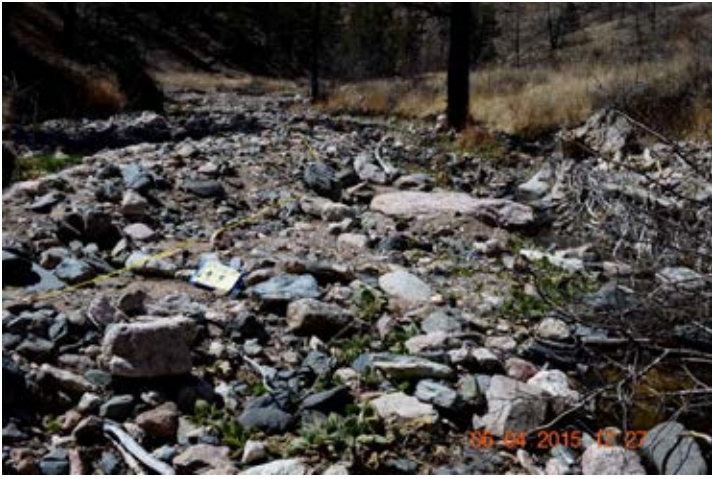
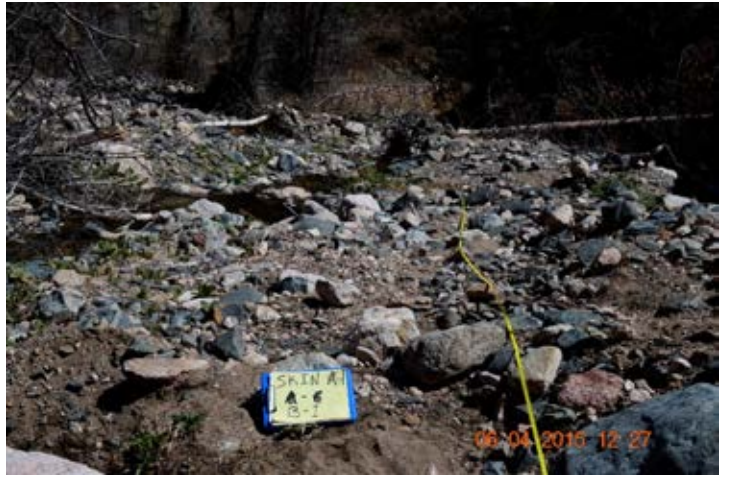
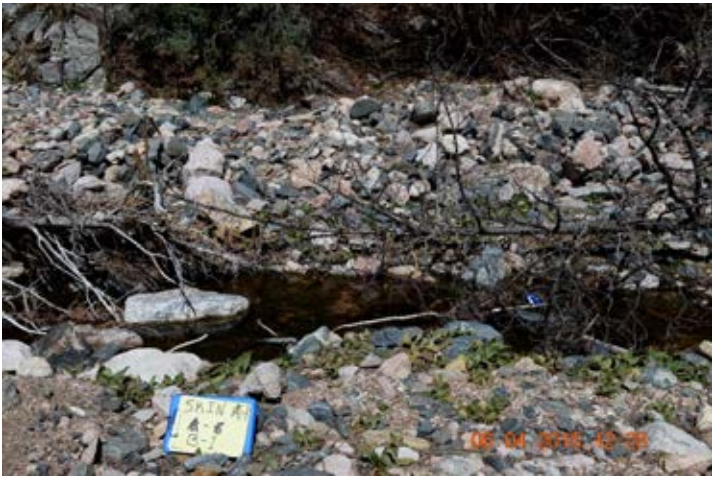
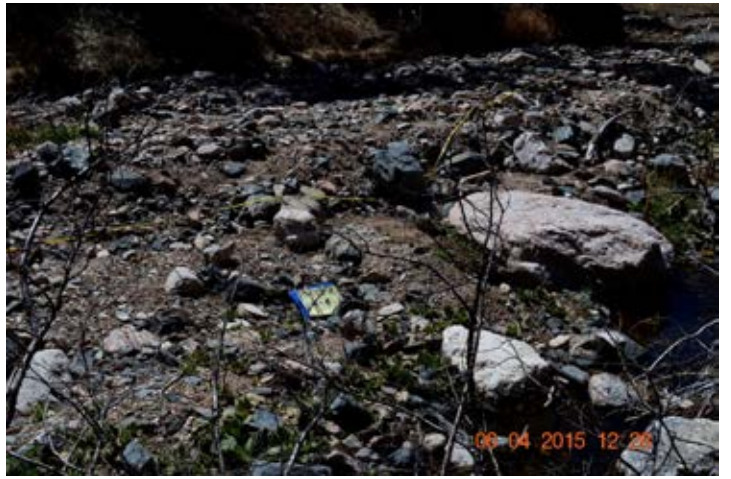
Skin Gulch, Subreach B1

Figure 4. Field photos of Skin Gulch Reach B. Clockwise from top left: Looking upstream on subreach B-1 over sand to boulder material deposited in channel and floodplain. Here, low flow seeps underneath this large wedge of deposited material. Looking upstream on subreach B-2 at channel through newly-deposited sand to boulder material and eroded hillslope on left bank. Looking downstream on subreach B-2. Eroded hillslope with loosed sand to silt-sized material on left bank of subreach B-2.
